Thompson Lake Dam  
Dam Identification No. 753 | City of Howell, Livingston County

## NATIONAL DAM SAFETY PROGRAM INSPECTION REPORT

December 20, 2021

August 12, 2021

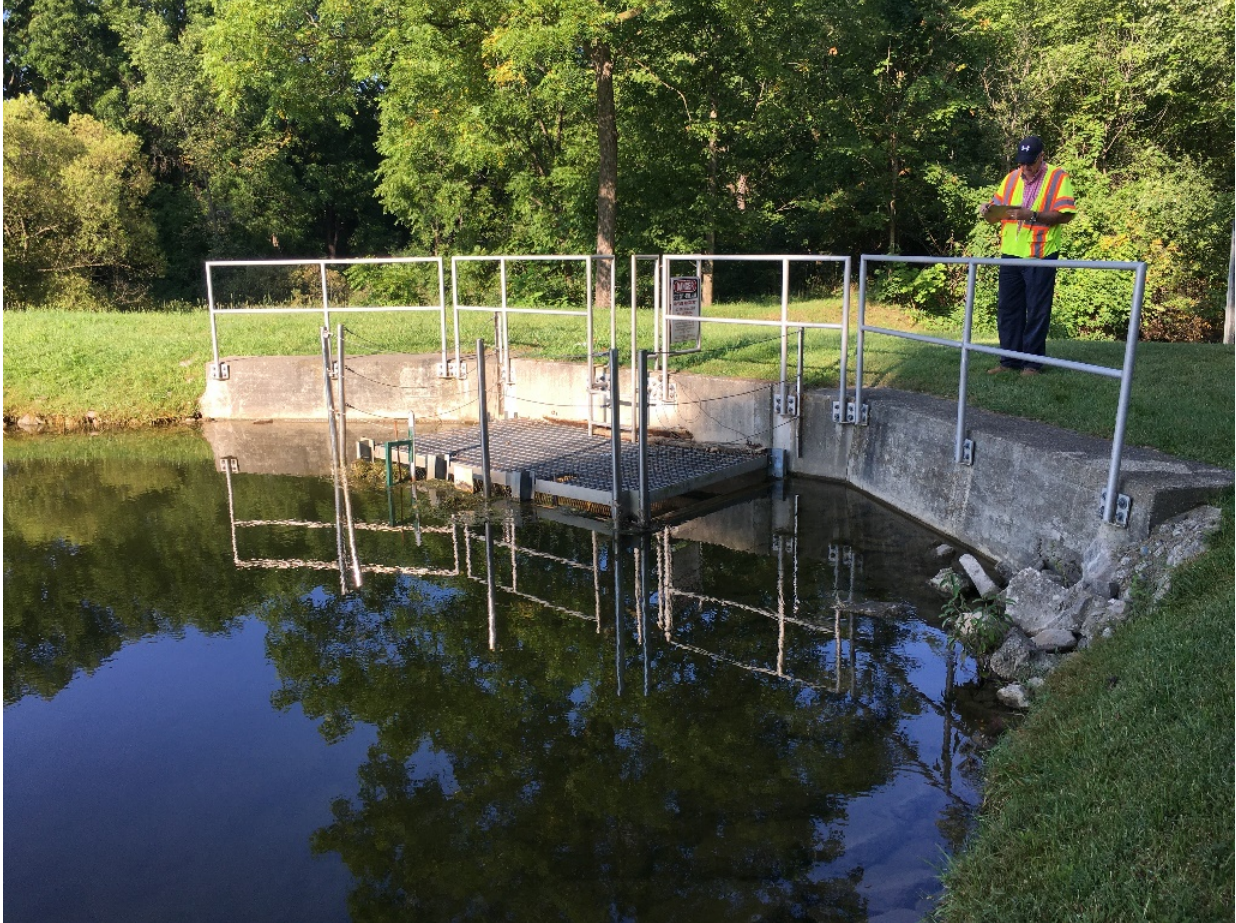
LOOKING DOWNSTREAM AT DAM & DROP STRUCTURE

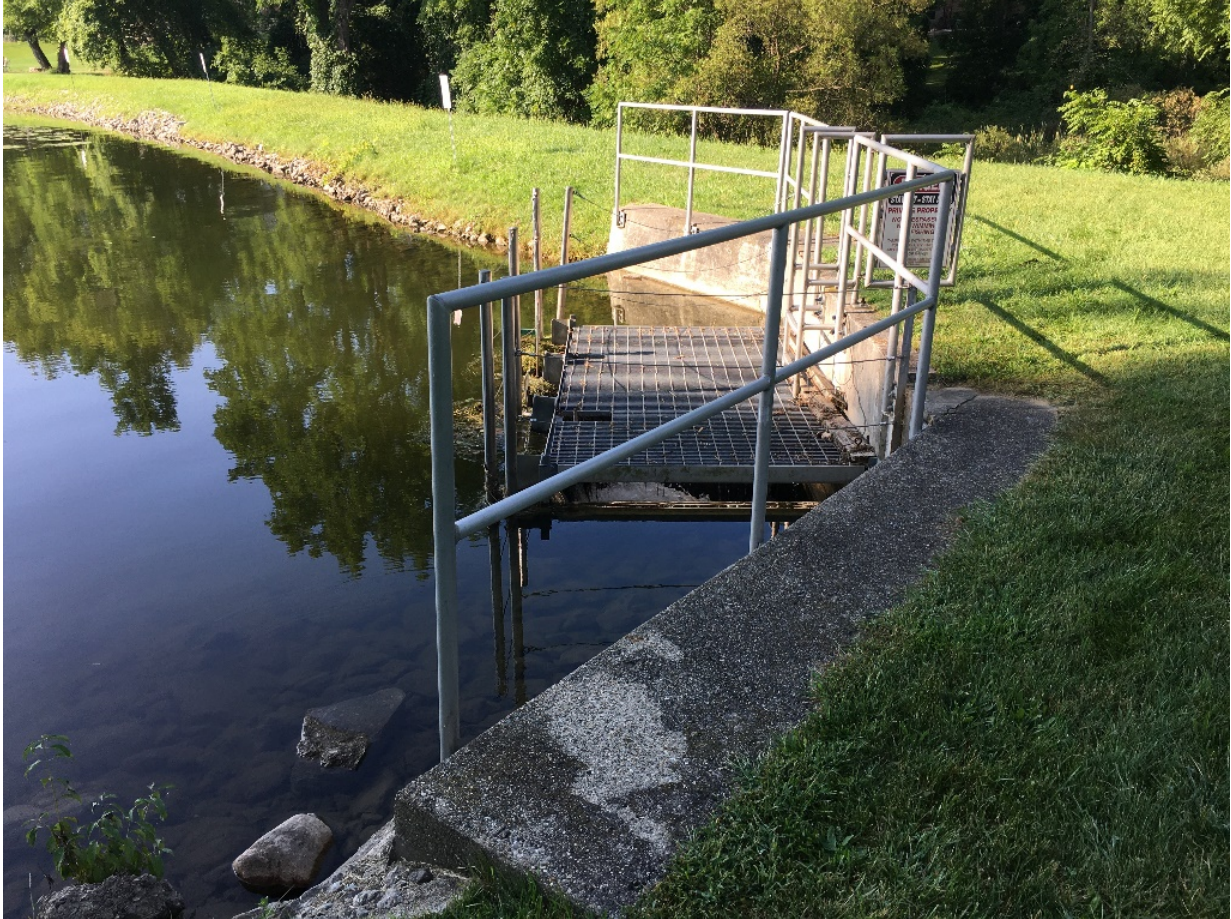
LOOKING SOUTH DROP CONTROL STRUCTURE AND WEST EMBANKMENT

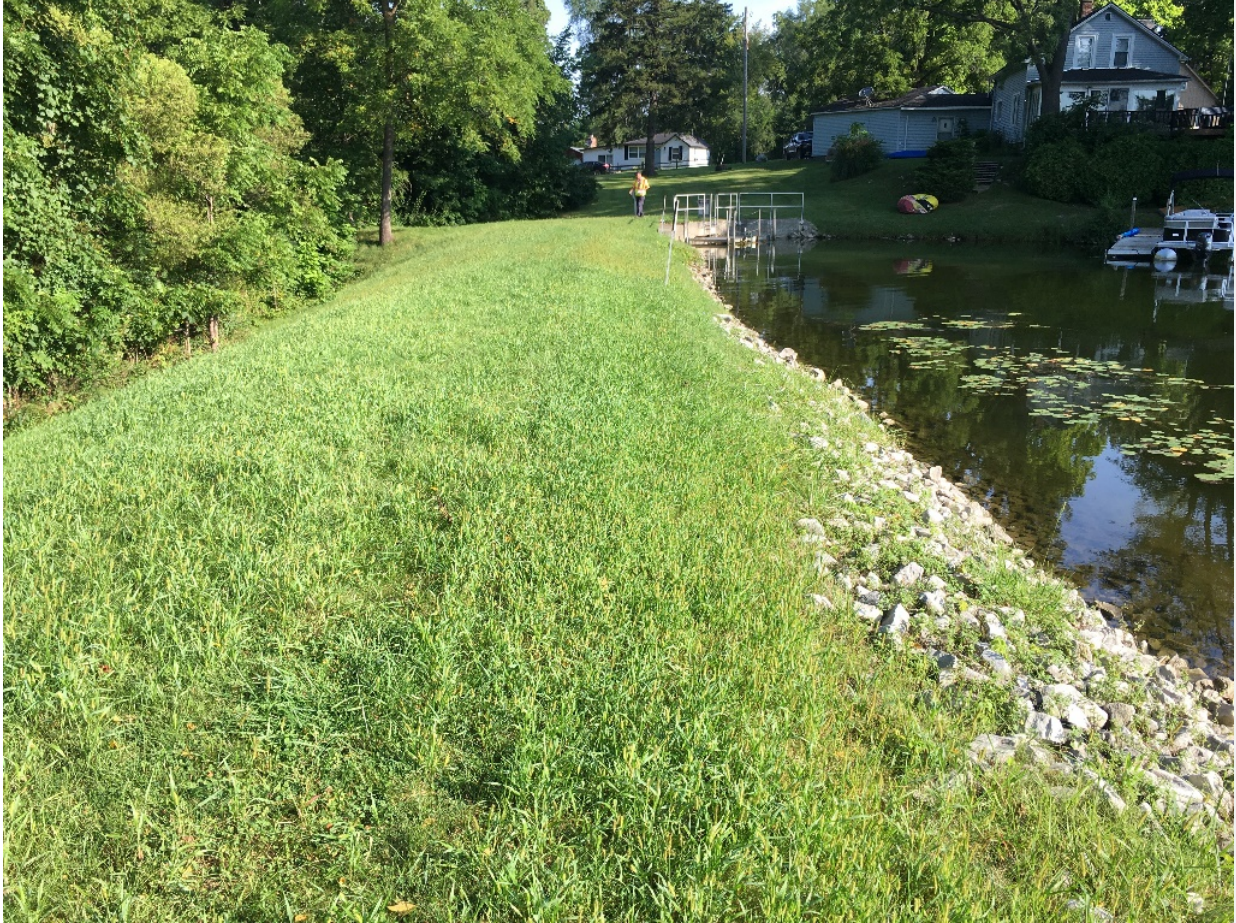
WEST EMBANKMENT AND RIP RAP ON IMPOUNDMENT SIDE

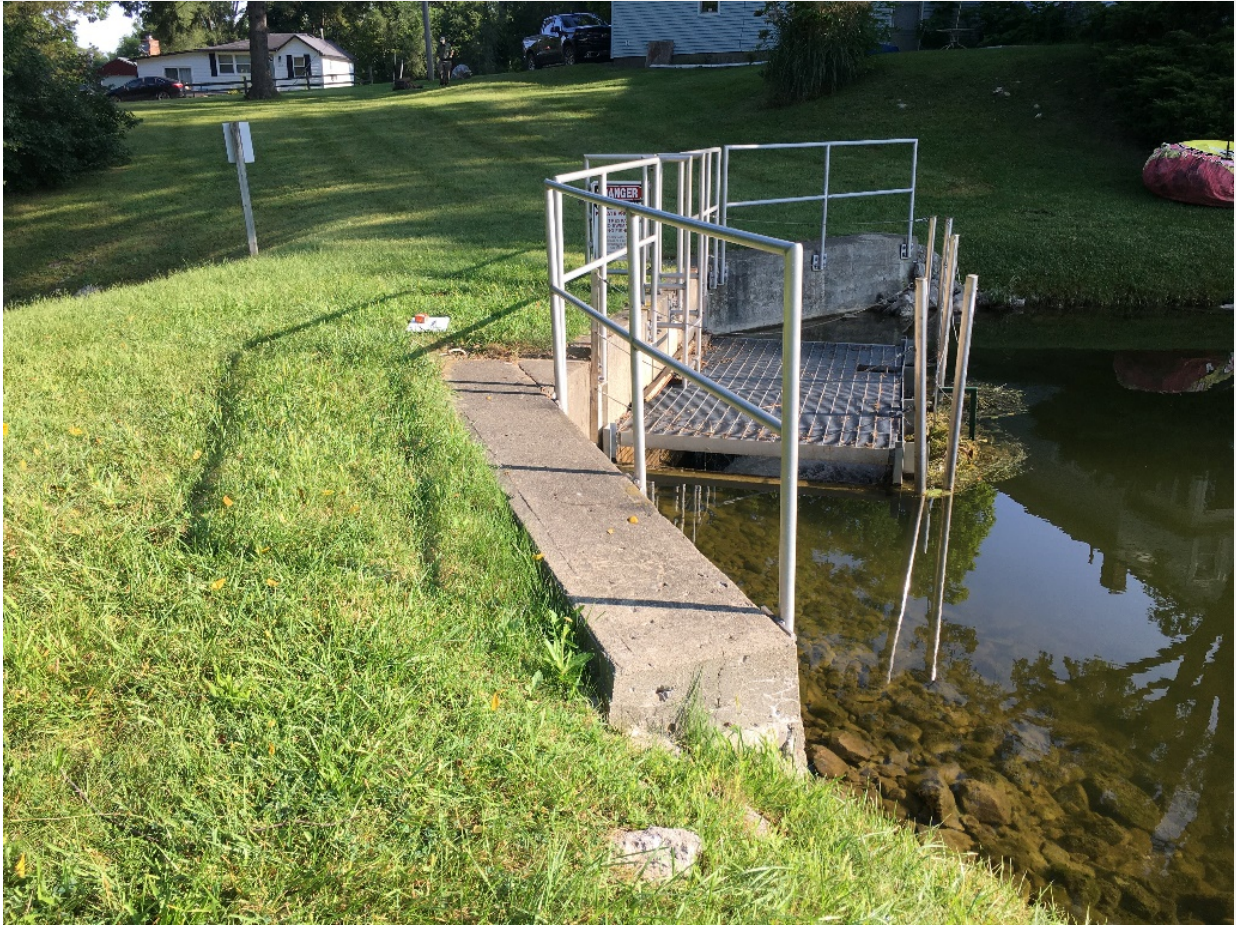
LOOKING NORTH AT DROP CONTROL STRUCTURE

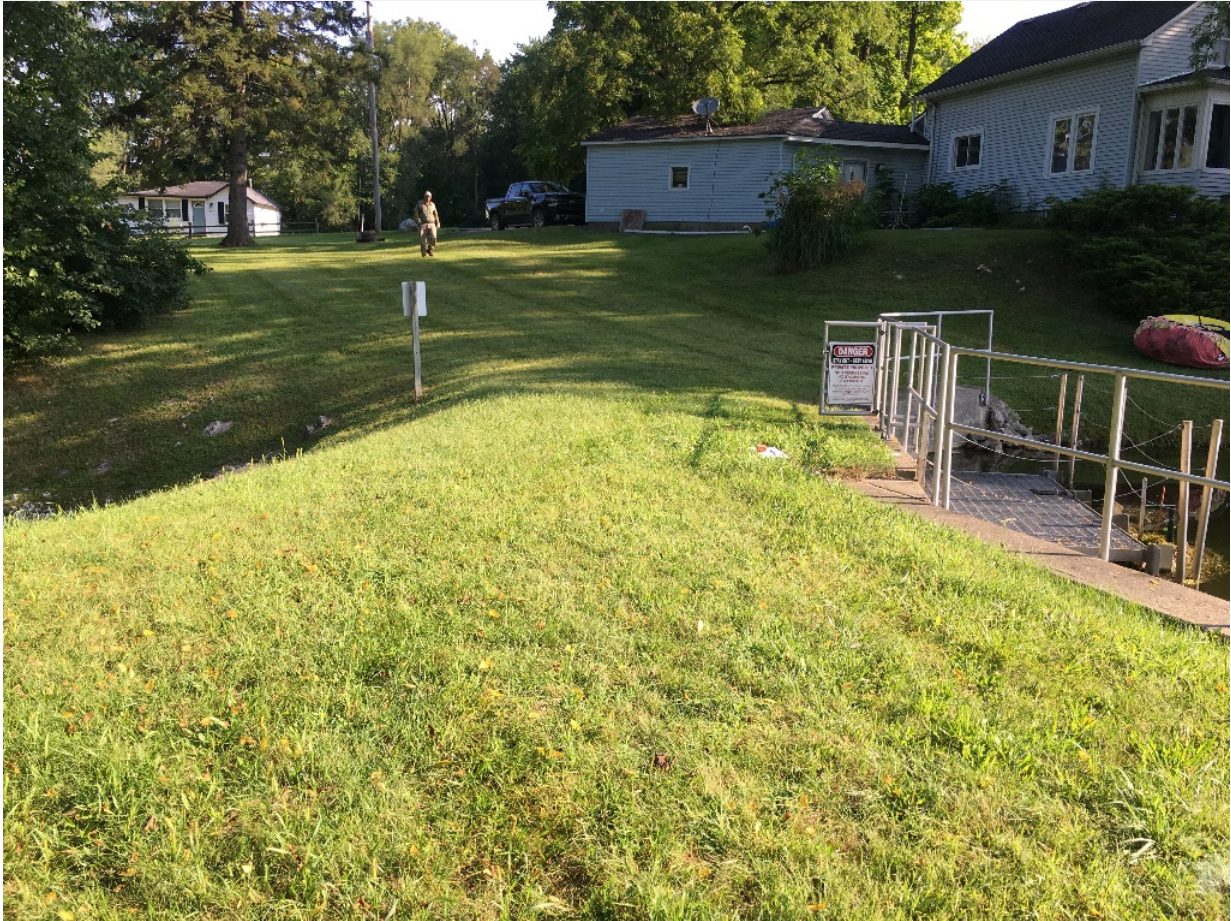
LOOKING NORTH AT EMBANKMENT ADJACENT AND OVER SPILLWAY

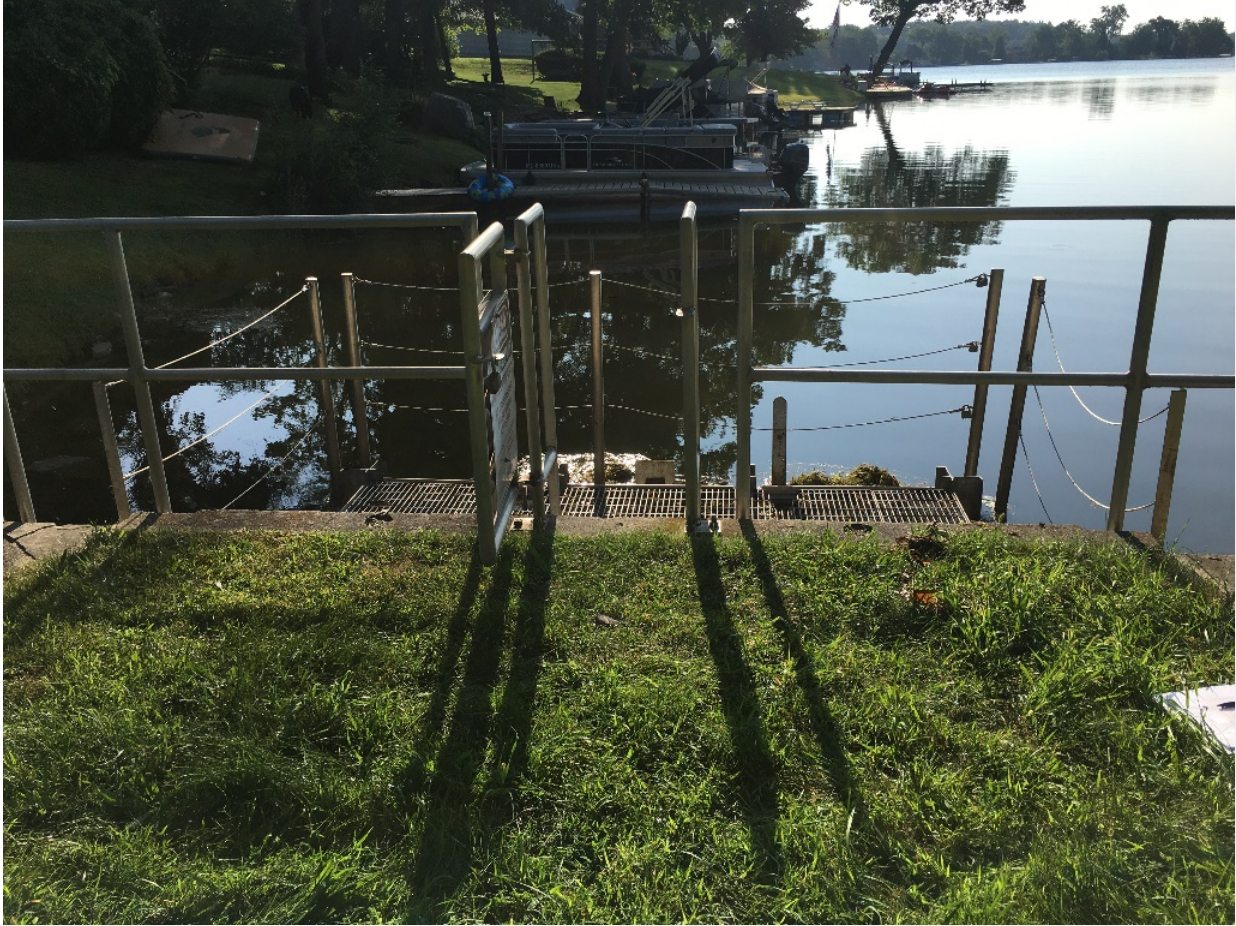
LOOKNG EAST AT DROP STRUCUTRE

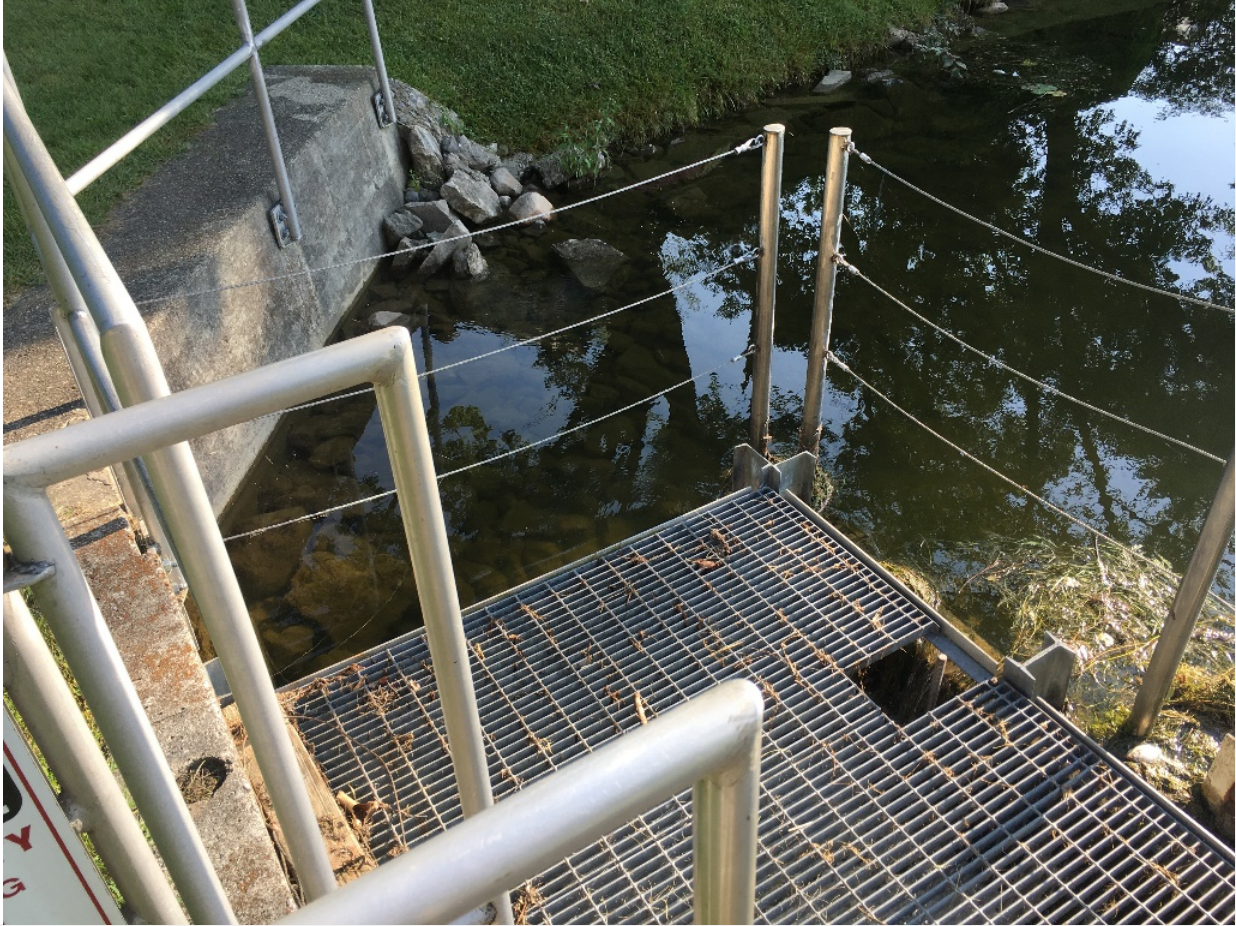
DROP STRUCTURE AND WINGWALL HANDRAIL

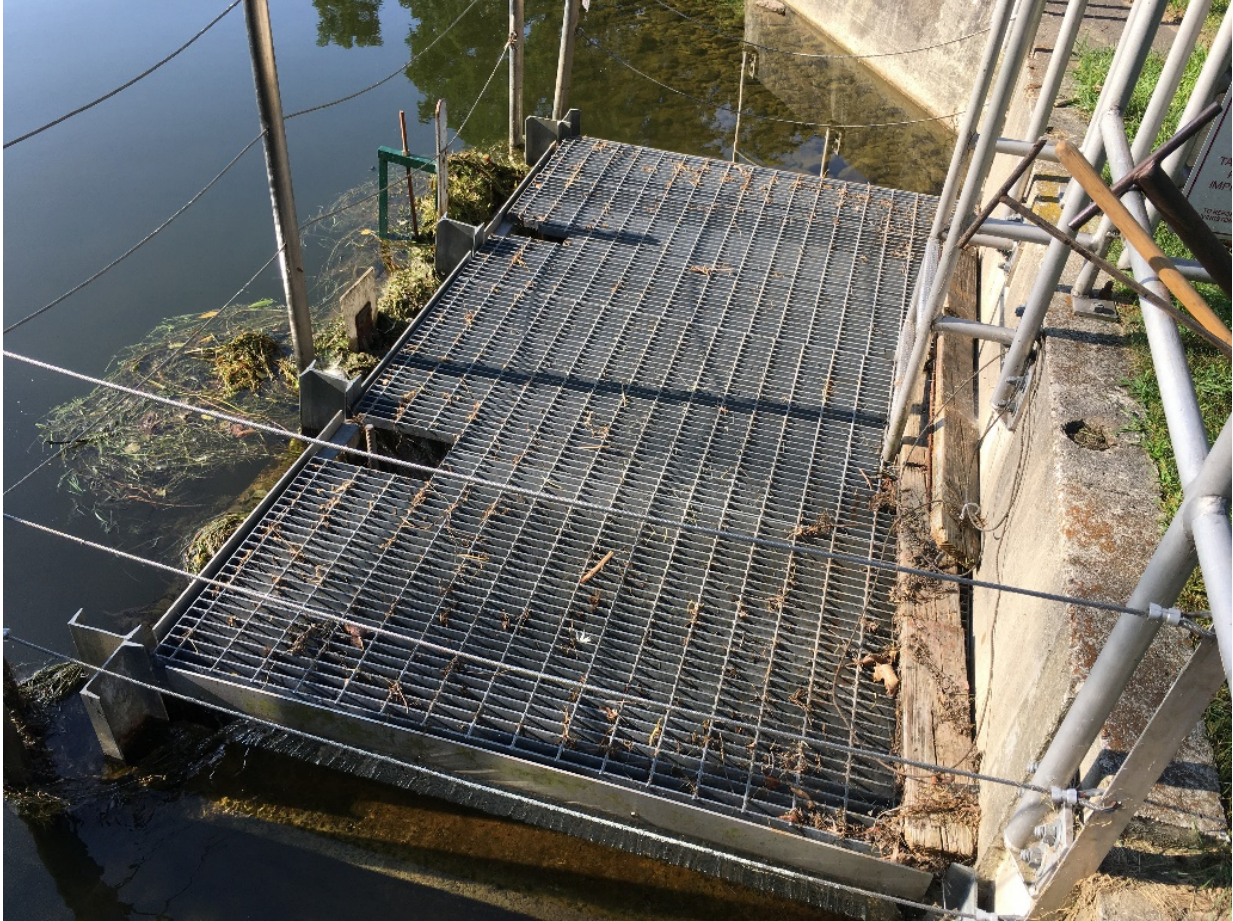
LOOKING SOUTH AT DROP STRUCTURE – STEEL BAR GRATING FLOOR

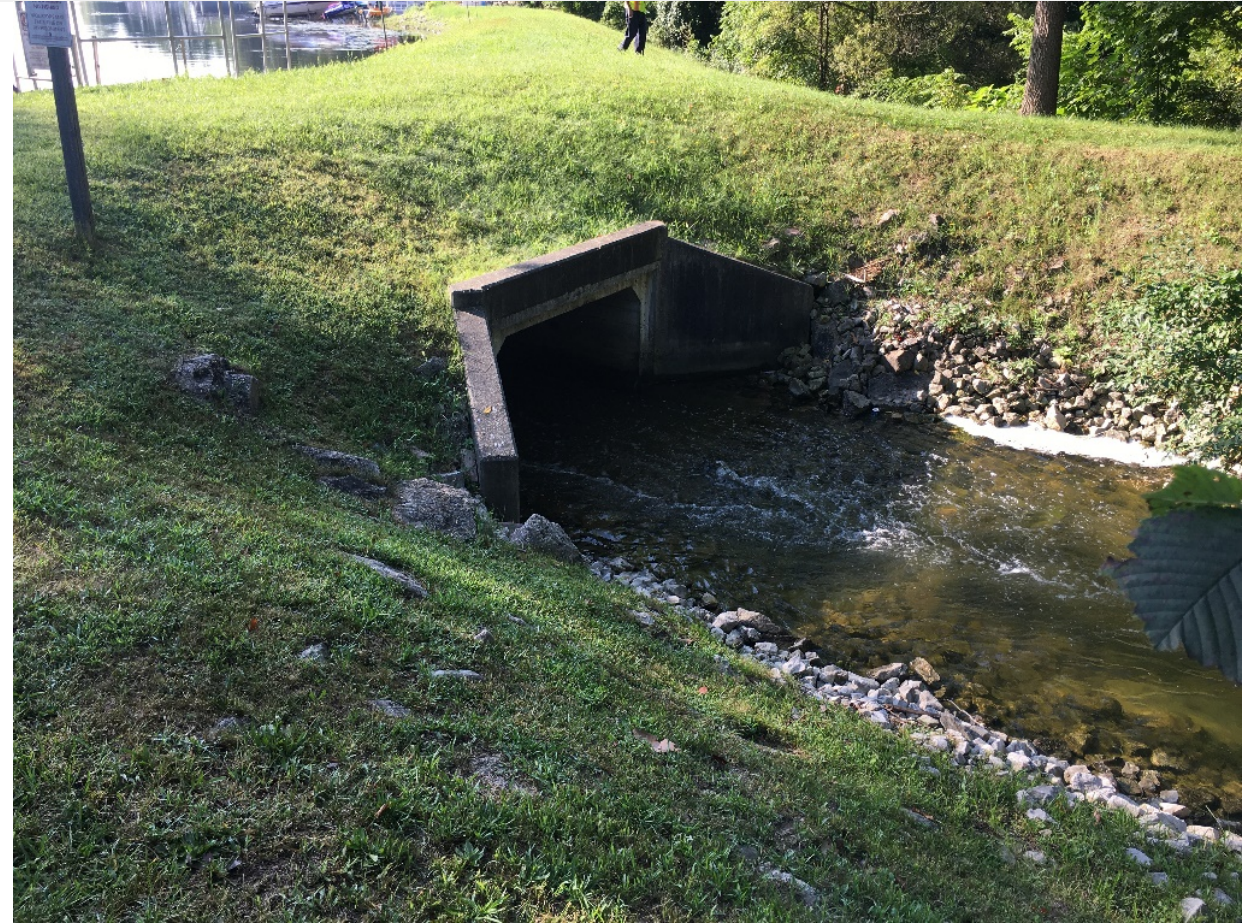
EMBANKMENT AROUND OUTLET CULVERT

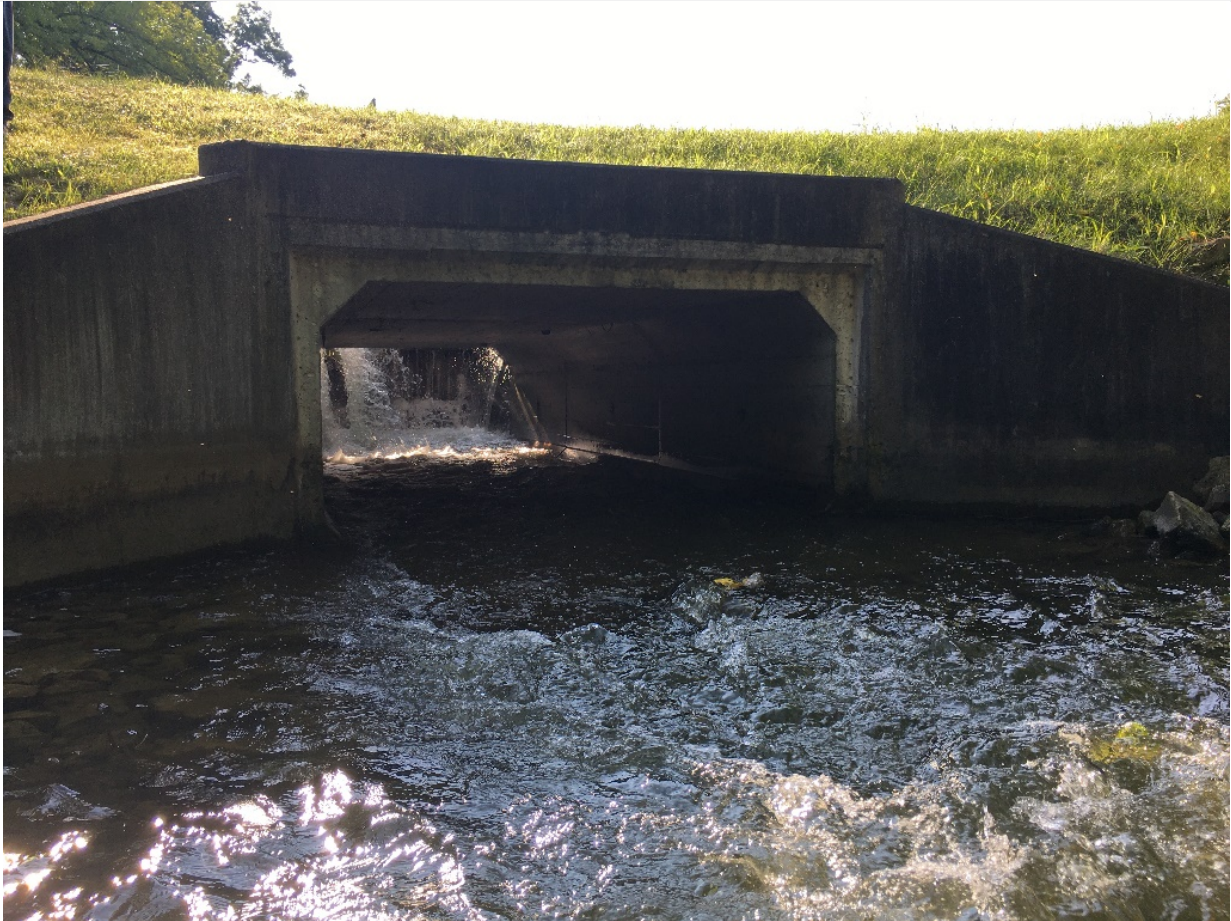
LOOKING UPSTREAM AT OUTLET CULVERT

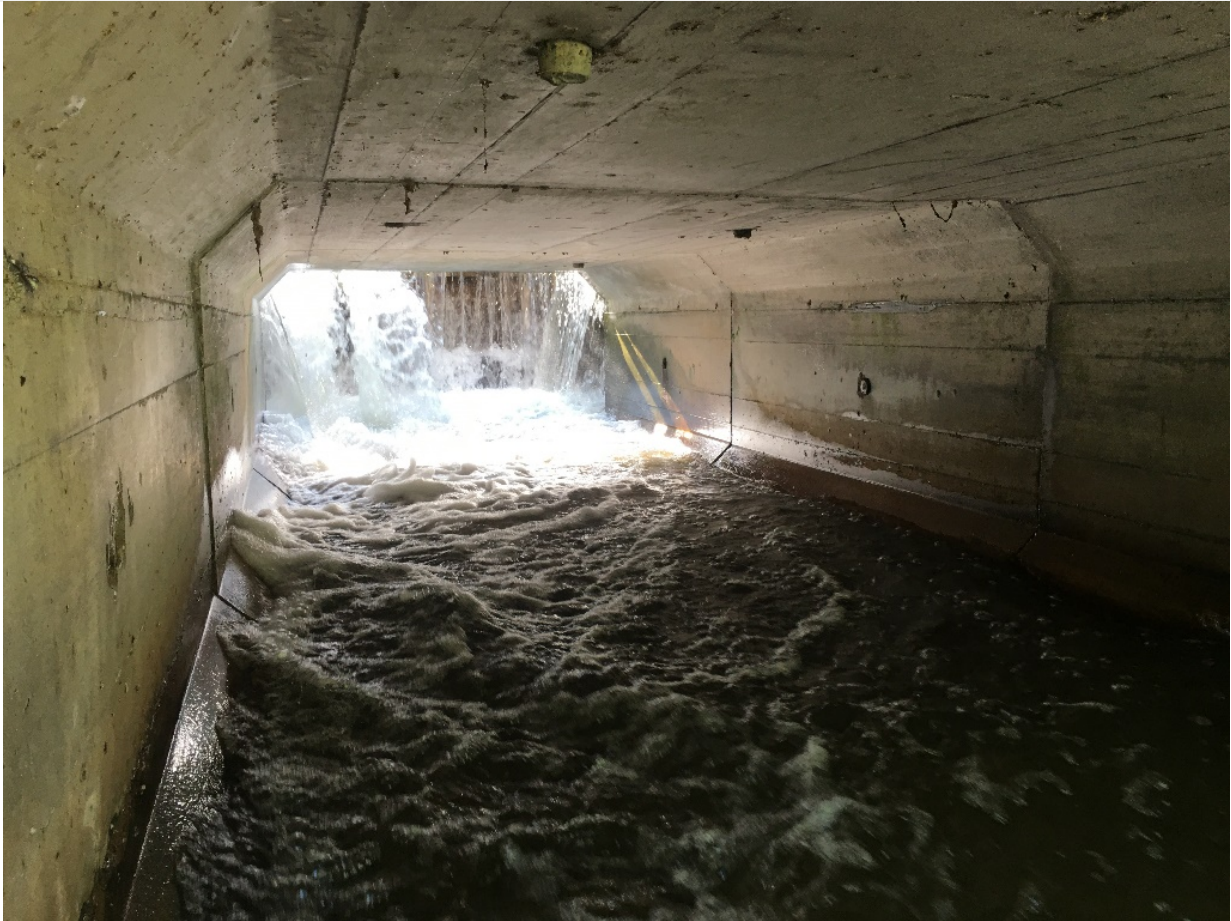
OUTLET CULVERT LOOKING UPSTREAM

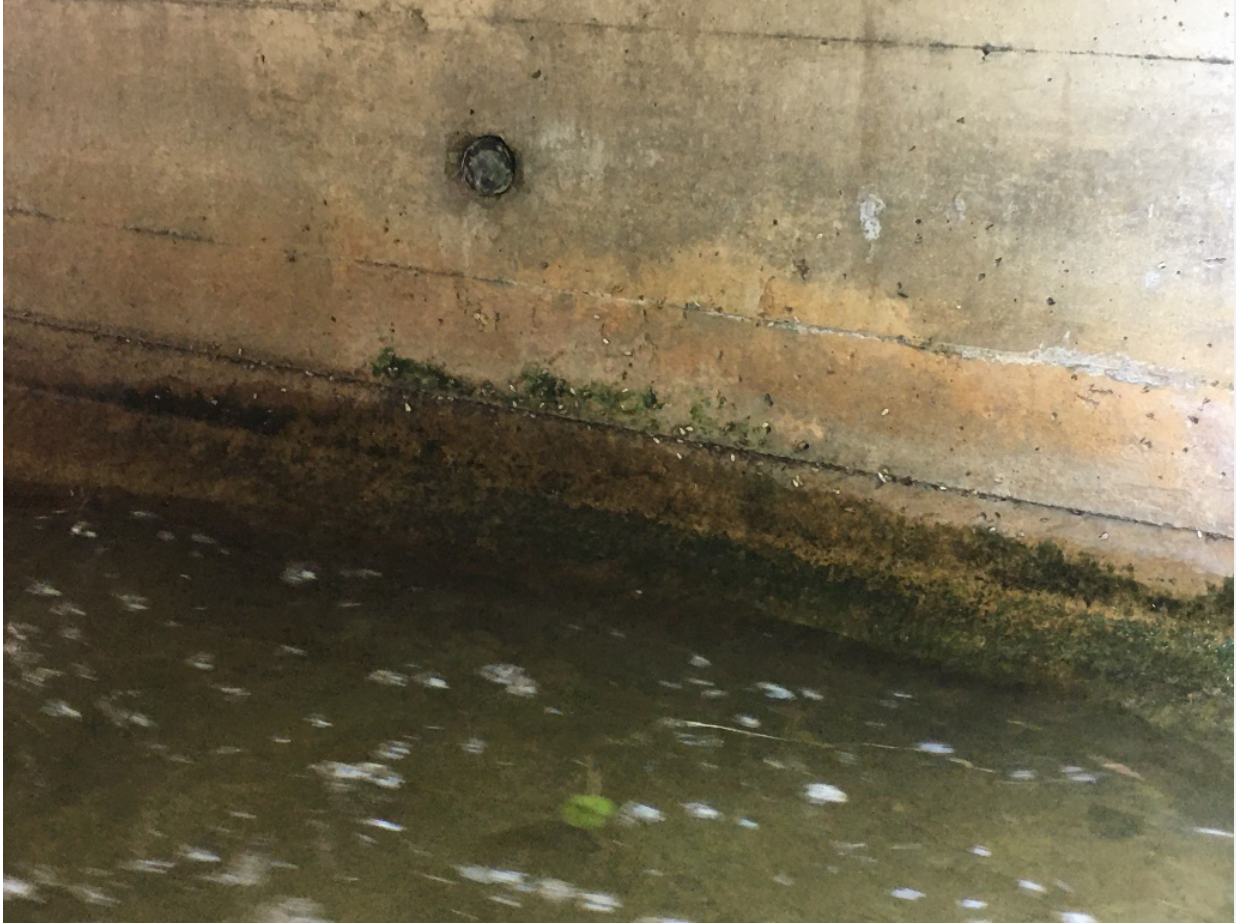
The 8-foot by 4-foot precast concrete box culvert that serves to convey downstream flow through the embankment is in good condition. There is some visible wear of the concrete surface near the waterline. There appears to be foundation underdrains that come through the side walls that appear plugged. There is no evidence (staining below outlet or water marks) that the outlet functions. The joints between the segments appear to be sound with no leakage showing.

SIDEWALL OF OUTLET CULVERT

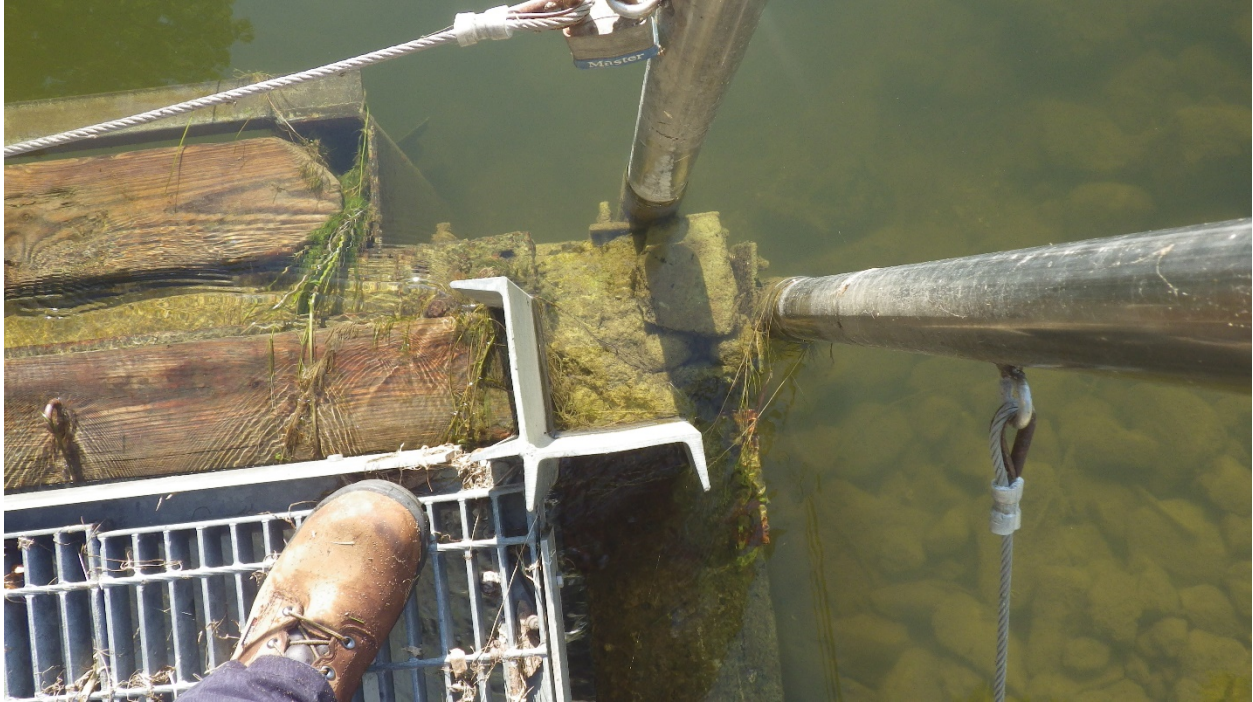
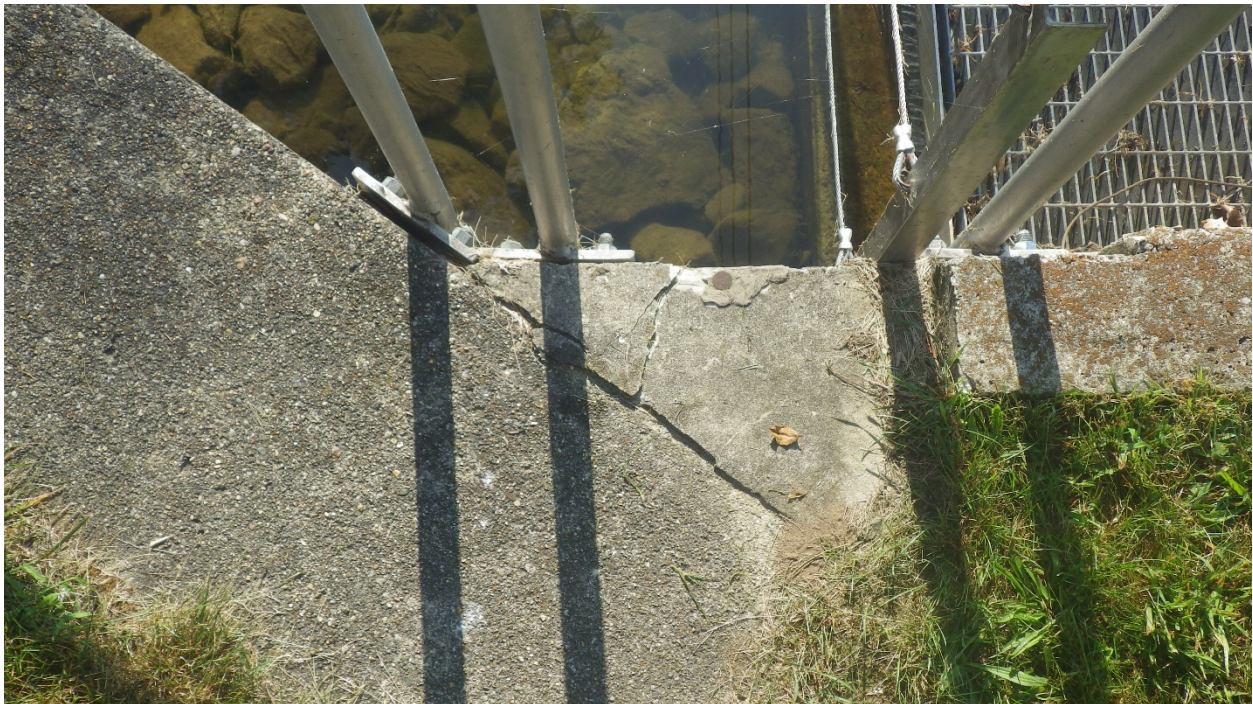
The portion of the drop structure visible during the inspection is in poor condition. The top of the structure is exhibiting cracking and spalling of the concrete surface. At the corners of the structure where the corner handrail posts are connected has extensive concrete cracking to the point where the handrail post anchor plates are very loose. It appears this is due to very close spacing of the expansion anchor bolts cracking the concrete. It is the opinion of this inspector that repairs should be made to the concrete and re-anchor the posts. It is uncertain, if the posts, as they currently exist, are capable of sustaining the design loads required for handrail posts. The embankment retaining/wingwalls appear to be in fair to good condition. There is general wear showing on the concrete with isolated cracking, spalling and delamination of the surface. Structurally, it appears sound otherwise. The two-step ladder from top of embankment to top of grating at drop structure is in good shape and appears to be securely anchored to the concrete wall.

US Concrete drop structure failing at right side railing/anchor locations. The upper 15 to 18 inches of the concrete drop structure at that area may need the brackets reinforced or need to be removed and repaired. Surface cracking and spalling noted at NE wing wall. Small amount of reinforcement exposed @ SW corner of spillway near Handrail

In place with warning sign. Railing connections are failing.

CLOSE UP OF HANDRAIL ANCHORAGE TO CRACKED /LOOSE CONCRETE – POSTS ARE NOT SECURE

CLOSE UP OF HANDRAIL ANCHORAGE TO CRACKED CONCRETE WALL -POSTS ARE NOT SECURE

1. The upper 15 to 18 inches of the concrete drop structure is in poor condition and should be repaired.
2. The handrail connection should be re-designed to have further spacing between the assumed expansion anchor bolts. Recommended edge distance at concrete is minimum 5 x 'd' and spacing between bolts is minimum 10 x 'd' ('d' is diameter of anchor bolt).
3. The concrete cap on the south end of the wing wall should be repaired.
4. Repair minor area of erosion on the downstream embankment slope around the riprap culvert outlet along downstream embankment slope.
5. Add rip rap to the upstream embankment shoreline from edge of water, up the embankment.
6. Unplug foundation underdrains at outlet culvert

The upper 15 to 18 inches of the concrete drop structure is in poor condition and should be repaired. The deterioration of the concrete drop structure appears to be a result of the connection between the steel grating, the handrail, and the drop structure itself. It appears that this is being caused by the anchor connection being too close together and are too close to the concrete edges. We recommend the design of these connection/anchor points be revised as recommended previously. The concrete cap on the south end of the wing wall should be repaired. Repair minor area of erosion on the downstream embankment slope around the riprap culvert outlet along downstream embankment slope.

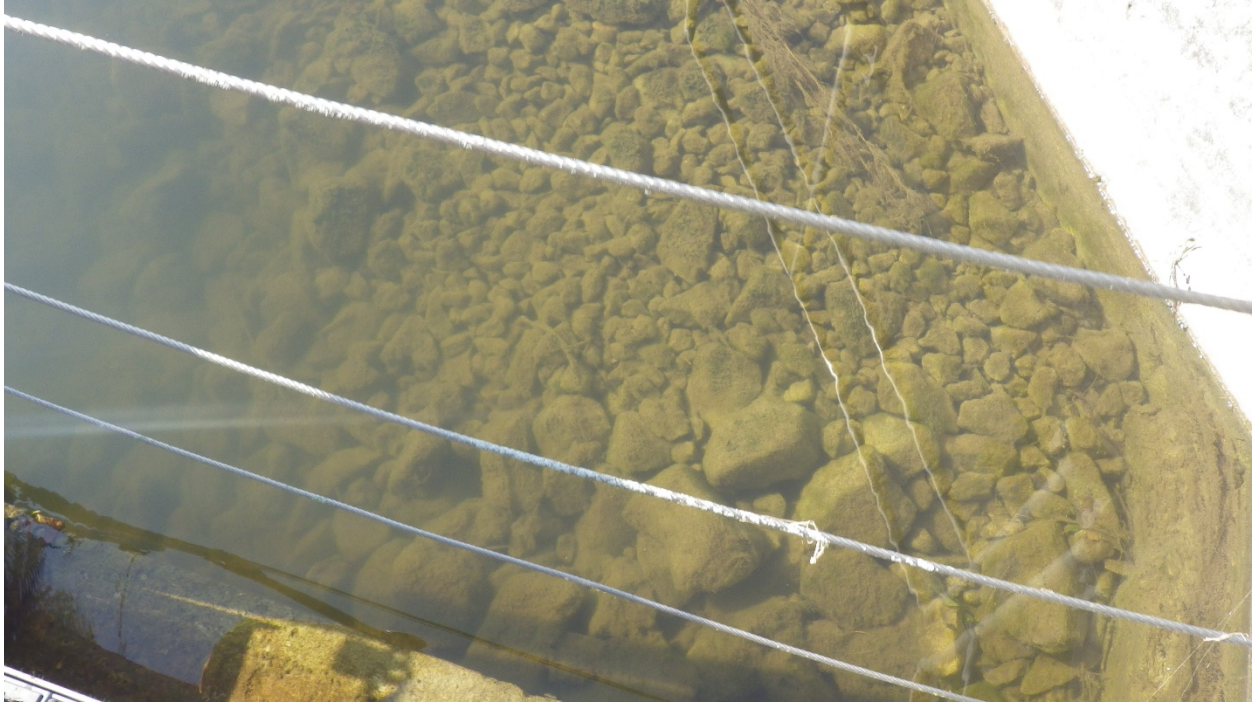
RIP RAP ADJACENT TO DROP STRUCTURE

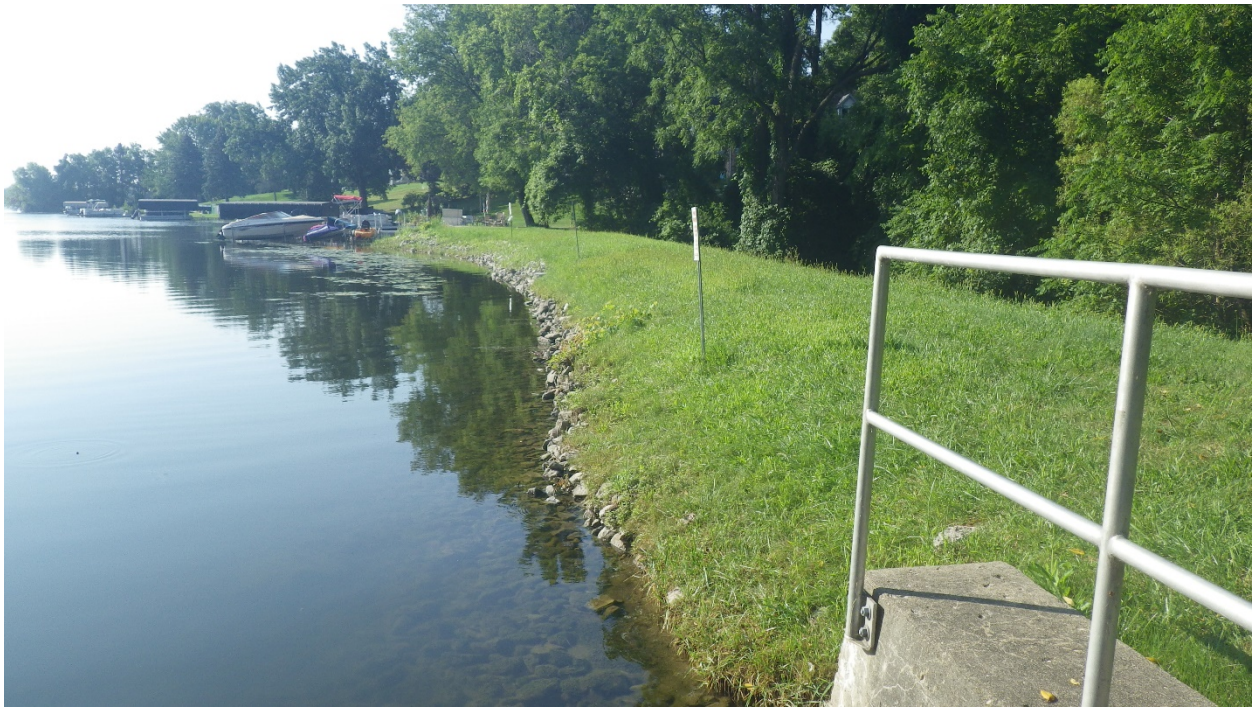
UPSTREAM SHORELINE OF EMBANKMENT

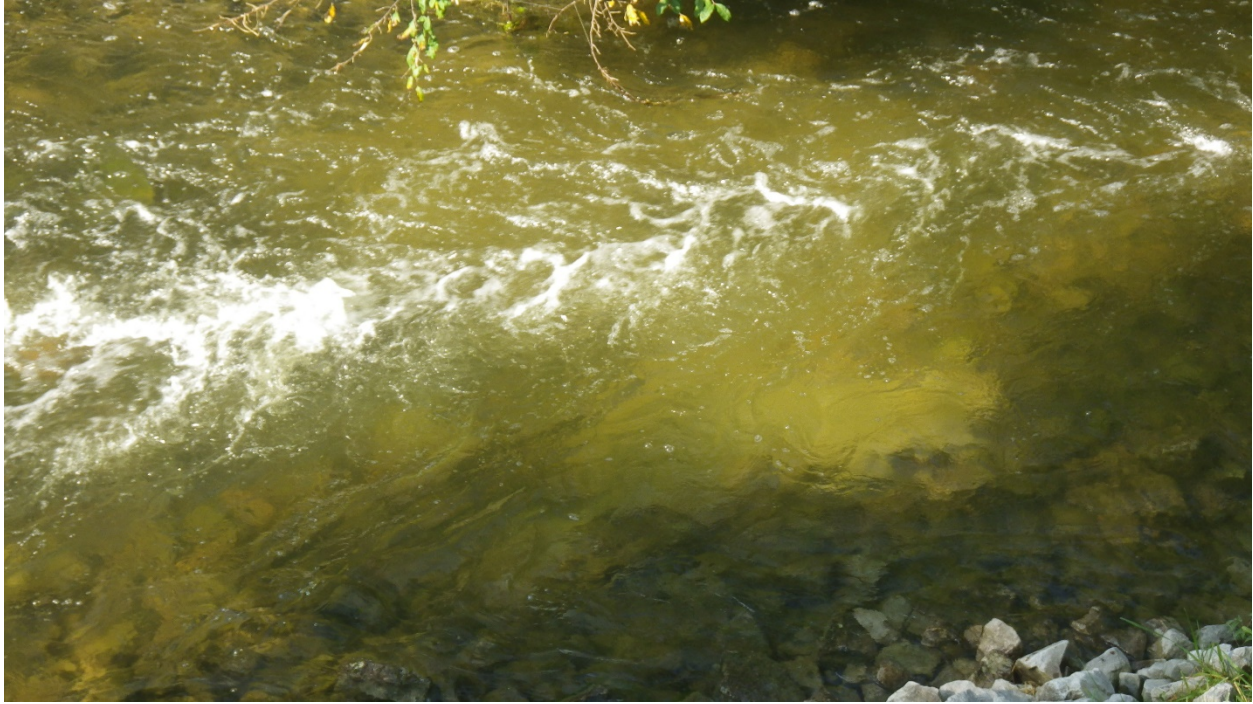
RIP RAP DOWNSTREAM OF SPILLWAY

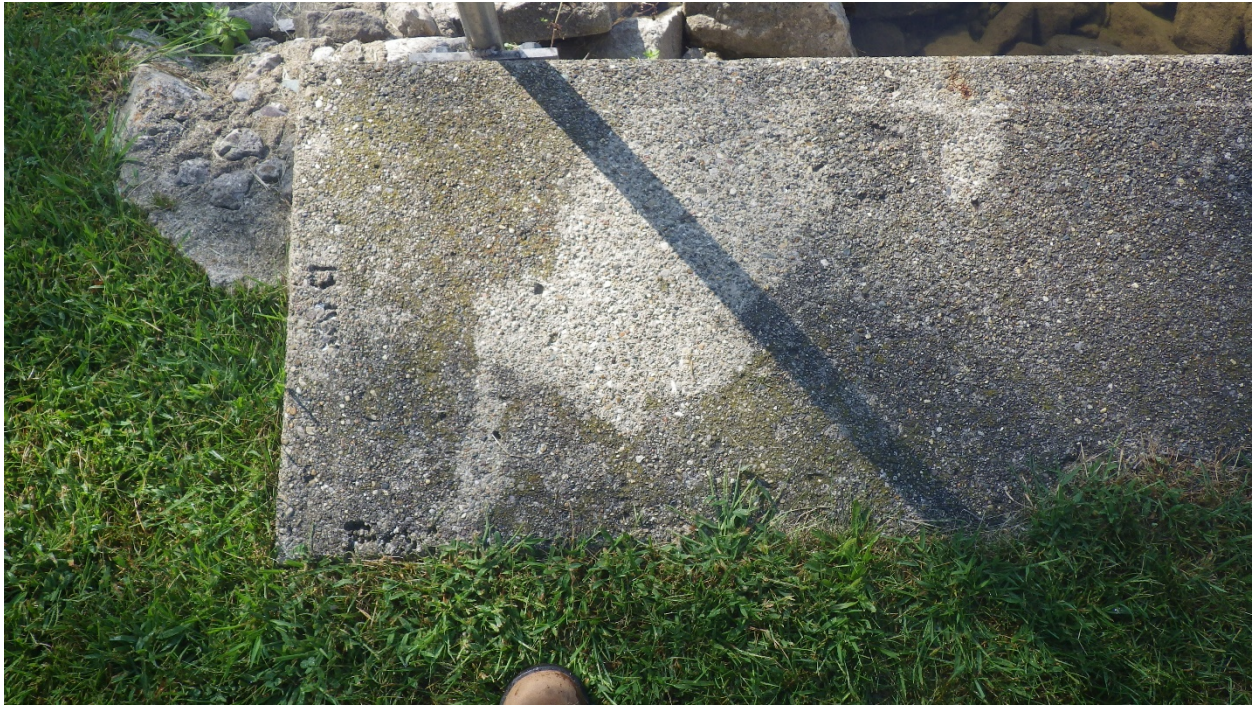
MINOR CONCRETE SCALING OF TOP OF WINGWALL ADJACENT TO DROP STRUCTURE
