Thompson Lake Dam during winter drawdown, photo taken November 28, 2022

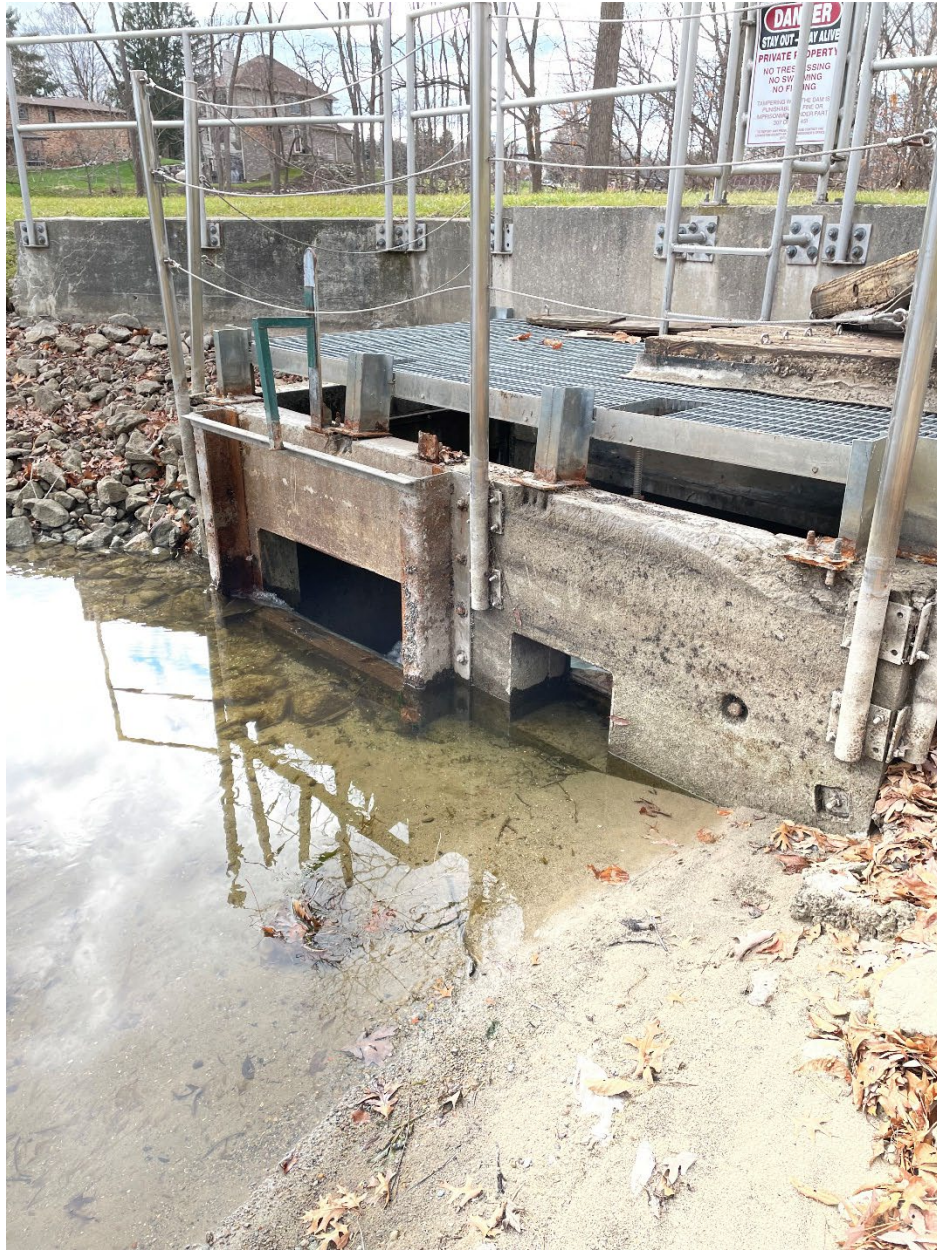
The opening on the left is the log gate and some concrete deterioration can be seen on the upper right side of the box weir.

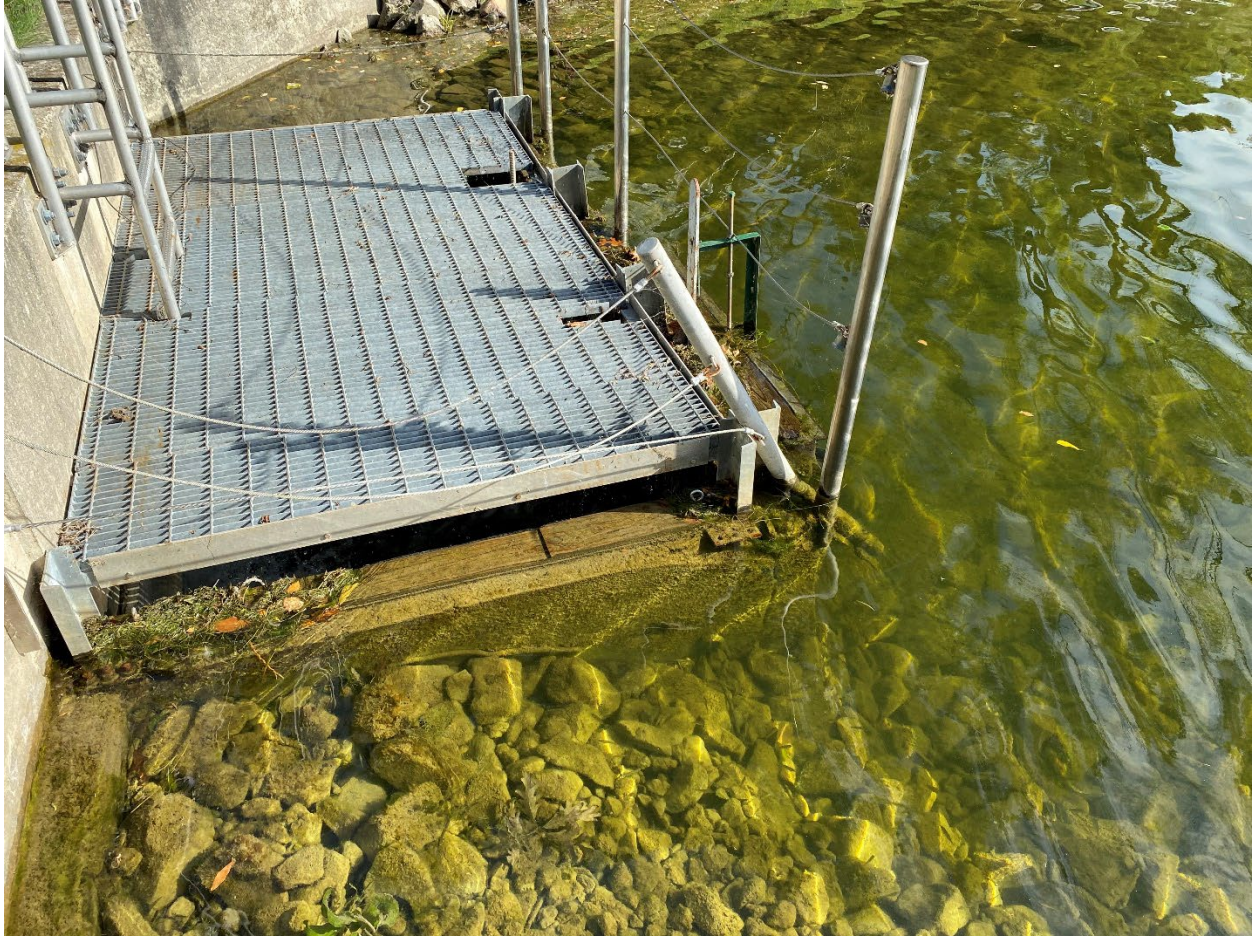
Thompson Lake Dam, photo taken on October 4, 2023
Safety railing support broken off concrete.

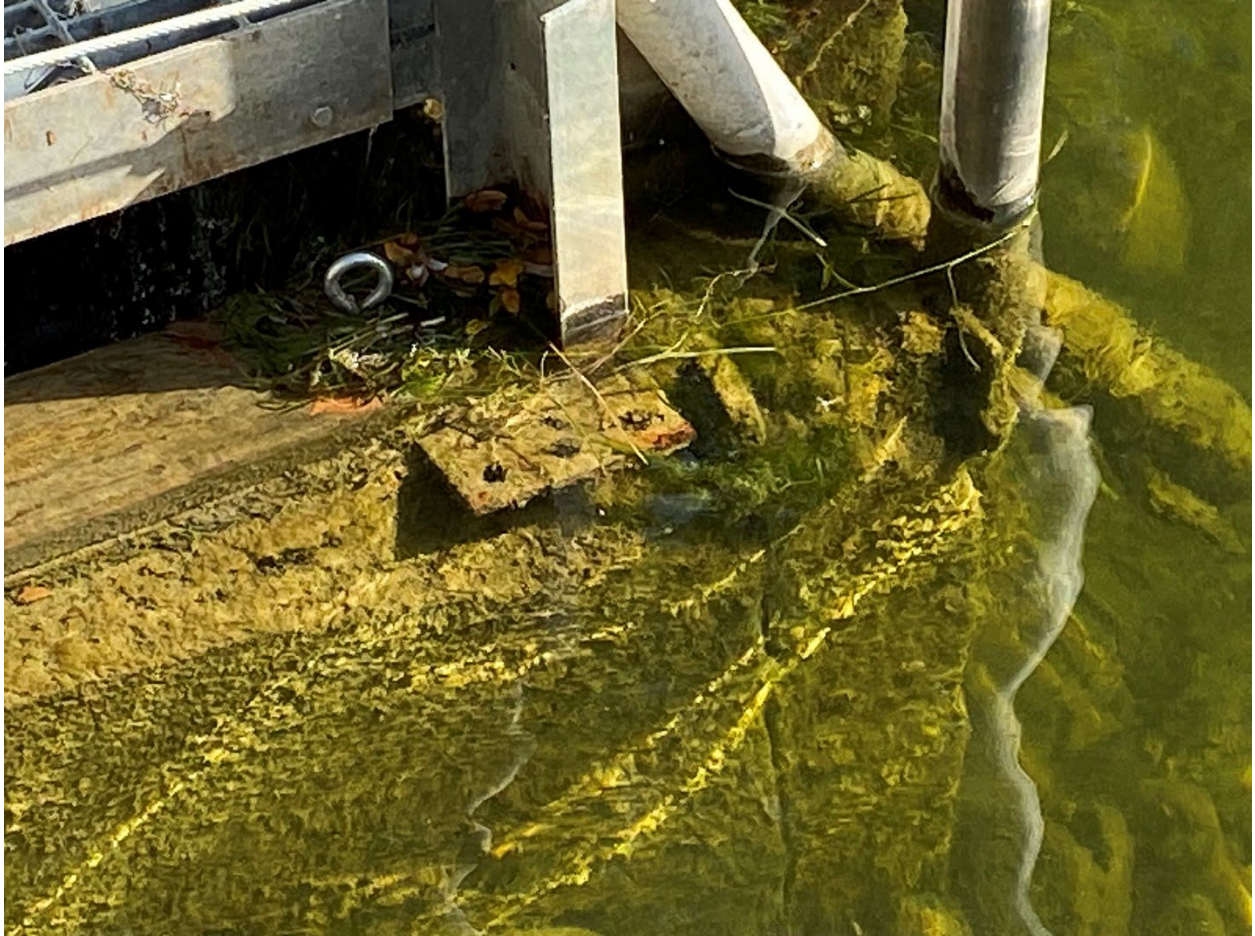
Thompson Lake Dam, photo taken on October 3, 2023
Concrete deterioration seen under water, railing support failure.

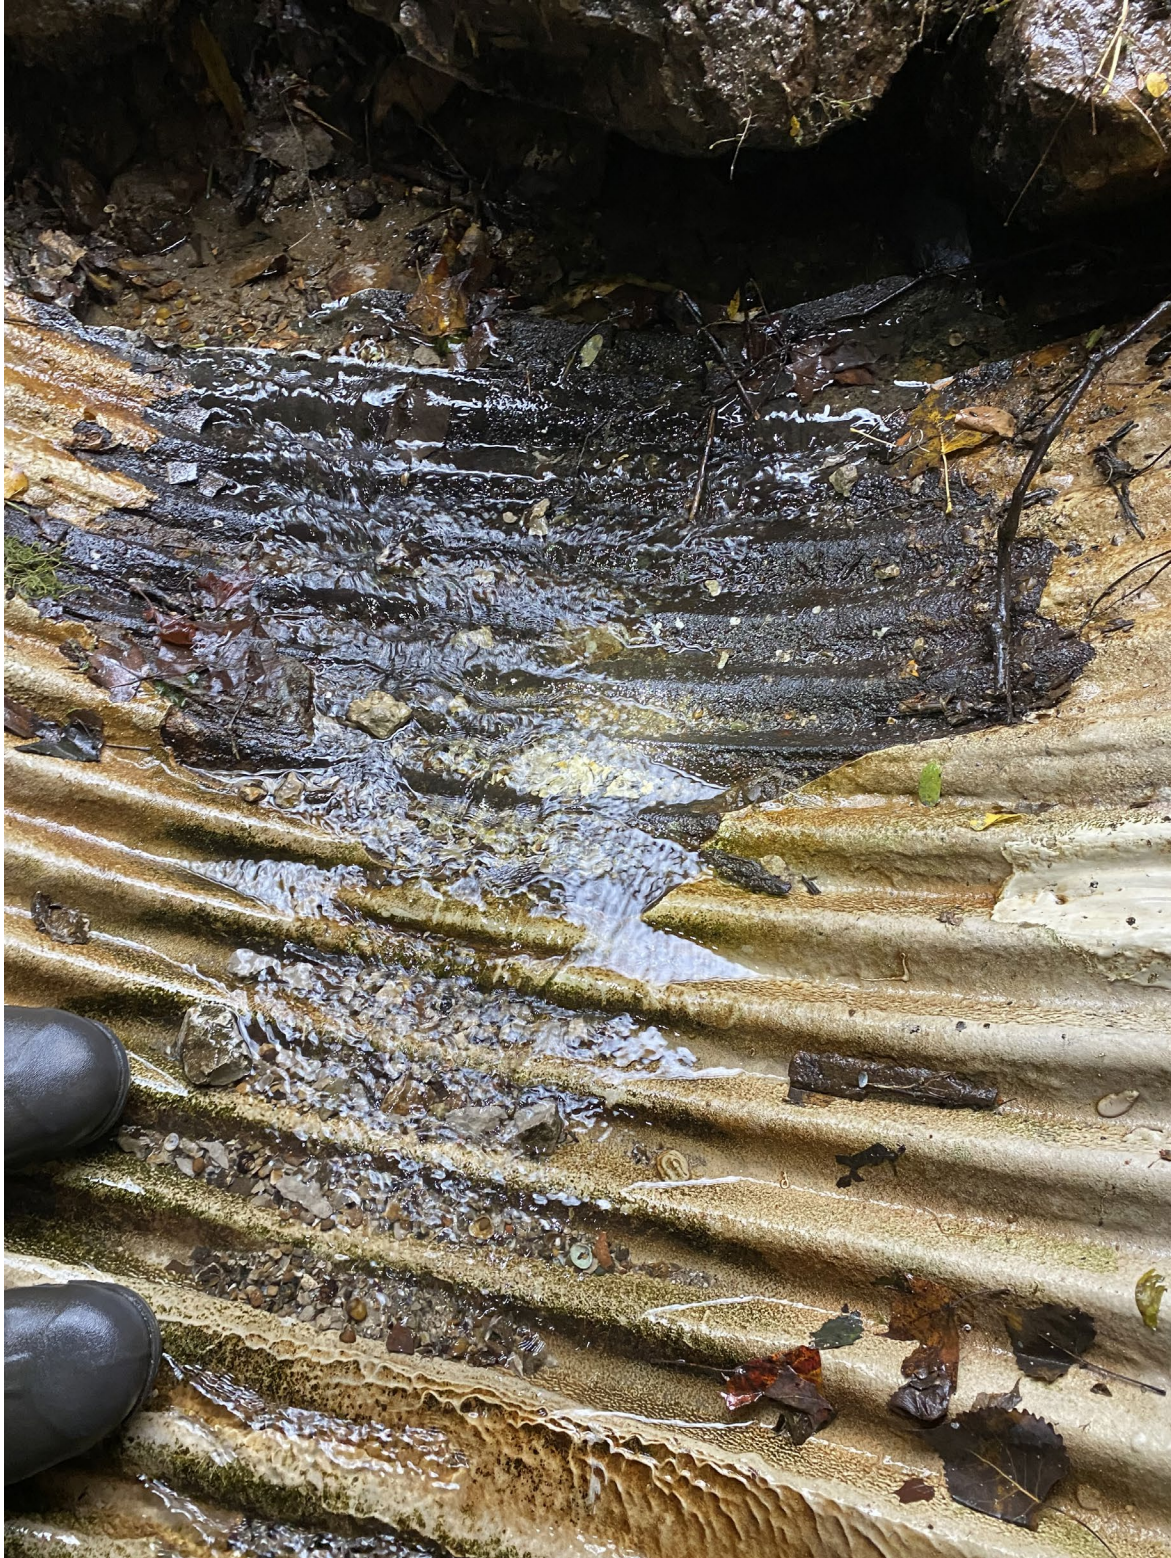
Thompson Lake downstream culvert entrance, photo taken October 26, 2022
Epoxy chipping, existing culvert material deteriorating.

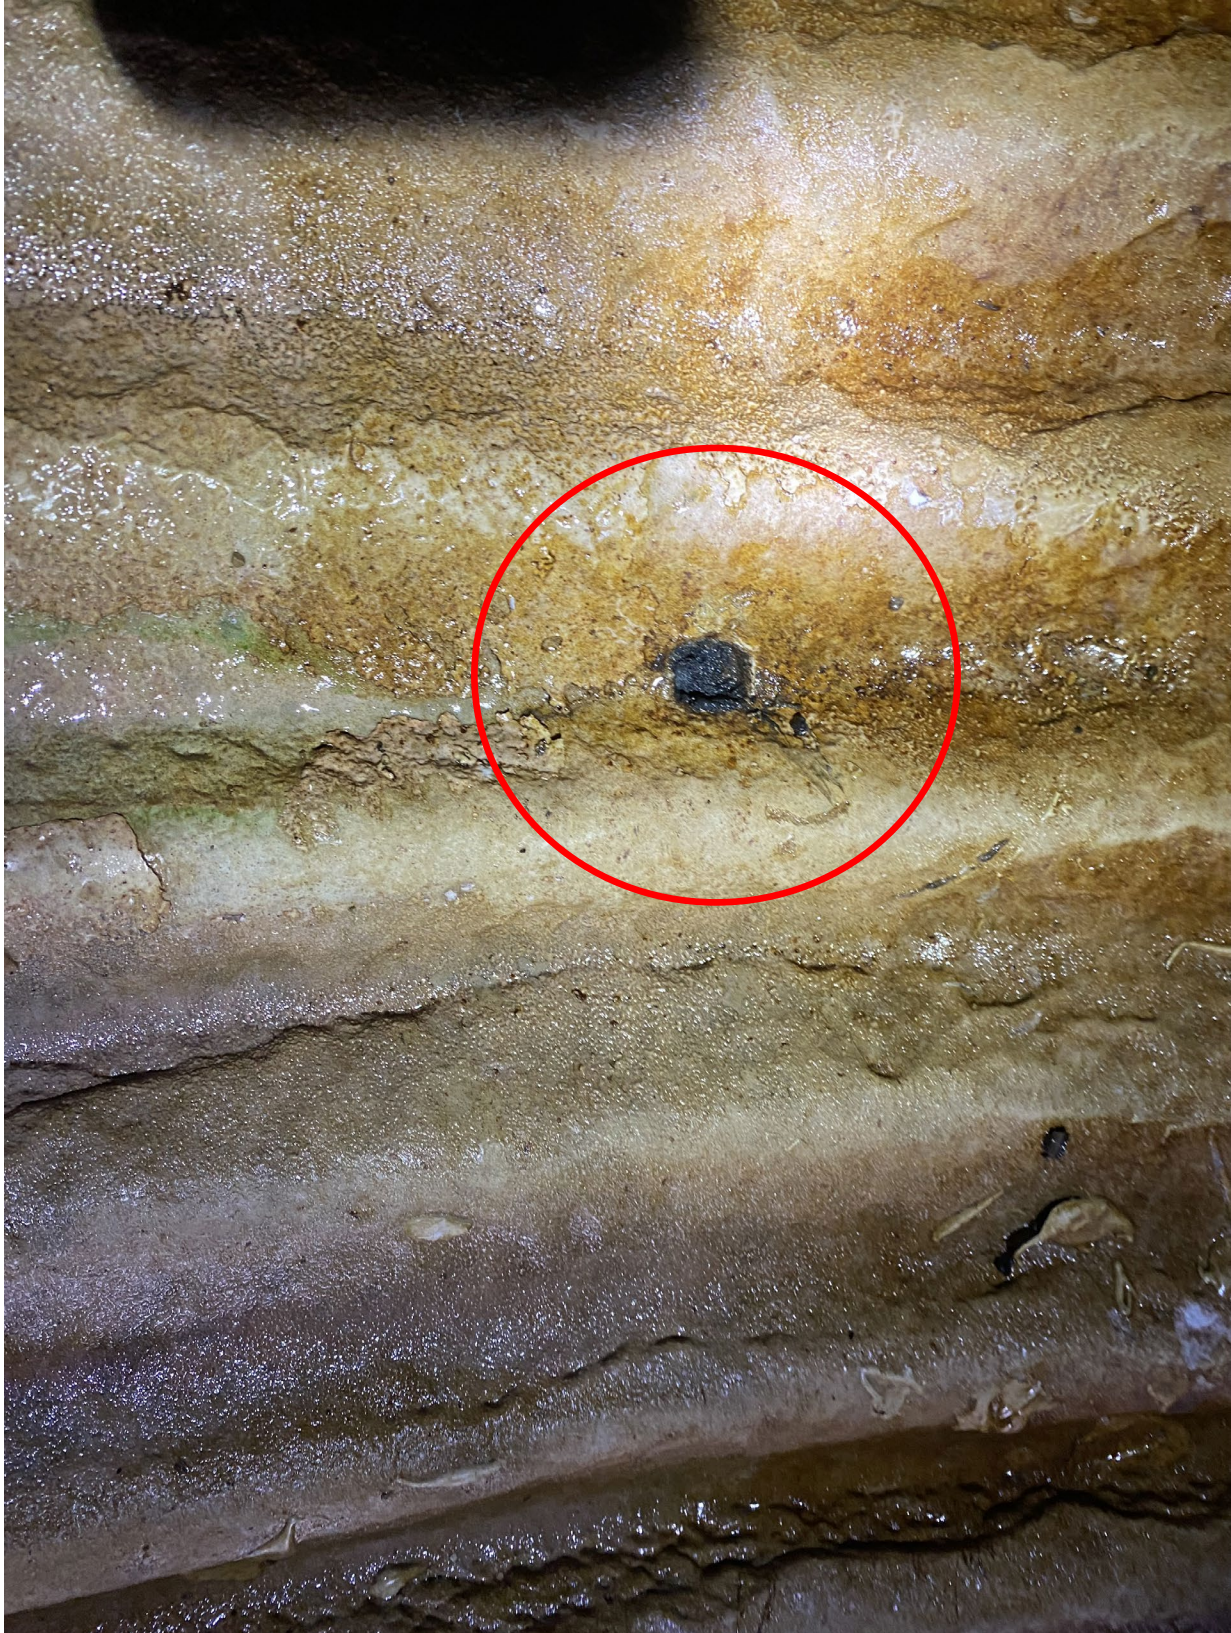
Thompson Lake downstream culvert, photo taken October 26, 2022

One of numerous spots within the culvert where the original culvert is exposed or rusted through.

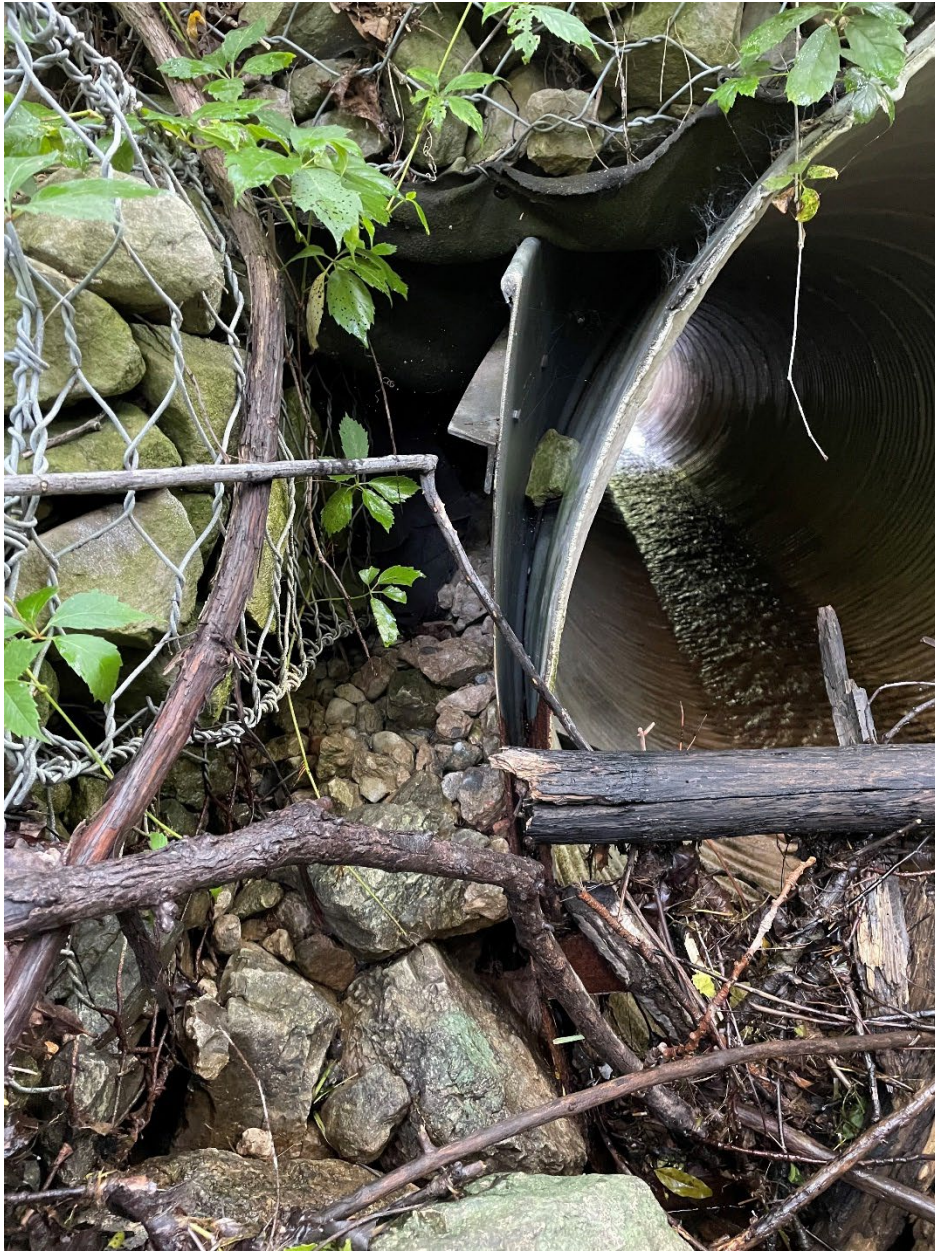
Thompson Lake downstream culvert, photo taken on July 18, 2023
Piping occurring, left side of culvert entrance

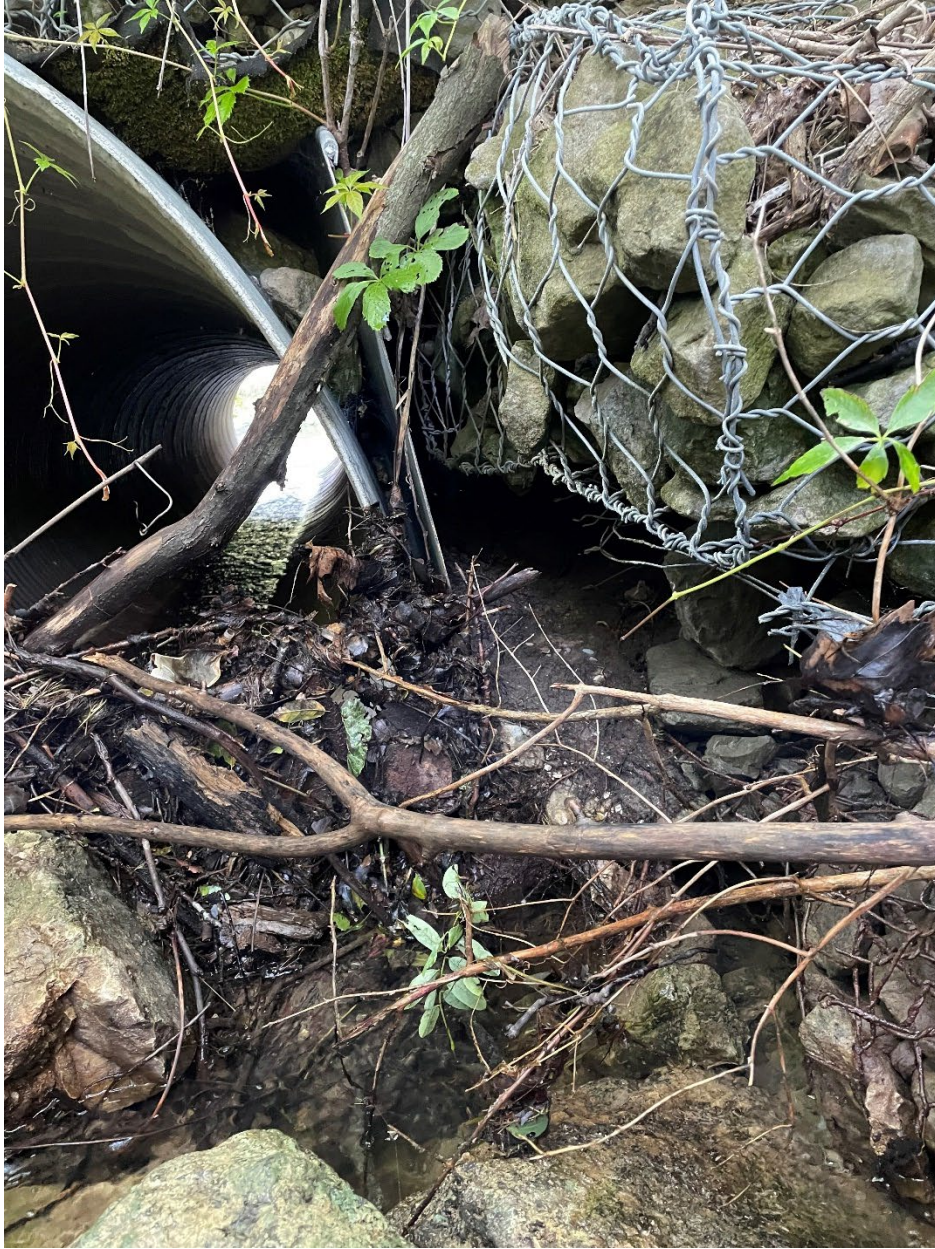
Thompson Lake downstream culvert, photo taken on July 18, 2023
Piping occurring, right side of culvert entrance.

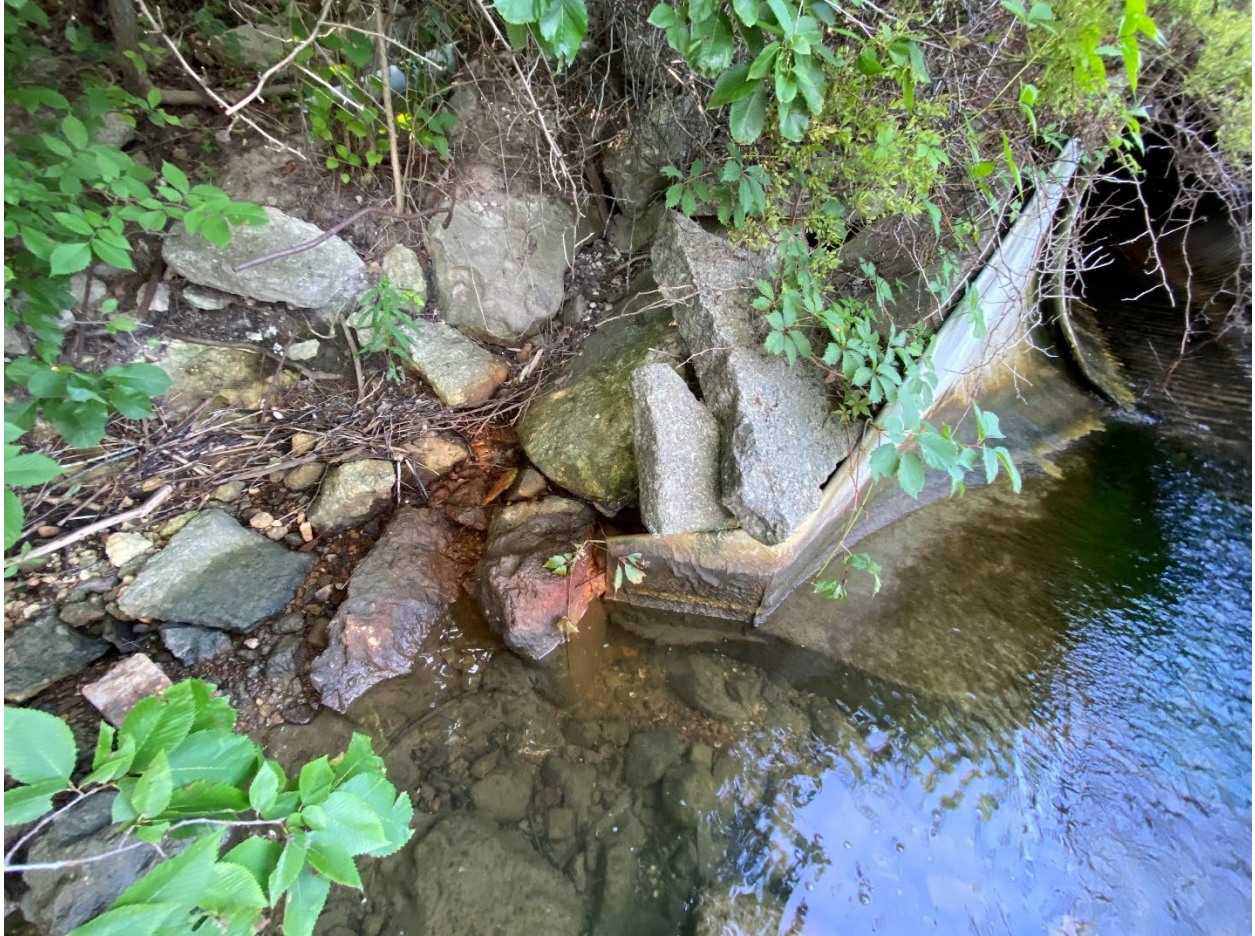
Thompson Lake downstream culvert, photo taken on July 18, 2023

Iron deposits and evidence of piping on the left side of culvert flared end section.
