LONG LAKE CONTROL STRUCTURE  
DAM SAFETY INSPECTION

**Hartland Township, Livingston County, Michigan  
Section 33, T03N, R06E**

Inspection Date: August 11, 2021

Report Date: December 20, 2021

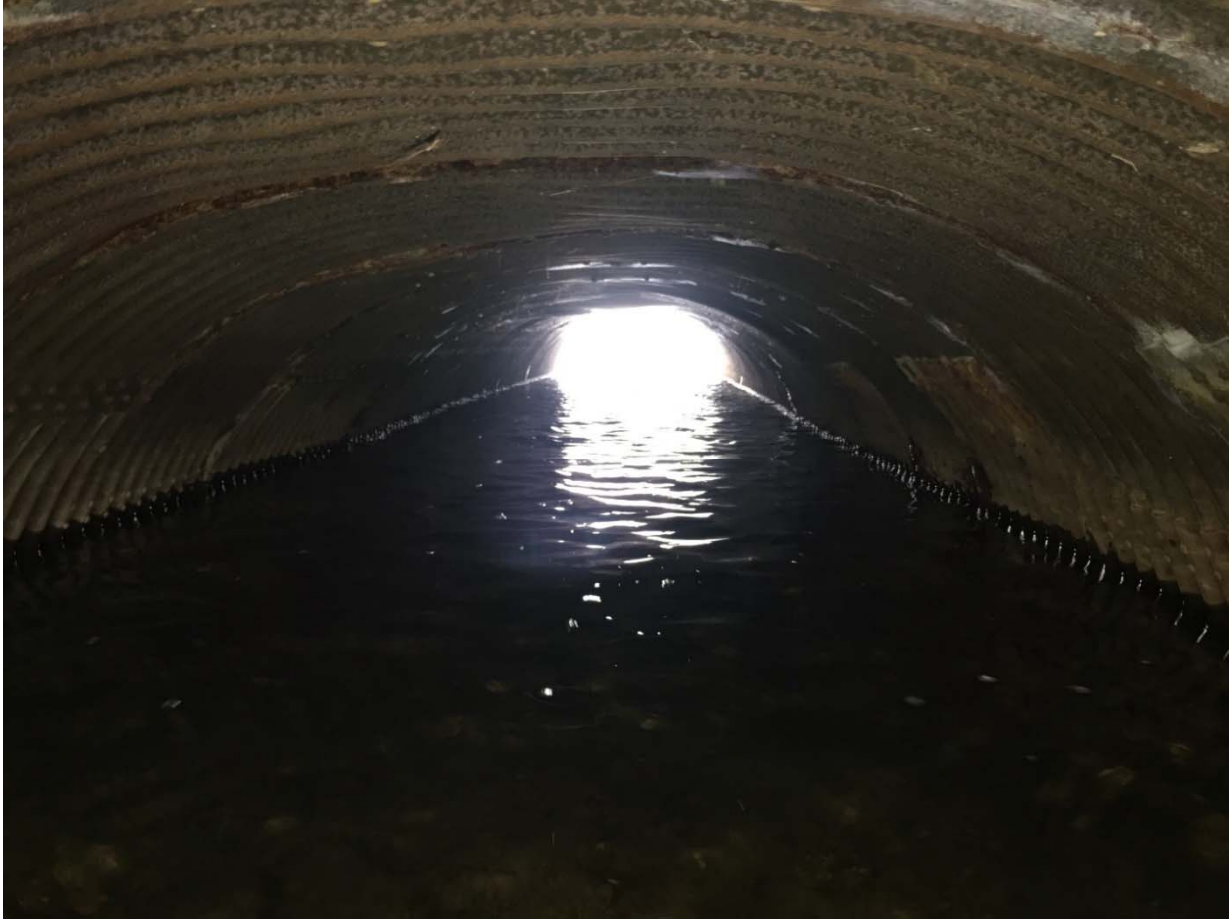
OUTLET PIPE: Check for damage from ice, logs, vandalism; inside discharge pipe for settlement and/or joint separation; condition of pipe coating.  
44" x 72" CMP under Blaine Road, vertical deflection in crown under road, surface rust and holes.. Notify Livingston County Road Commission

VIEW INSIDE OUTLET CMP PIPE LOOKING UPSTREAM

- Crown deflection at CMP pipe under road – Recommend replacement – Coordinate with Road Commission
- Upstream headwall deterioration – see photos
- Fencing around drop structure poor - Recommend replacement
- Repair some downstream erosion and place riprap.
- Rebuild settling road surface curb and behind curb.
- Heavy vegetation prevented inspection of all sheet piling of stilling basin, noted in 2018 inspection was to replace a failing portion of sheet piling part of basin, may still need done.

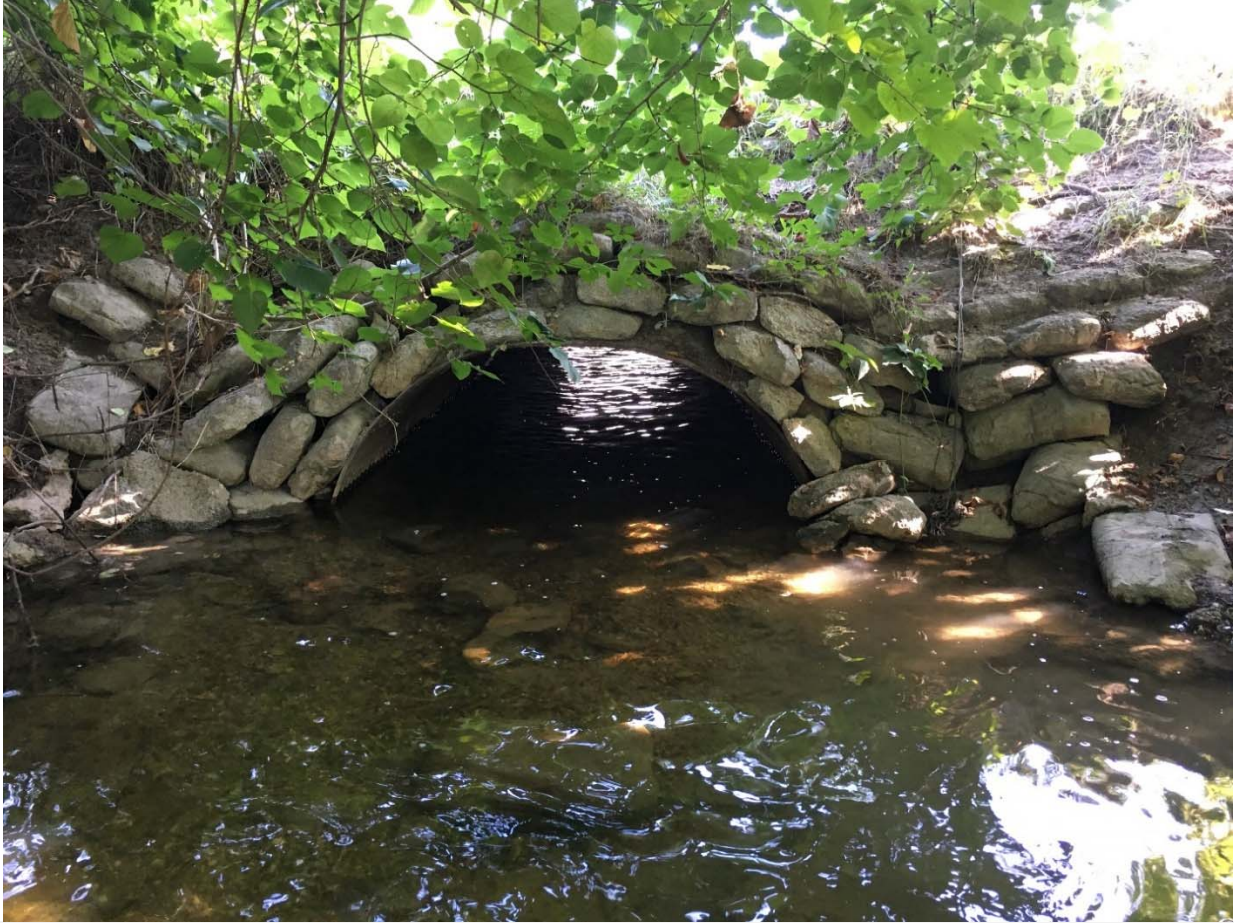
VIEW OF DOWNSREAM OUTLET CMP PIPE

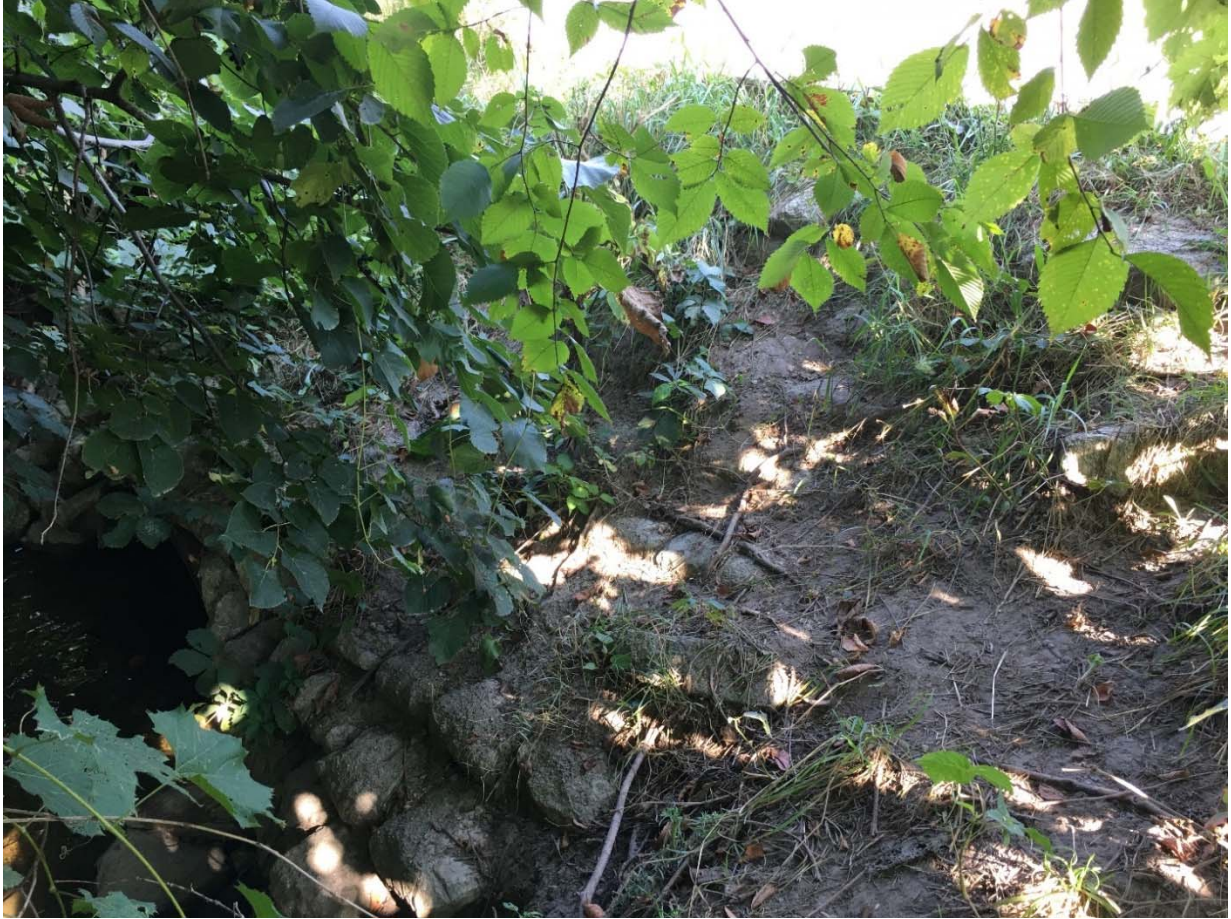
MINOR EROSION A DOWNSTREAM BANK

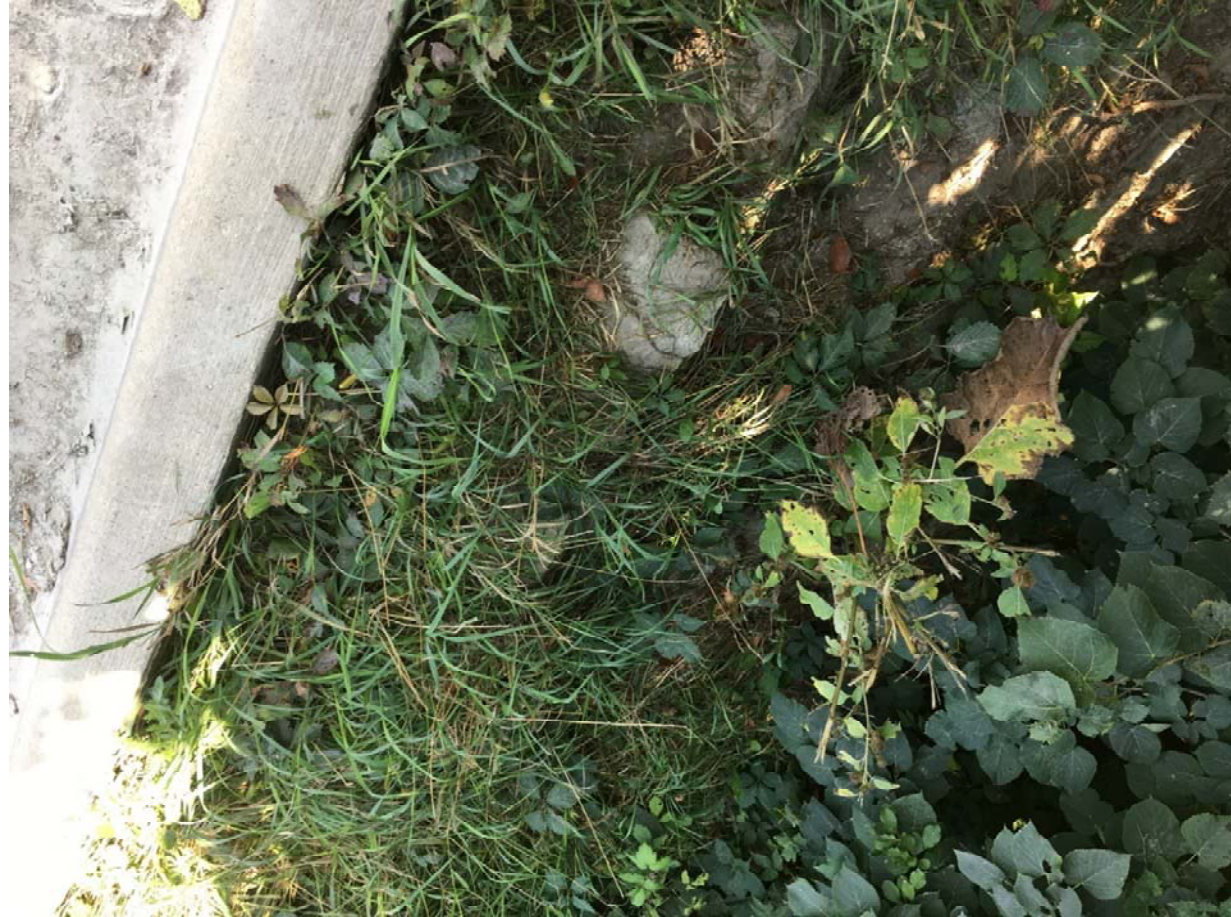
CONCRETE STRUCTURE: Check for erosion; location of cracking or spalling. If old or new; settlement; need for crack repairs.  
Poor condition, Settlement between head wall and curb, headwall spalling and deterioration,

SETTELEMENT/EROSION BEHIND SOUTH ROADWAY CURB OVER OUTLET PIPE

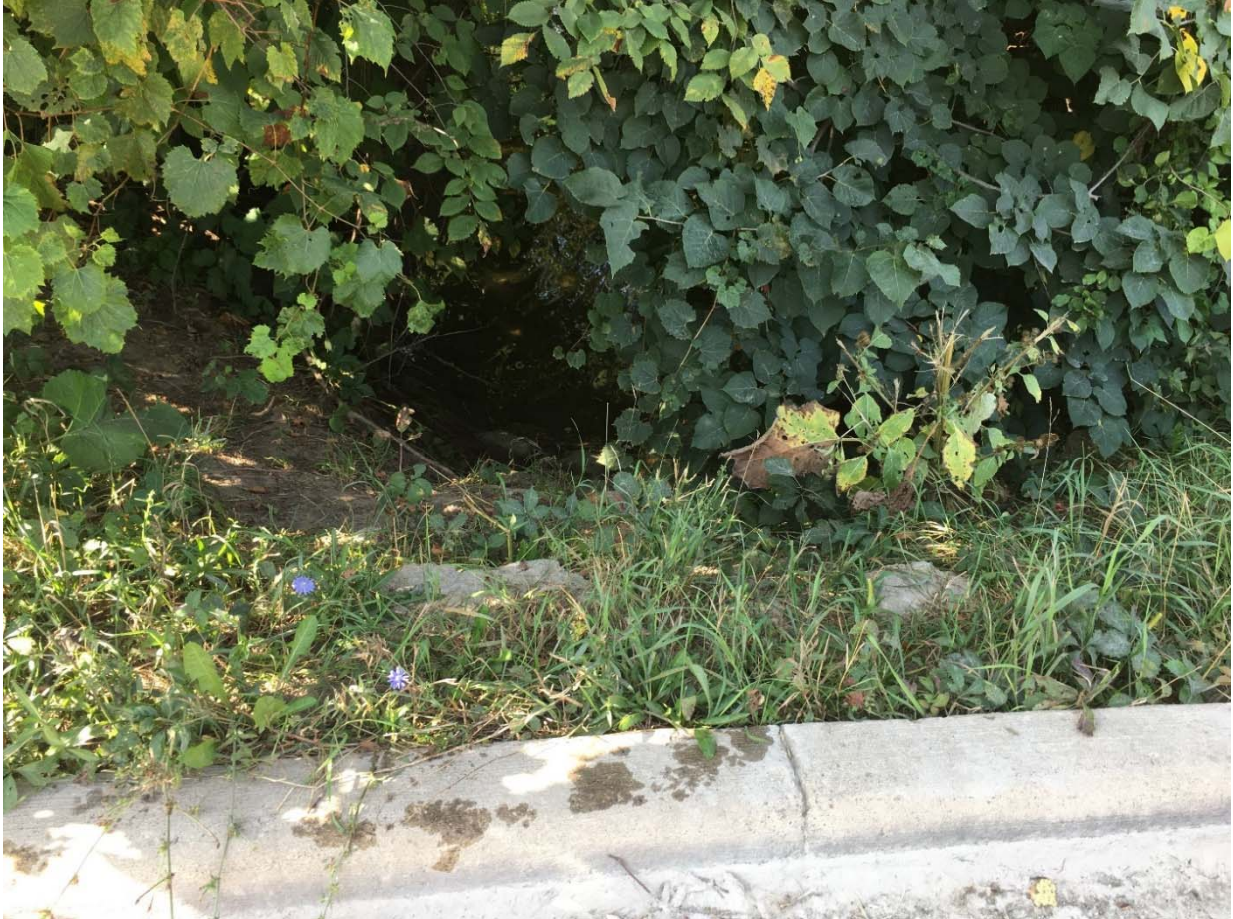
LOOKING SOUTH AT CONCRETE CURB SHOWING MINOR EROSION OVER OUTLET PIPE

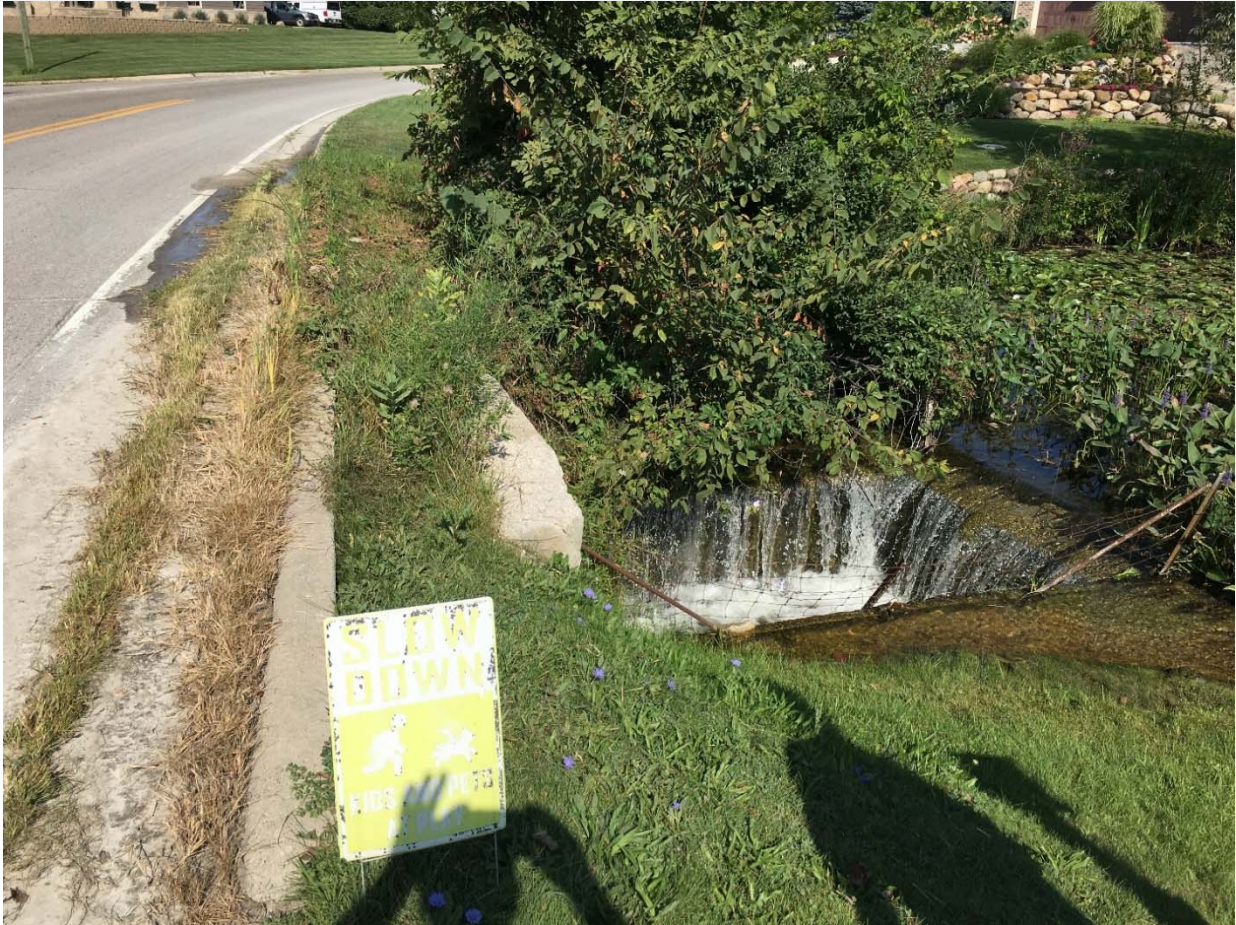
LOOKING WEST AT OVERFLOW STRUCTURE

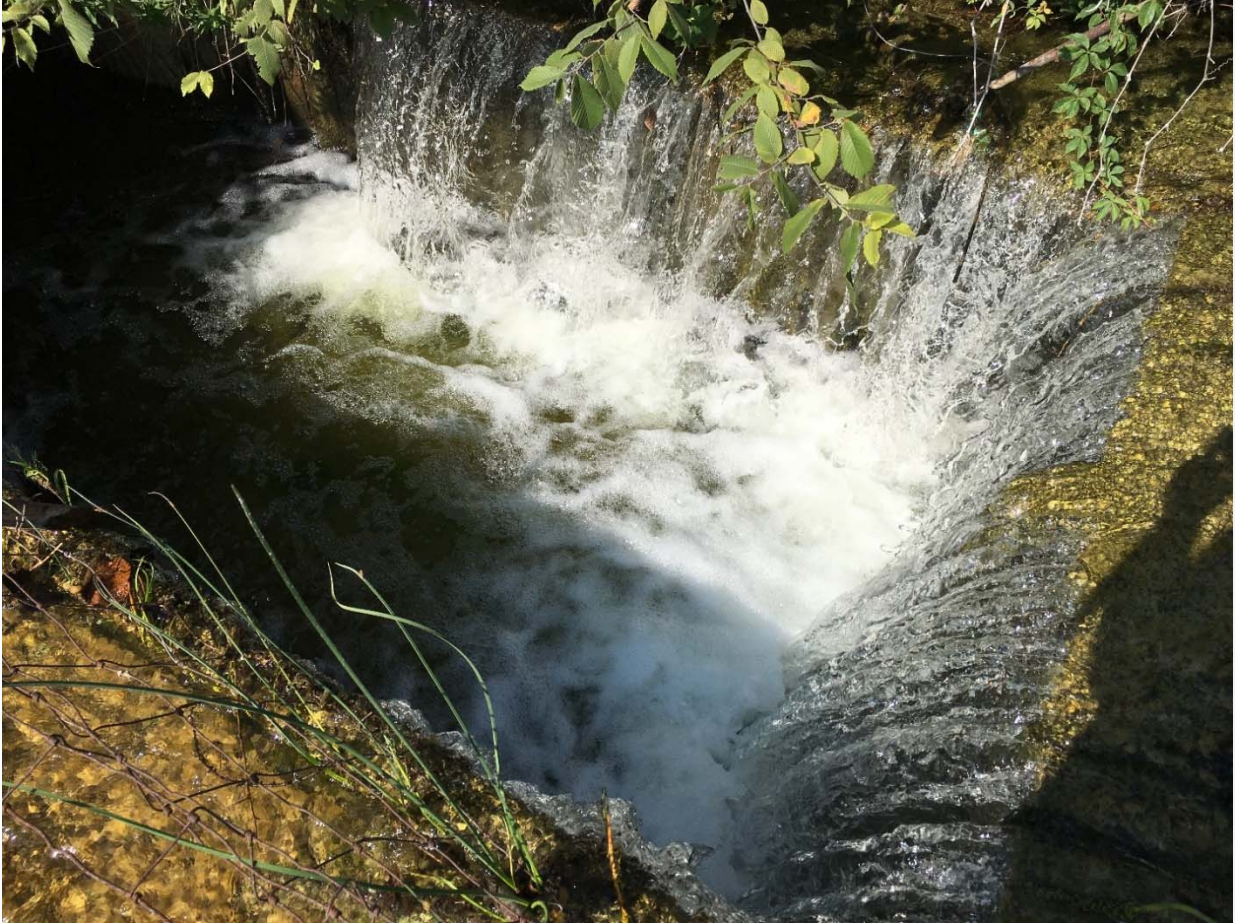
CLOSE UP OF OVERFLOW STRUCTURE – OUTLET PIPE TO LEFT; UPSTREAM CHANEL TO RIGHT

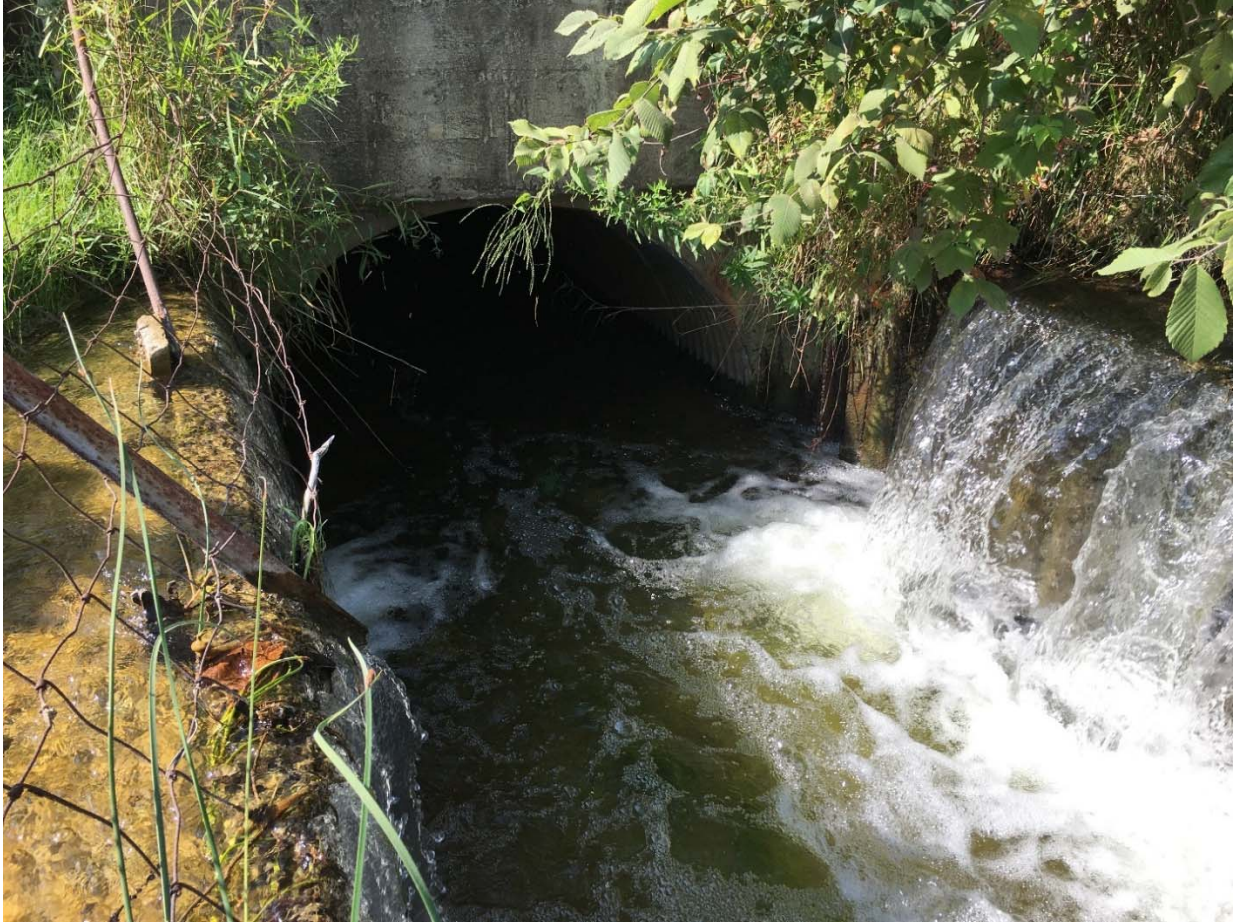
LOOKING SOUTH AT OVERFLOW STRUCTURE WITH OUTLET PIPE AND CONCRETE HEADWALL

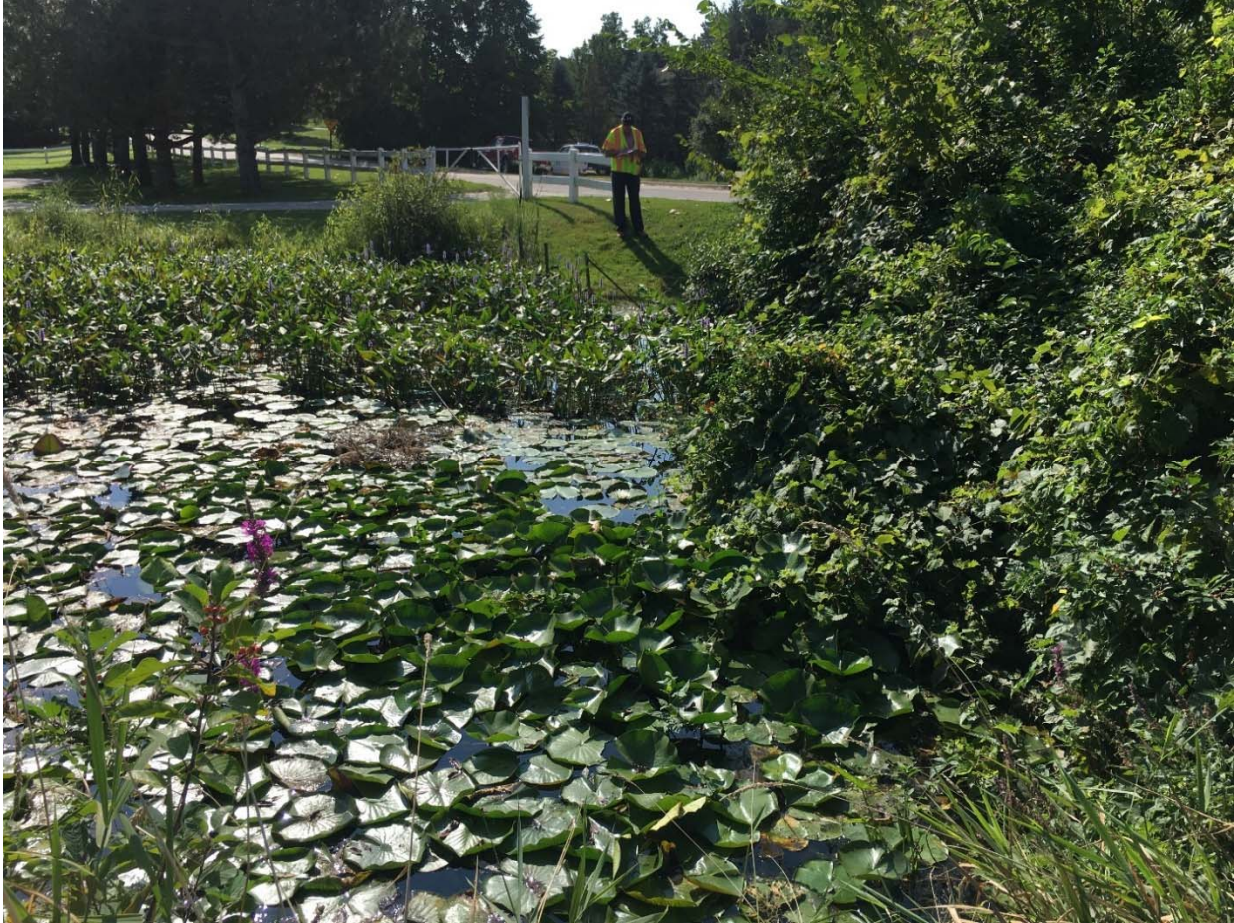
VIEW OF UPSTREAM CHANNEL SHOWING HEAVY WATER VEGETATION GROWTH

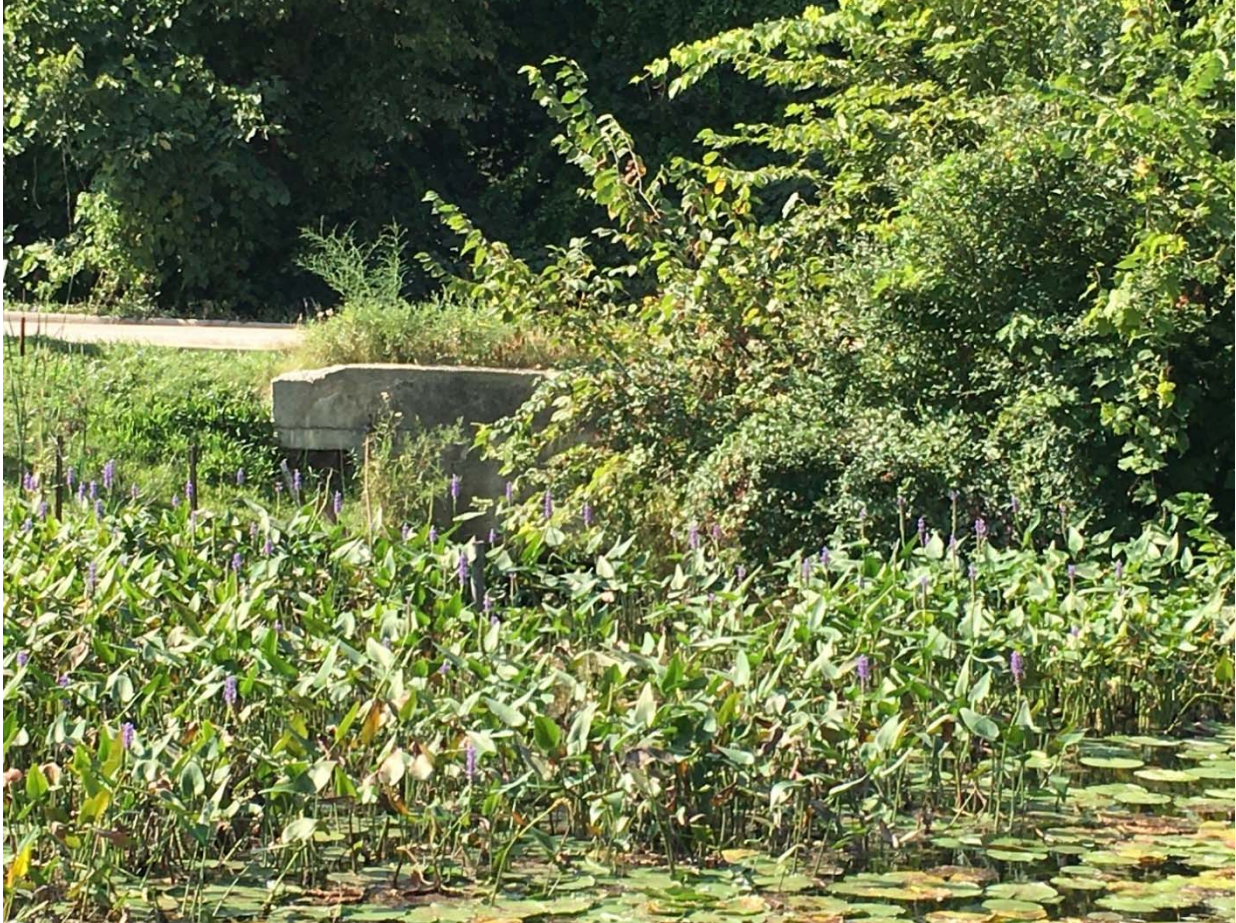
LOOKING SOUTH TOWARDS BLAINE ROAD – UPSTREAM CONCRETE HEADWALL IN BACKGROUND

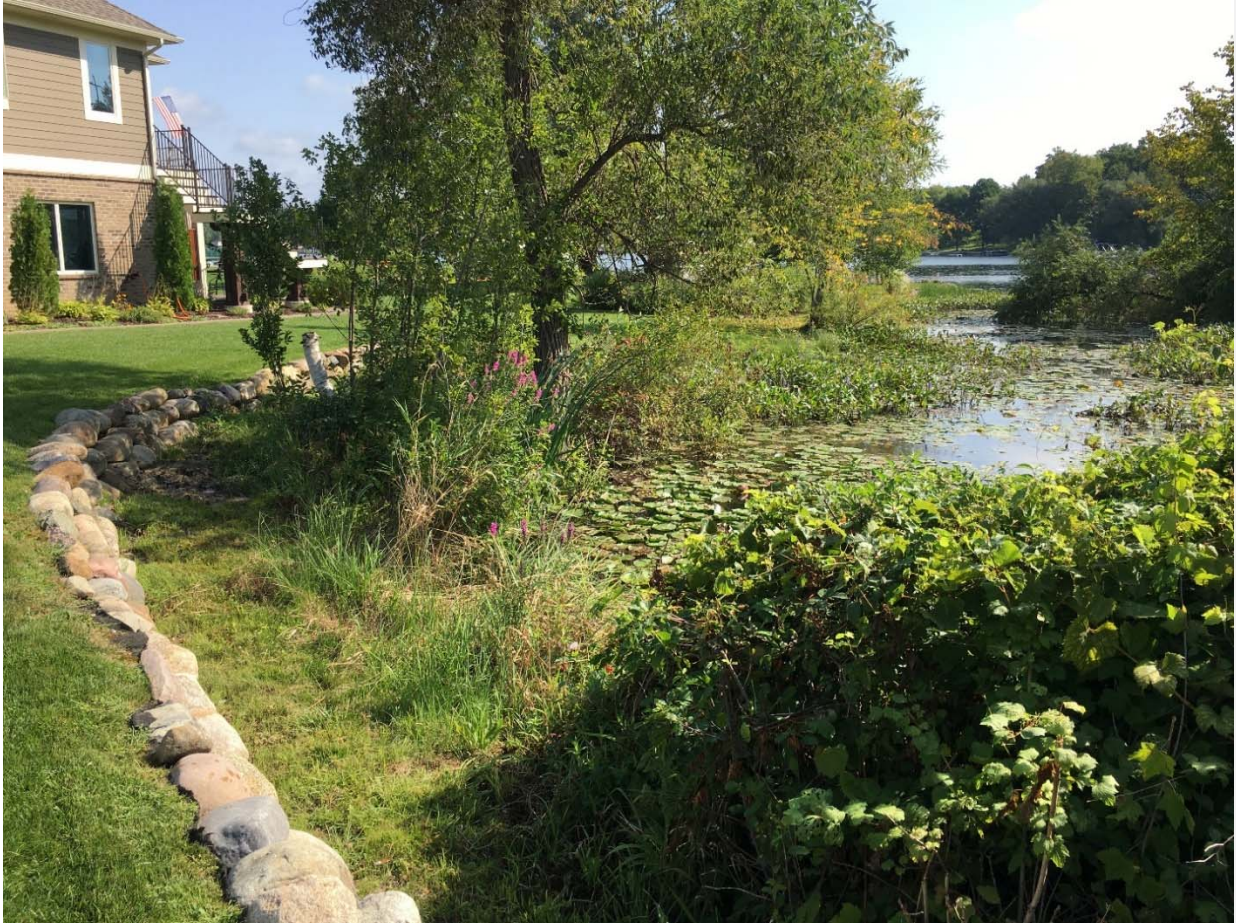
LOOKING NORTH OF UPSTREAM CHANNEL (LONG LAKE IN BACKGROUND)

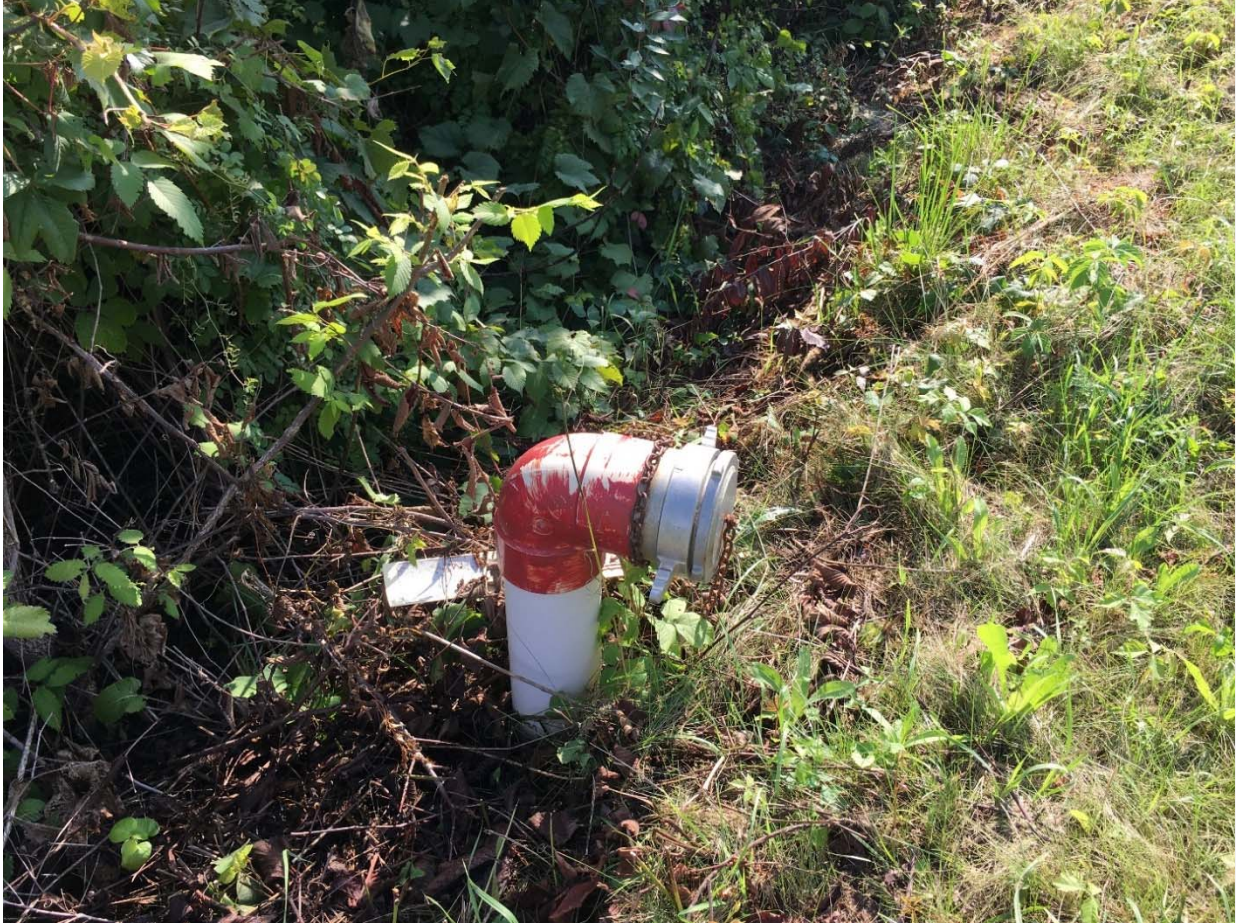
DRY HYDRANT LOCATED ALONG WEST UPSTREAM BANK

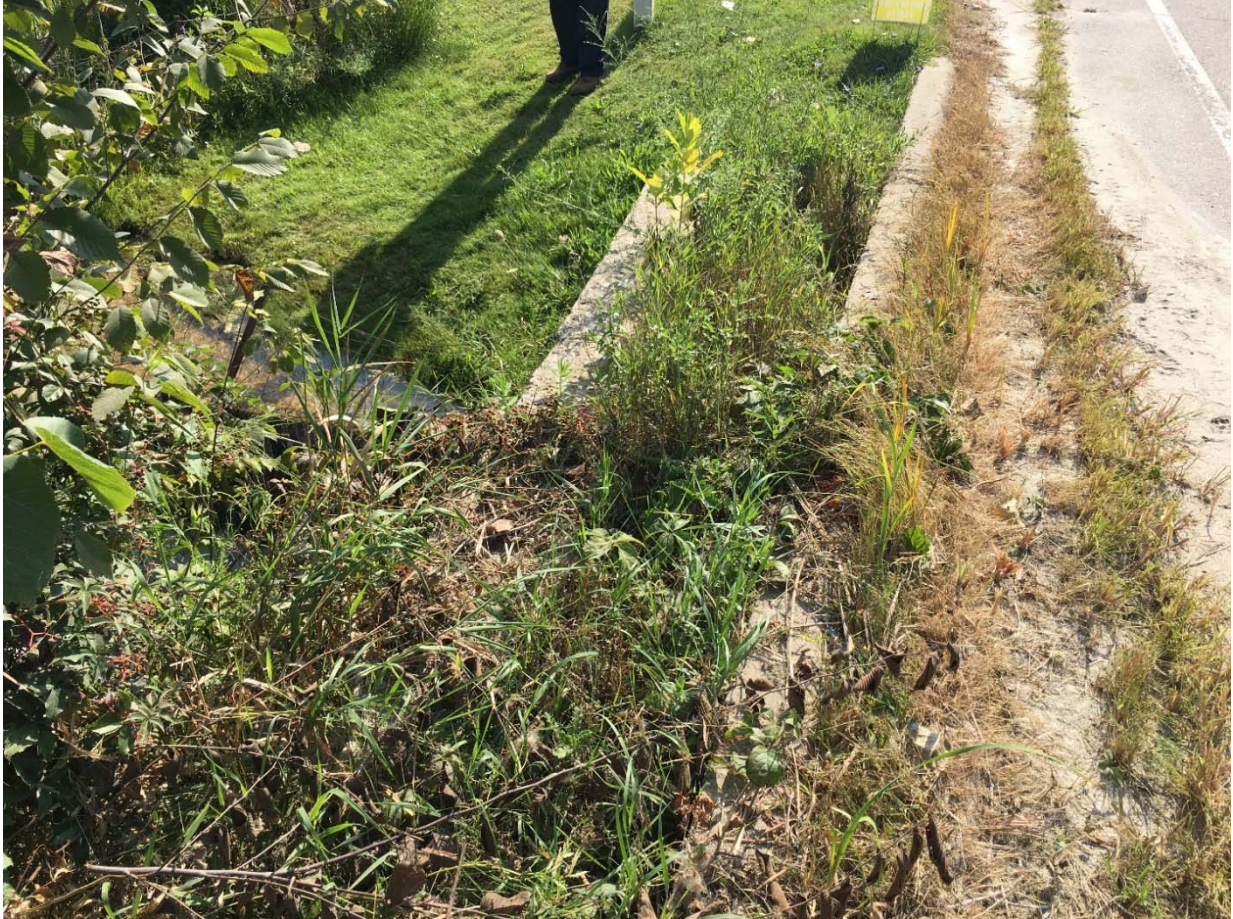
LOOKING EAST AT CONCRETE HEADWALL

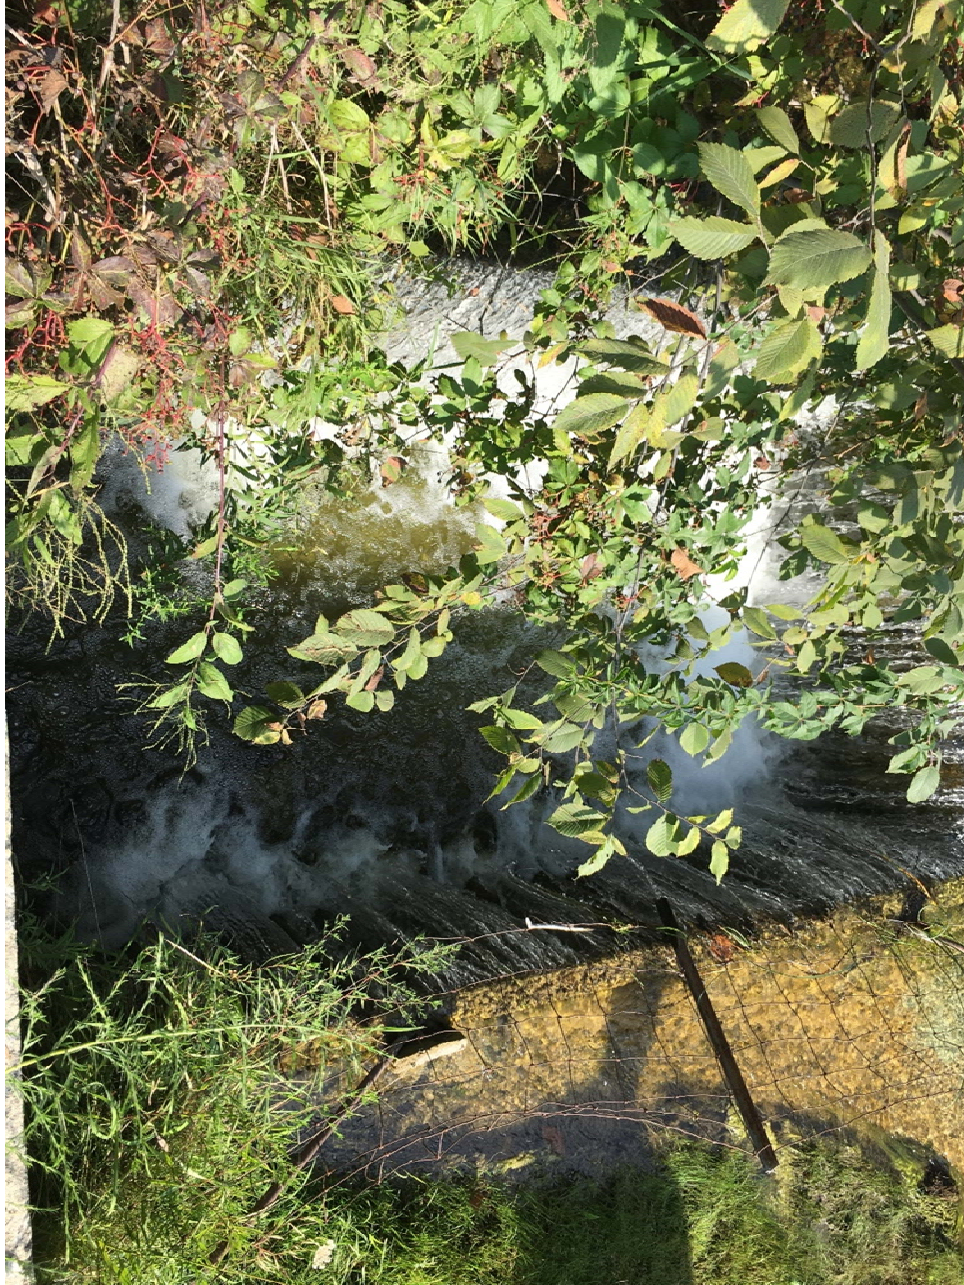
VIEW OF CONROL STRUCTURE - NOTE HEAVY VEGATATIVE GROWTH

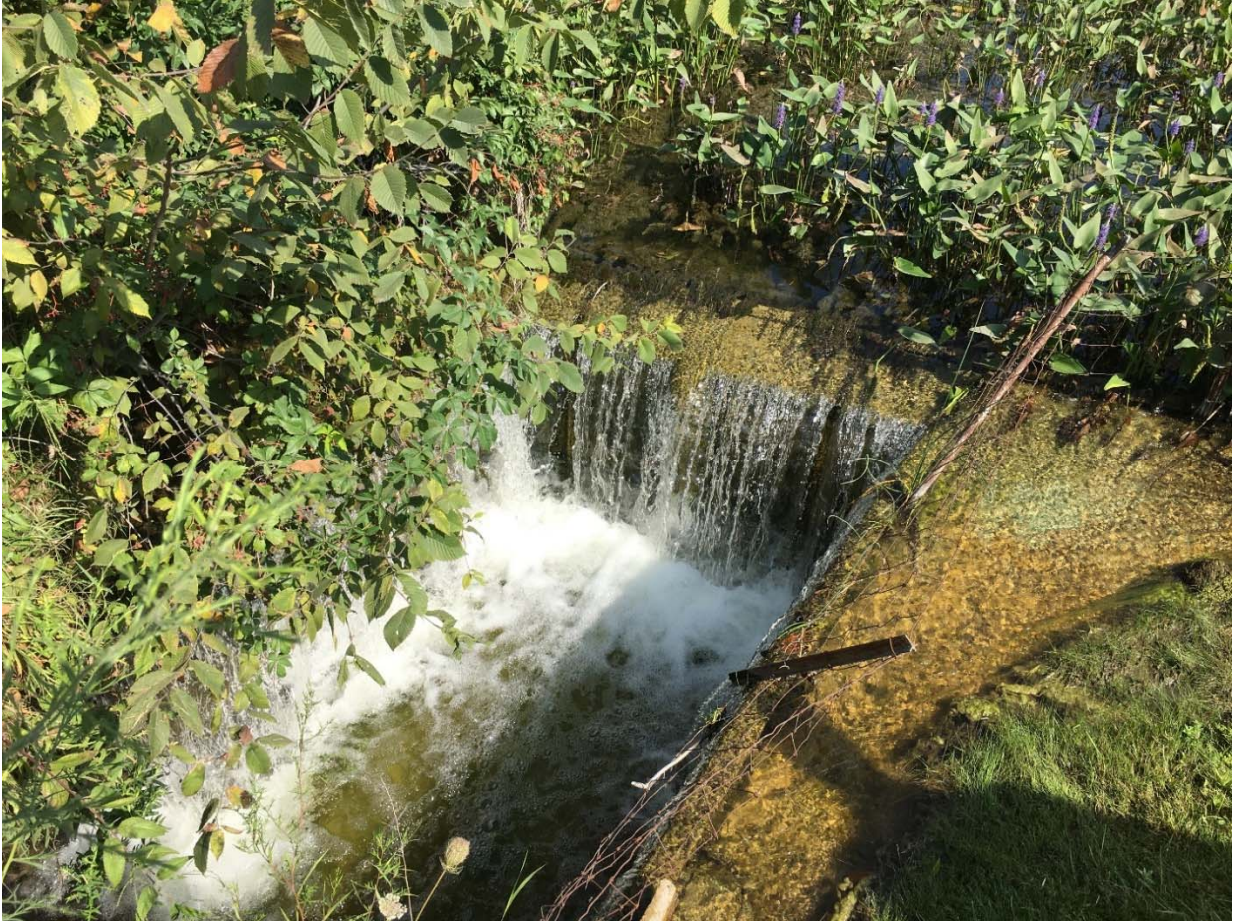
VIEW OF CONROL STRUCTURE – NOTE HEAVY WATER VEGETATION GROWTH

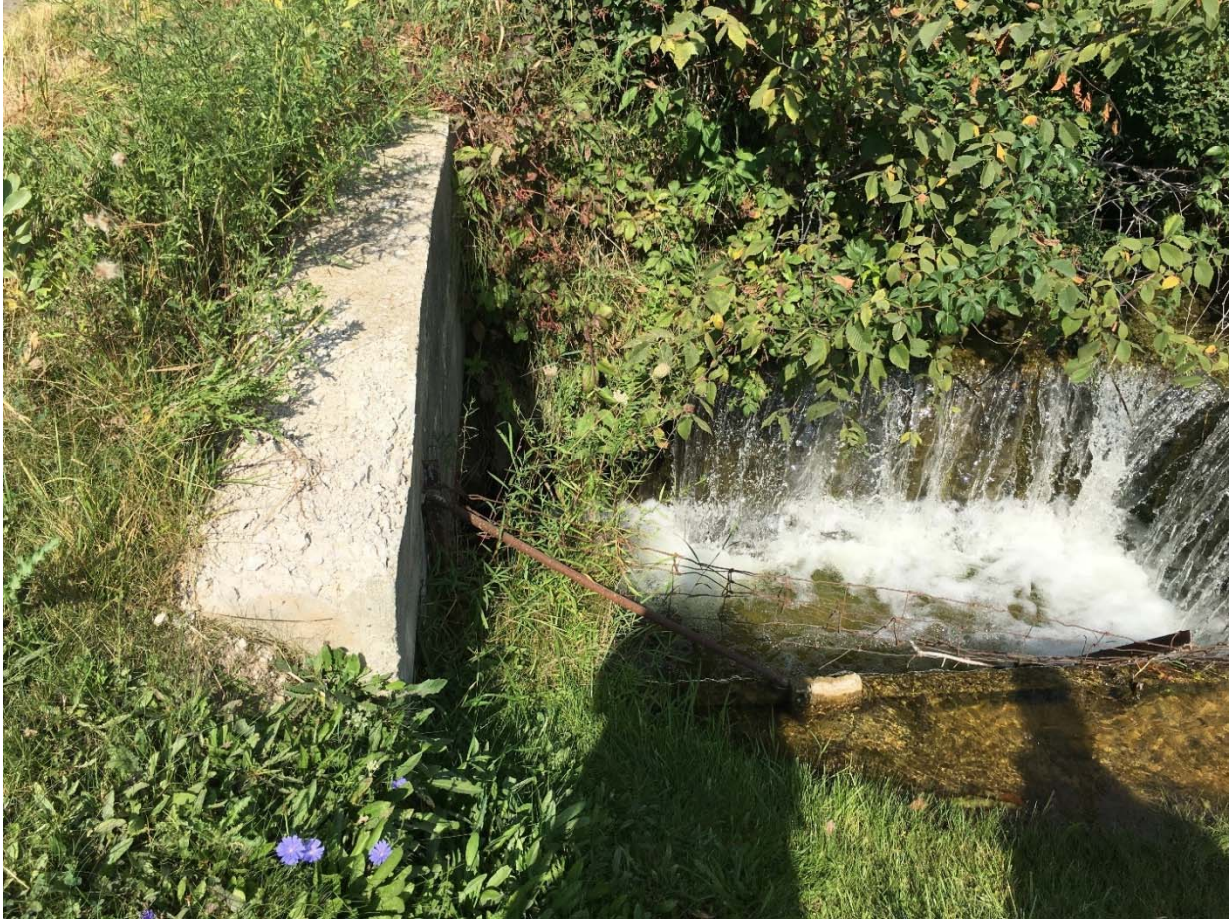
LOOKING WEST AT CONCRETE HEADWALL (LEFT) AND CONTROL STRUCTURE (RIGHT)  
NOTE HEADWALL SPALLING AND DELAMINATION
