Faussett Lake Dam Inspection Report

Dam Identification No.: 307
Hazard Potential: Low
Section 33 ; T.04N. – R.05E.
Deerfield Township, Livingston County, Michigan
Located on the Yellow River
Per Part 315, Act 451 of 1994

Date of Inspection: August 9, 2022
Date of Final Report: December 22, 2022

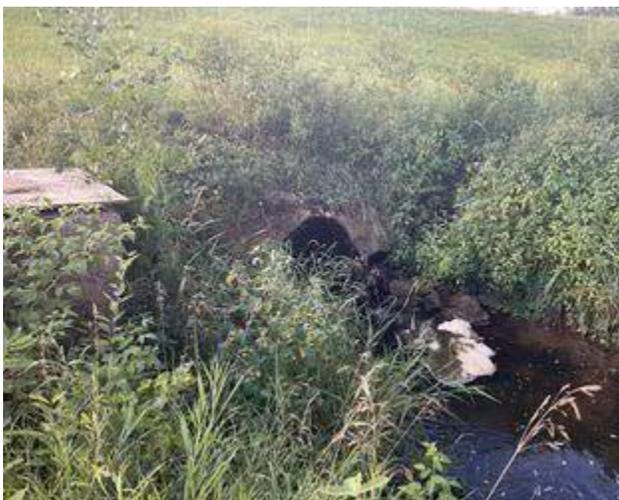
SEVERITY: Low

- K. Ground cover vegetation is established well in the auxiliary spillways.
- L. The cracks in the downstream headwall for the 36-inch outlet are becoming larger and the structure should be repaired.

DESCRIPTION: Looking upstream at headwall failure

Recommend: Continue to monitor the corrosion annually until repair or replacement can be made to the pipe and headwall. Monitor the soil over the length of the top of the outlet pipe for evidence of additional settlement or sinkholes.

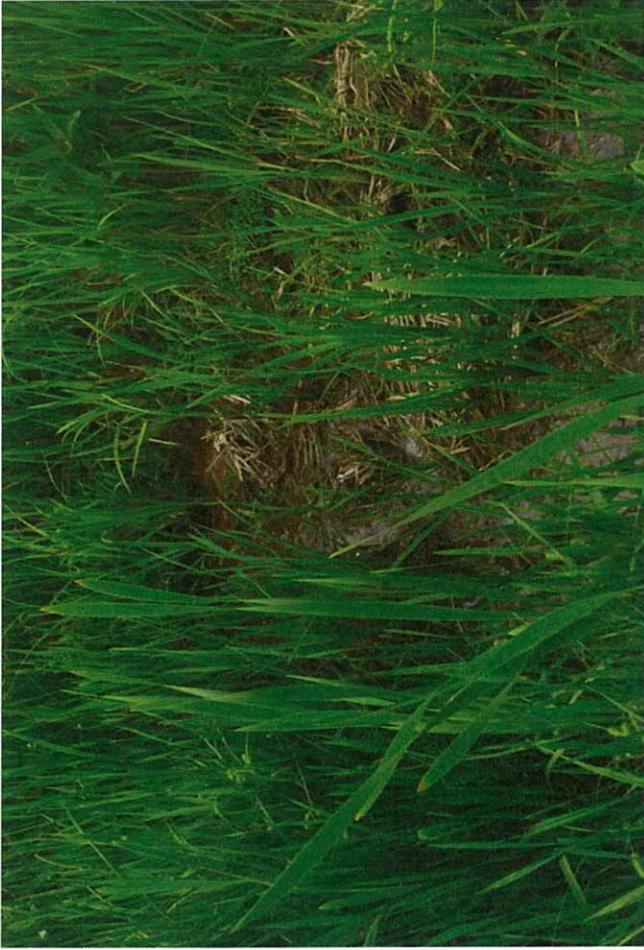
- D. Seepage was visible along the downstream face of the dam on the western one third of the structure. The driveway along the toe of slope in this area is wet. No boils were noted but the area is wet.

Seepage along western portion of downstream slope of Faussett Lake Dam.

Recommend: As recommended in the 2022 geotechnical report (included in Appendix E) a drained buttress should be implemented to remediate seepage and stabilize the earthen embankment. Continue to routinely monitor seepage until remedial action is taken.

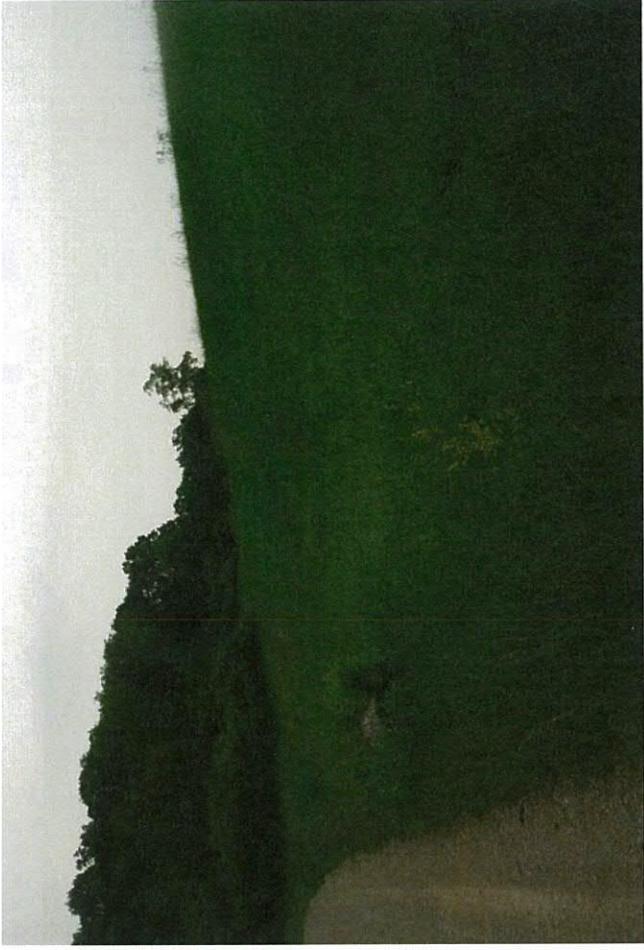
Looking east along downstream slope of Faussett Lake Dam.

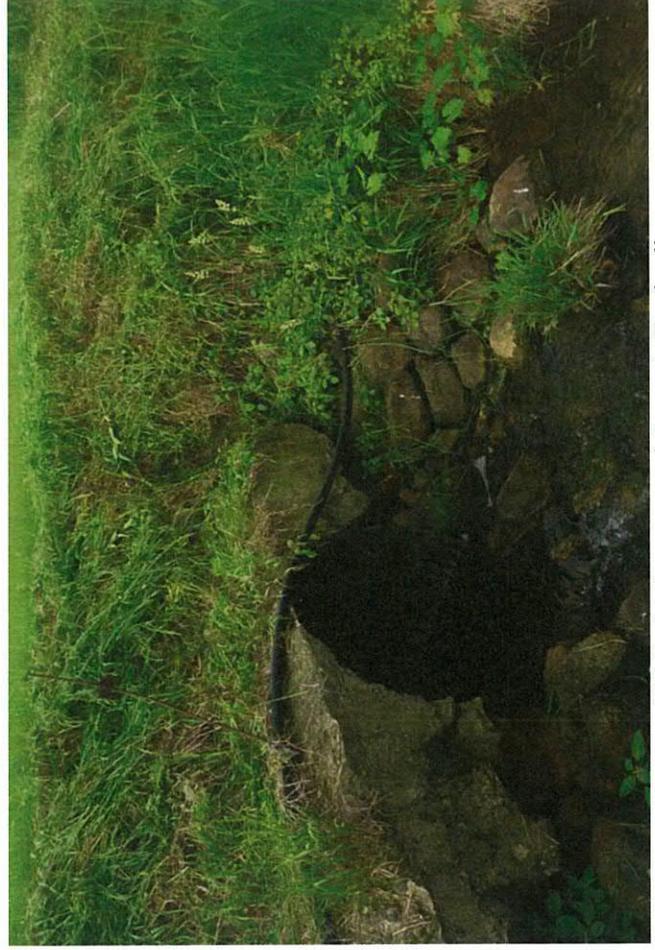
36" Outlet Structure and Concrete Headwall.

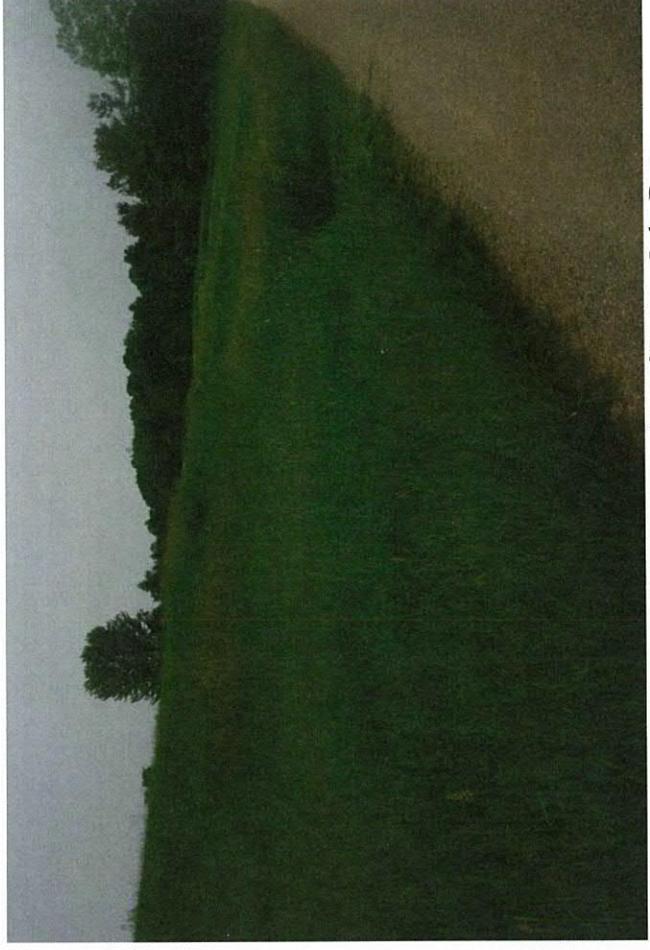
Looking west along downstream slope of Faussett Lake Dam.

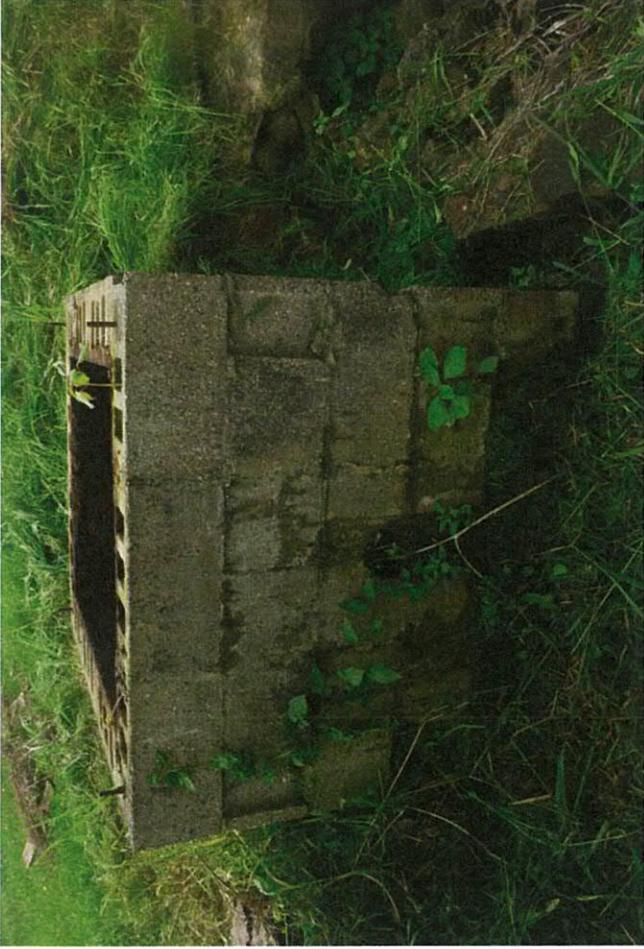
4-foot by 4-foot concrete block, location of low flow draw down valve.

Recommend: Continue to monitor the inlet as needed. If operable, exercise the draw down valve at least once per year. It may be pertinent to engage the services of an experienced dive team to film the structure and provide condition documentation, if it is not replaced as part of the outlet pipe project. Place a heavy wire grate or baffle system around the inlet to prevent floating materials or woody debris from entering the inlet and obstructing flow.

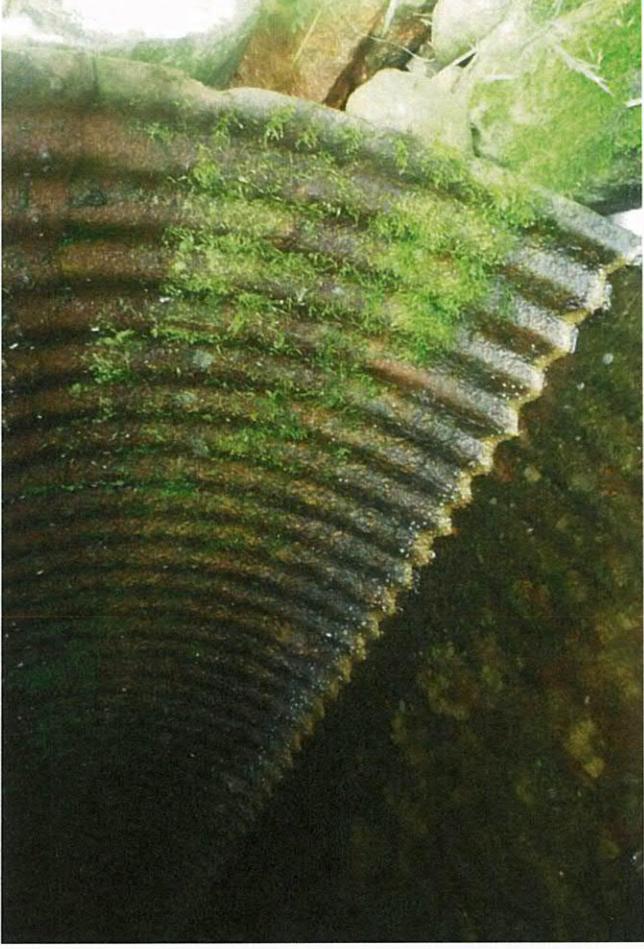
- H. The outlet functions well, outlet channel and approaches are free of debris.
- I. There is corrosion of the 36-inch outlet pipe.
- J. There appears to be settlement directly above the outlet pipe at the downstream toe of the embankment. Based upon conversations with the Owner, this area of settlement corresponds with the location where the outlet pipe was added onto in order to widen the access road.

36" CMP outlet pipe.

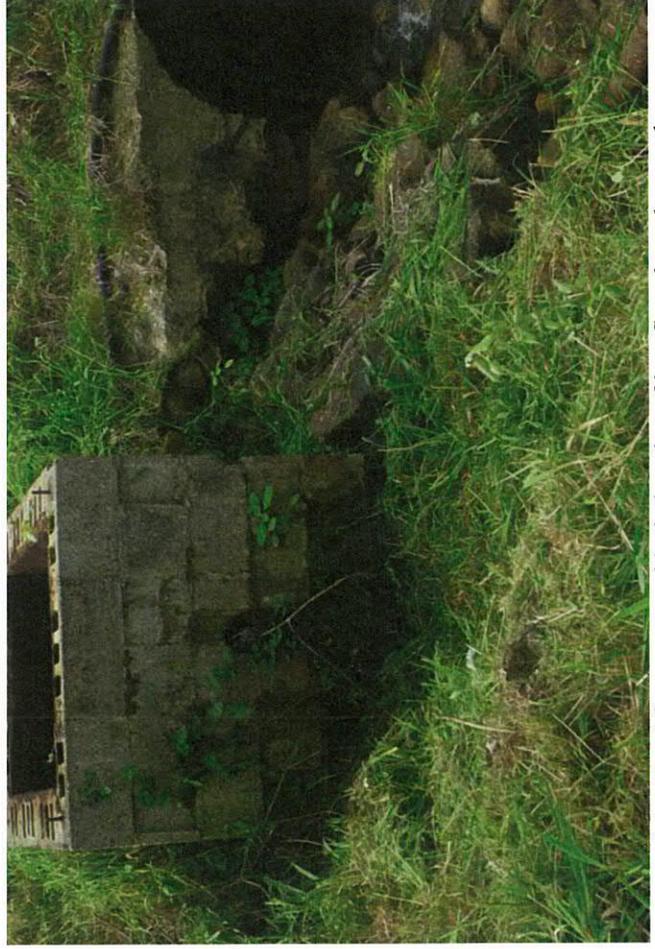
4-foot by 4-foot concrete block, location of low flow draw down valve.

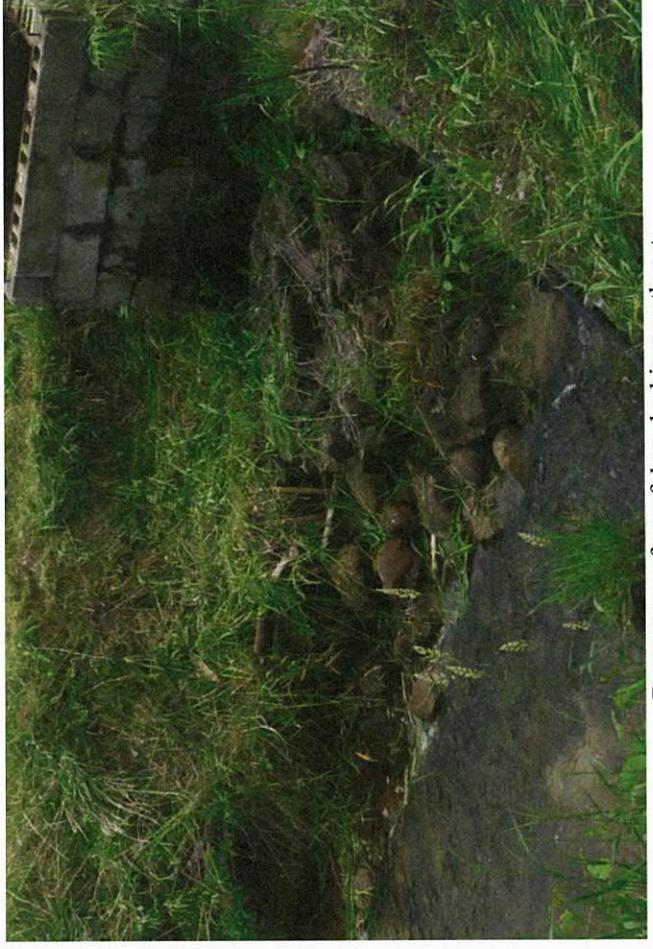
Downstream face of dam, looking northeast.

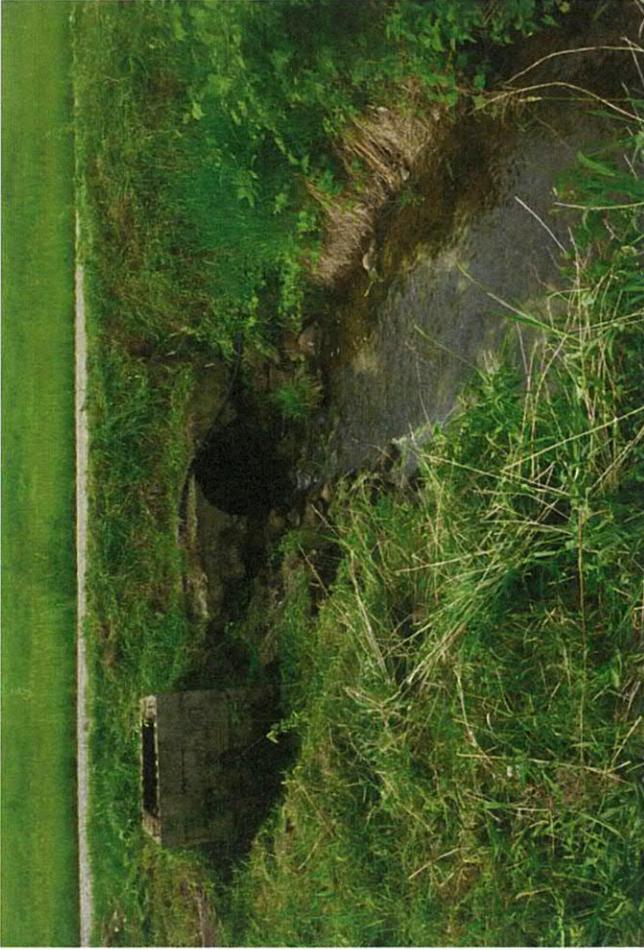
Downstream face of dam, looking upstream.

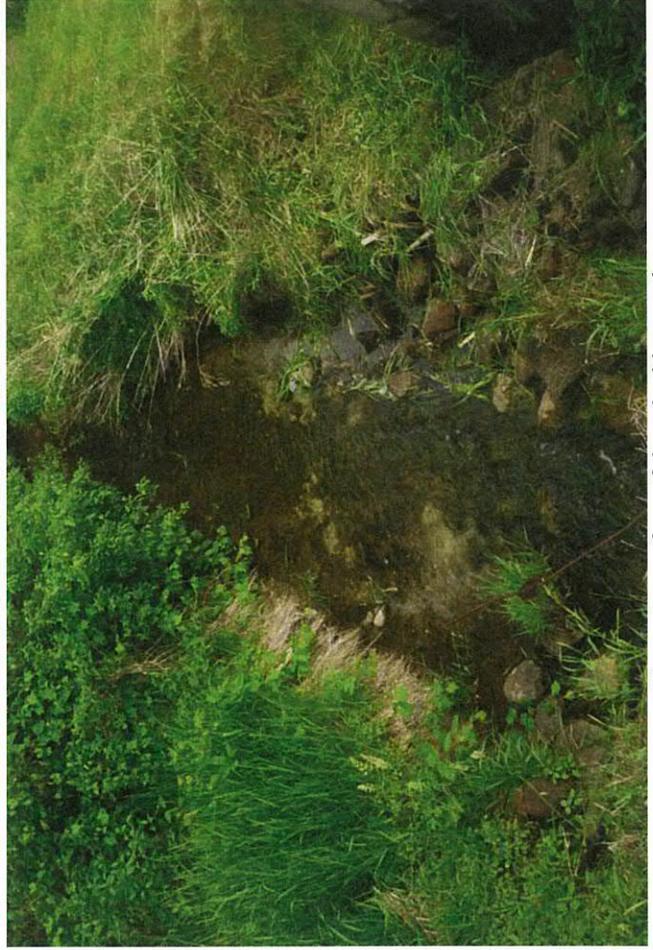
Downstream face of dam, looking north.

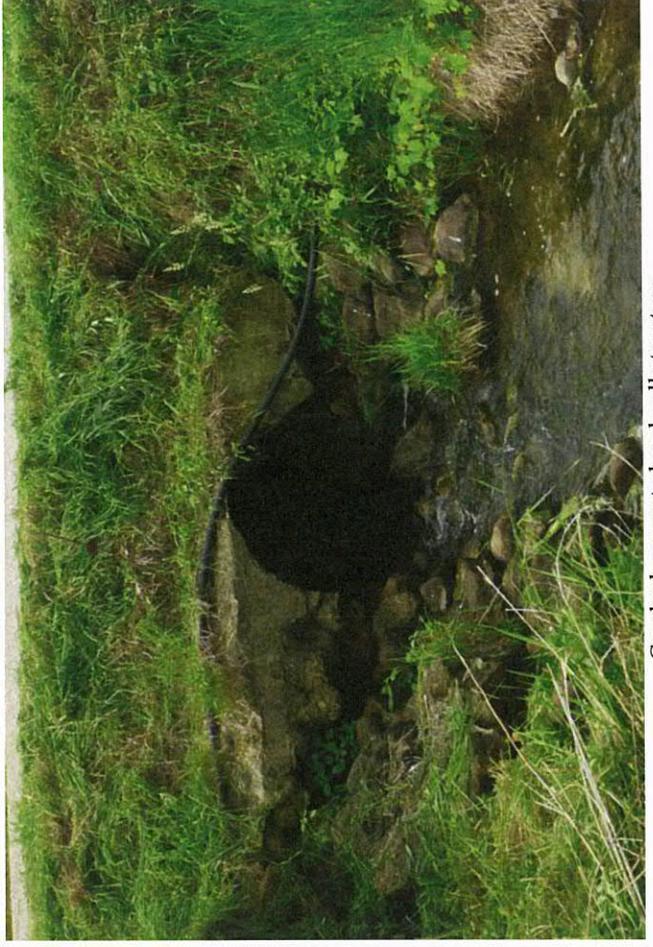
Cracked concrete headwall structure.

The second cost estimate includes the removal and replacement of the existing concrete headwall structure.

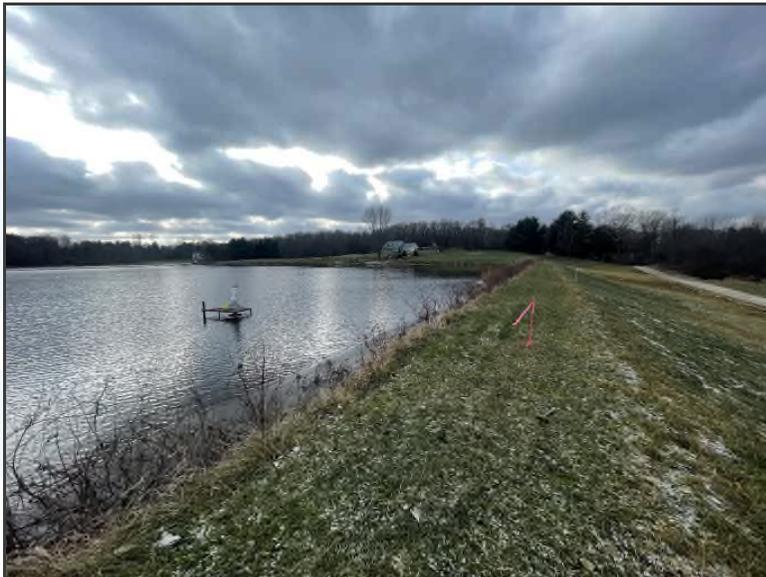
Image 2: Looking west along the crest of the dam embankment (photo date: 12/7/2021).

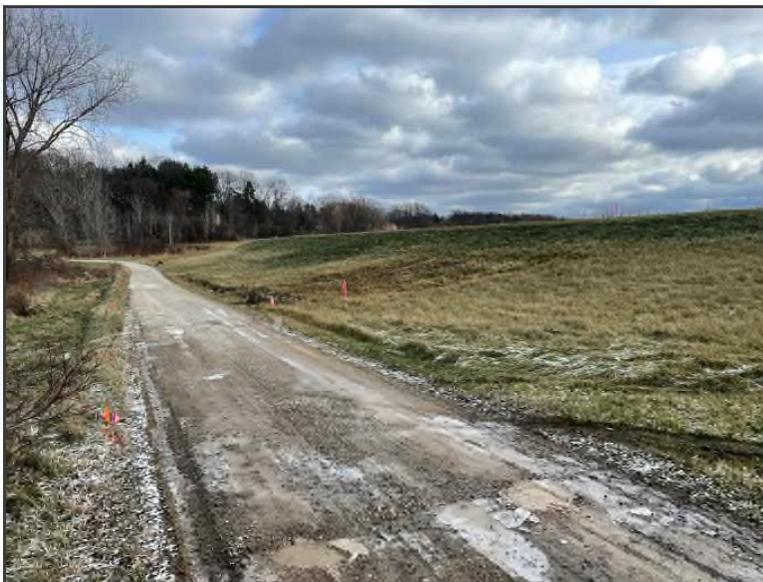
Image 3: Looking east along the driveway at the toe of the embankment. The seepage area is visible to the right of the driveway in the background of the pink stake (photo date: 12/7/2021).

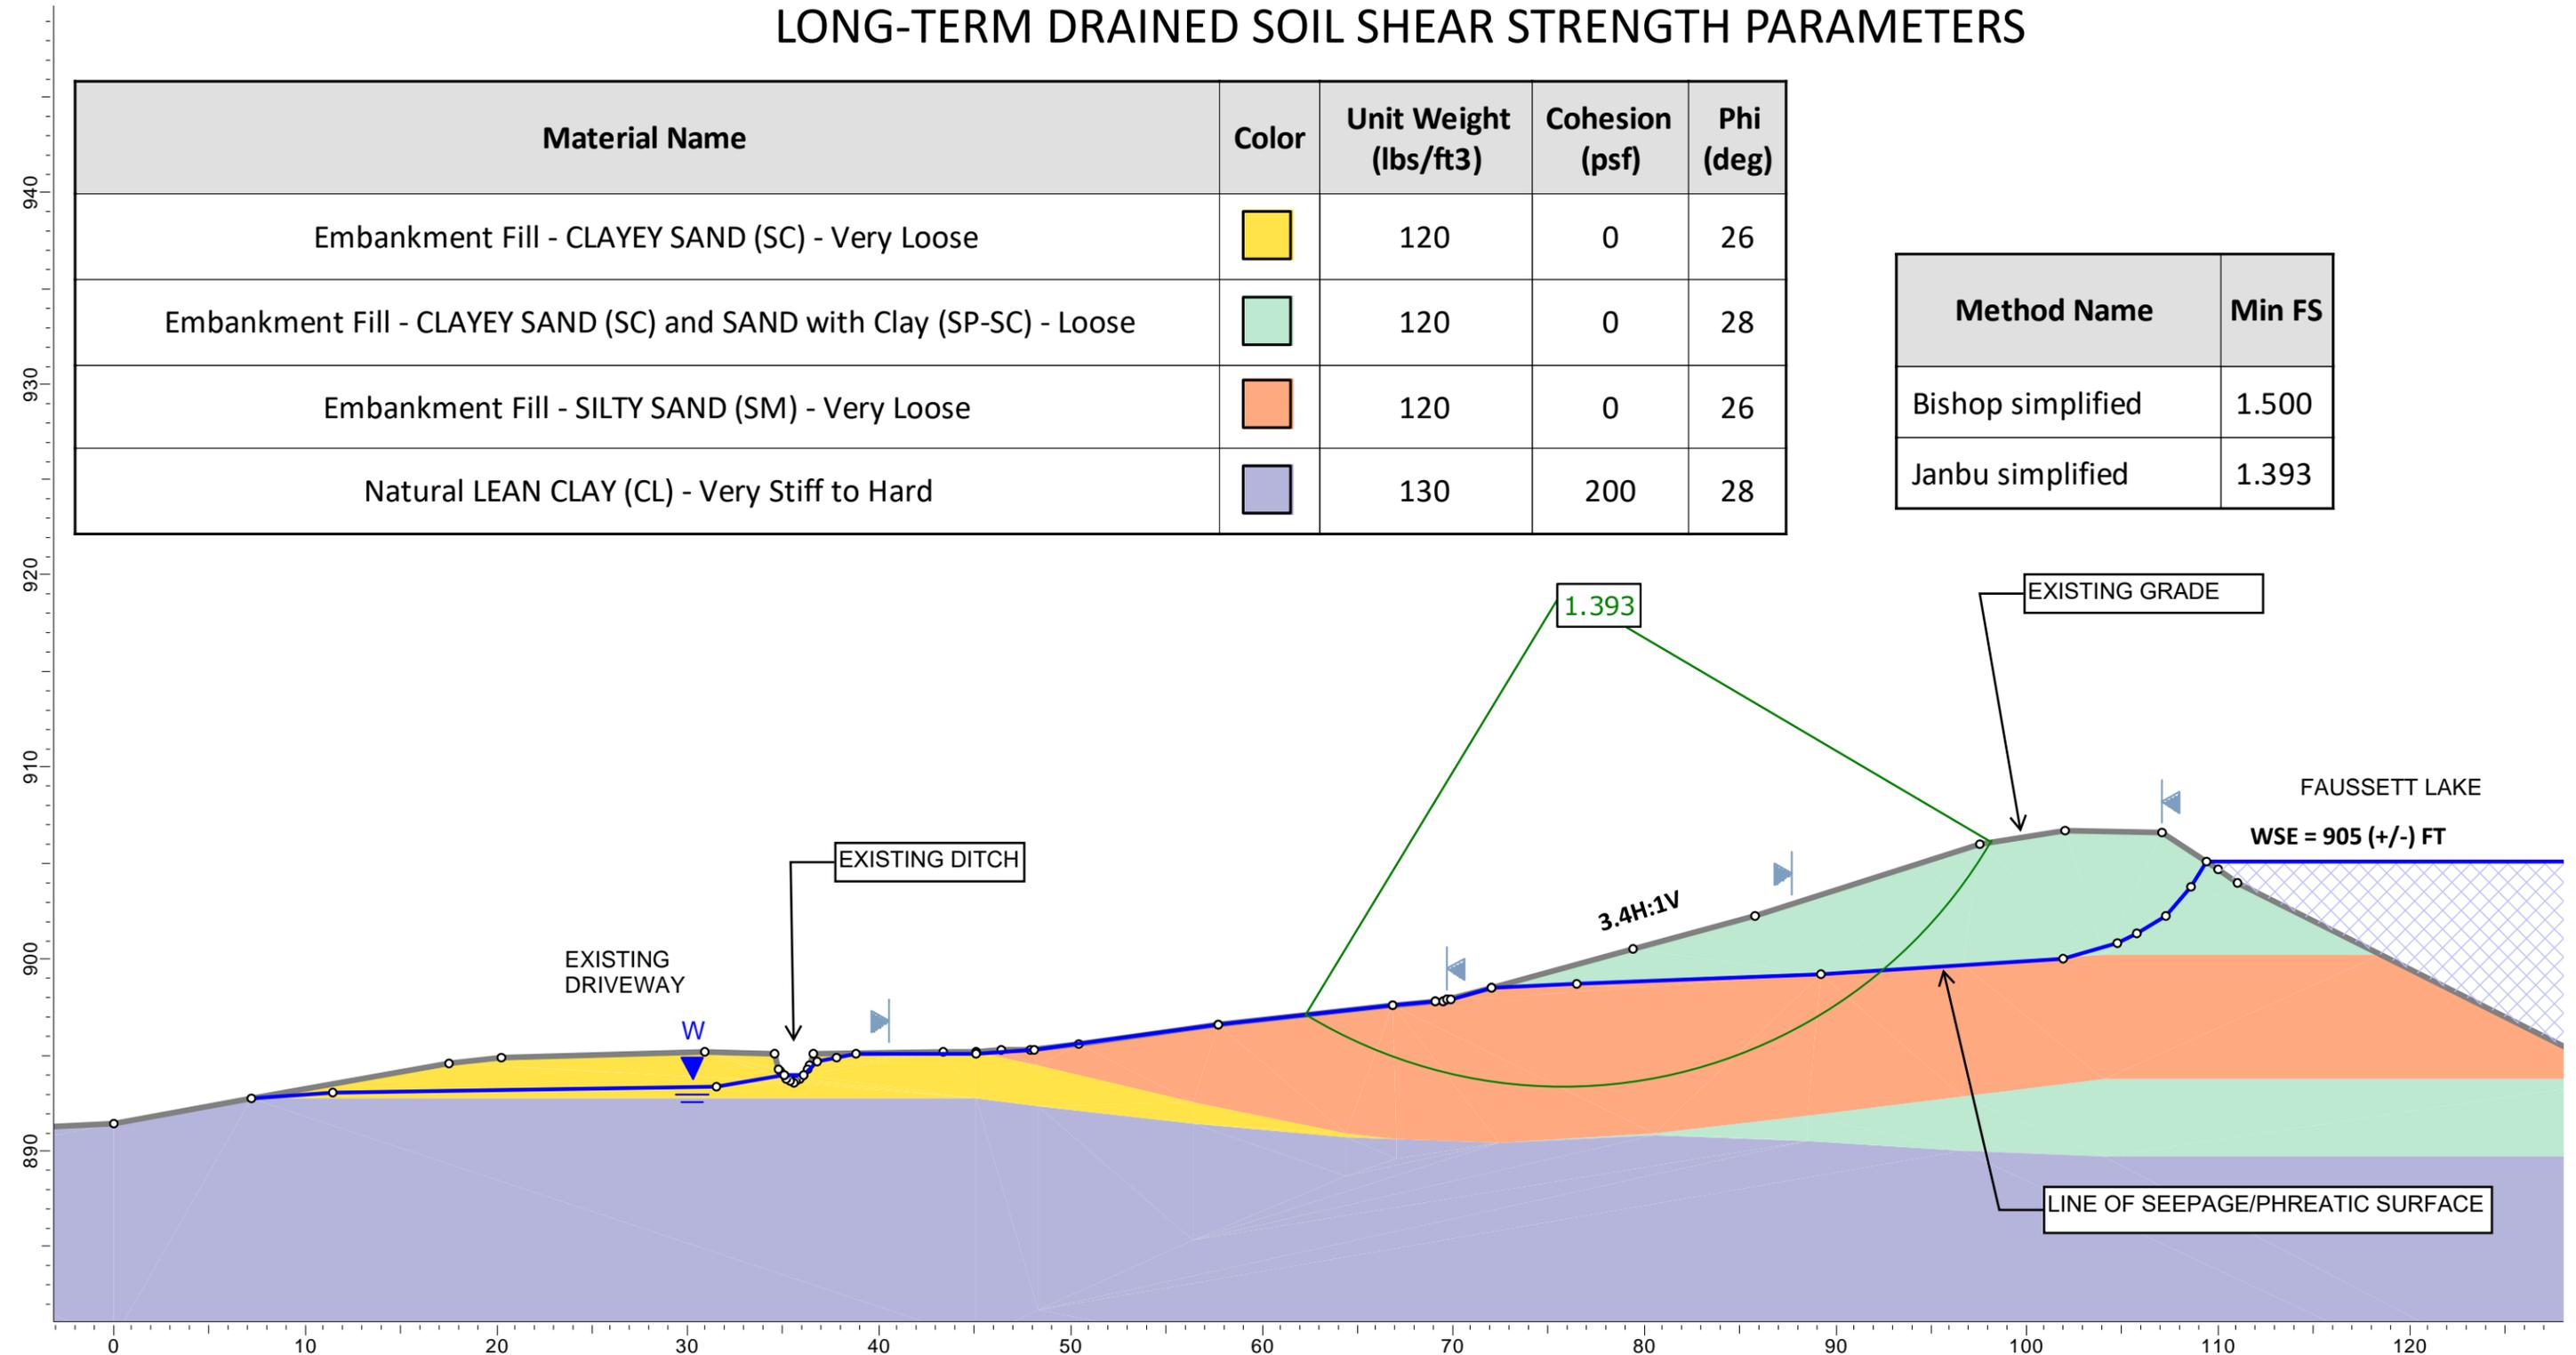
FIGURE NO. C2
CROSS SECTION A-A WITH DRAINED BUTTRESS,
STEADY-STATE SEEPAGE CONDITIONS
FAUSSETT LAKE DAM
DEERFIELD TOWNSHIP, LIVINGSTON COUNTY, MICHIGAN

Method Name	Min FS
Bishop simplified	1.500
Janbu simplified	1.393
