Wade Trim Associates, Inc.
25251 Northline Road • Taylor, MI 48180
734.947.9700 • www.wadetrim.com

January 25, 2023

Re: Faussett Lake Dam Technical Memorandum

Faussett Lake Dam Site Investigation
December 22, 2022

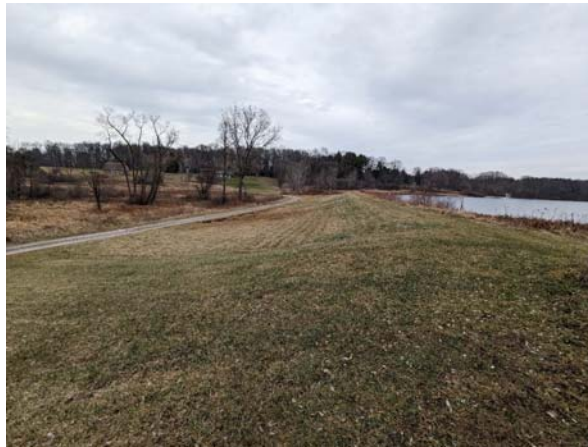
Picture 1 - Looking east at embankment.

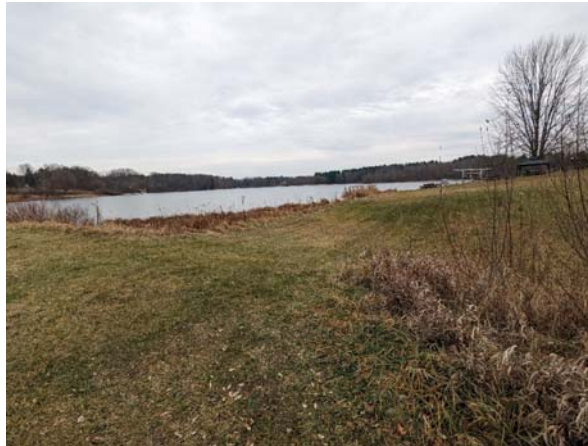
Picture 2 - West spillway.

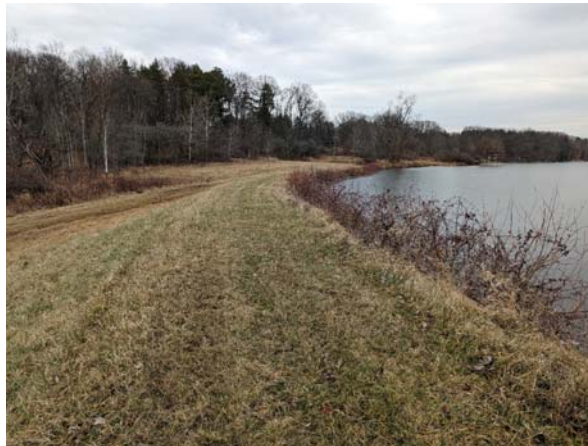
Picture 3 - East spillway.

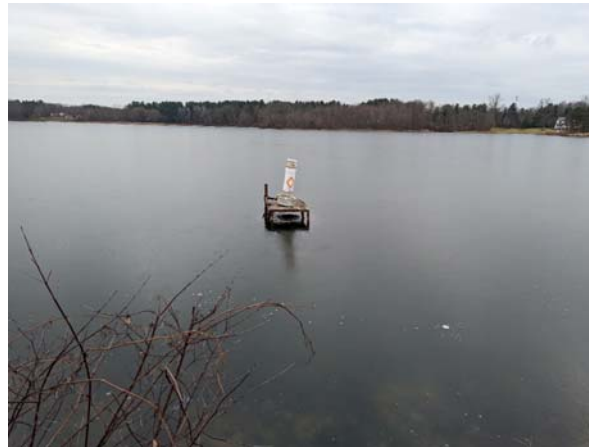
A drop inlet structure, approximately 32 feet from water's edge of the embankment (see Picture 4), is comprised of a vertical 24-inch diameter CMP pipe which connects to a 24-inch diameter CMP pipe that extends towards and under the embankment. At the water surface, there is a metal railing system around the drop inlet, safety buoy, and an operating nut and stem for opening and closing a gate down at the connection to the 24-inch horizontal pipe. It is assumed the gate assists in any necessary lake drawdown. The 24-inch connects to a 36-inch diameter CMP that extends to the north to a concrete headwall⁽¹⁾, where it discharges into a private open drain. The open drain connects to the Yellow River Drain north and west of the dam.

Picture 4 - Drop inlet structure.

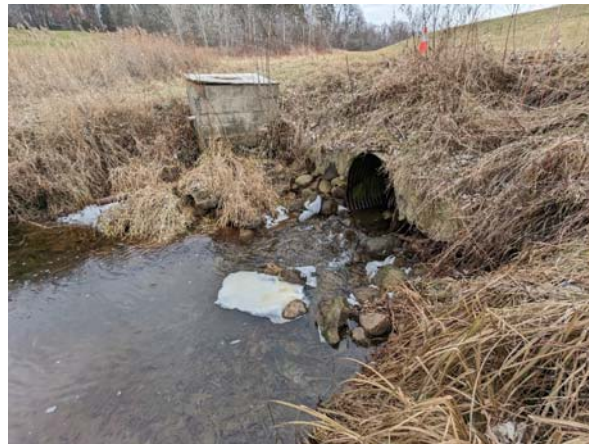
The existing concrete headwall was inspected and was found to be in very poor condition. The other item found from the December 2022 inspection is the CMP pipe which is identified as a 36-inch diameter, was measured, and found to be 40-inch wide in the horizontal direction (see Picture 5). It is uncertain if the pipe is actually larger than identified or if the pipe has deflected downward, creating a more oval-shaped pipe with the horizontal as the major axis of 40 inches.

Picture 5 - Outlet pipe.

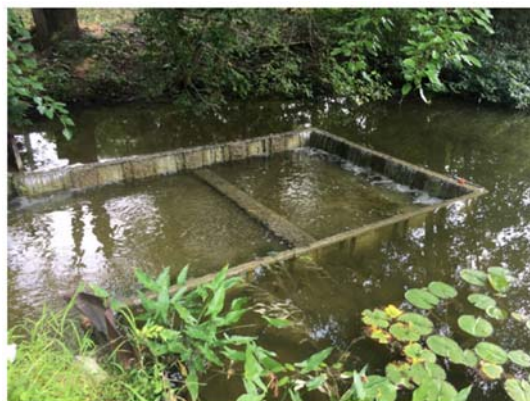
Picture 6

LOOKING NORTHEAST AT LAKE LEVEL CONTROL STRUCTURE

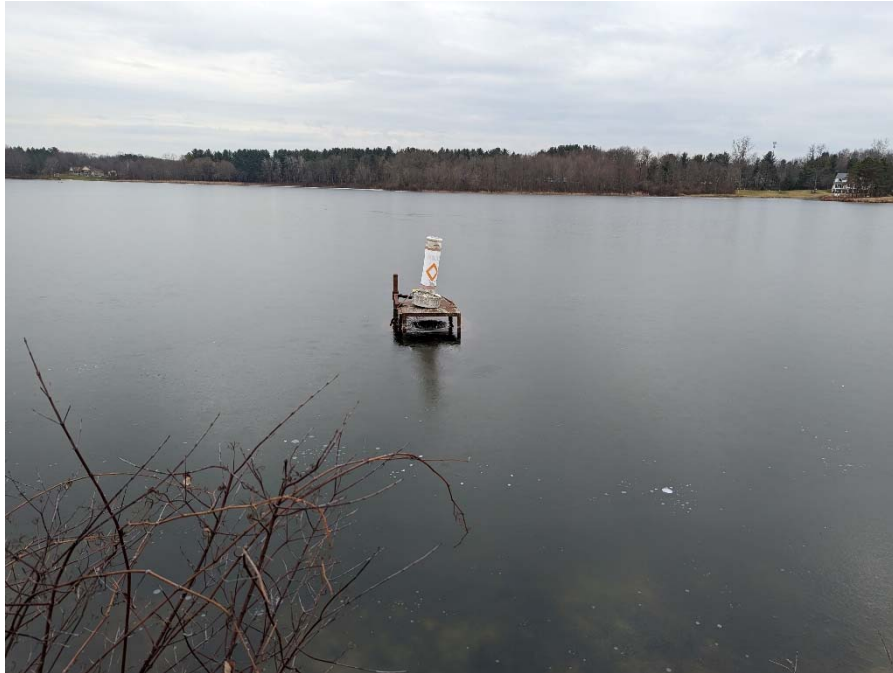
Figure 1 - Looking north from top of dam at the inlet, 36" drop pipe. Valve on left side of structure.

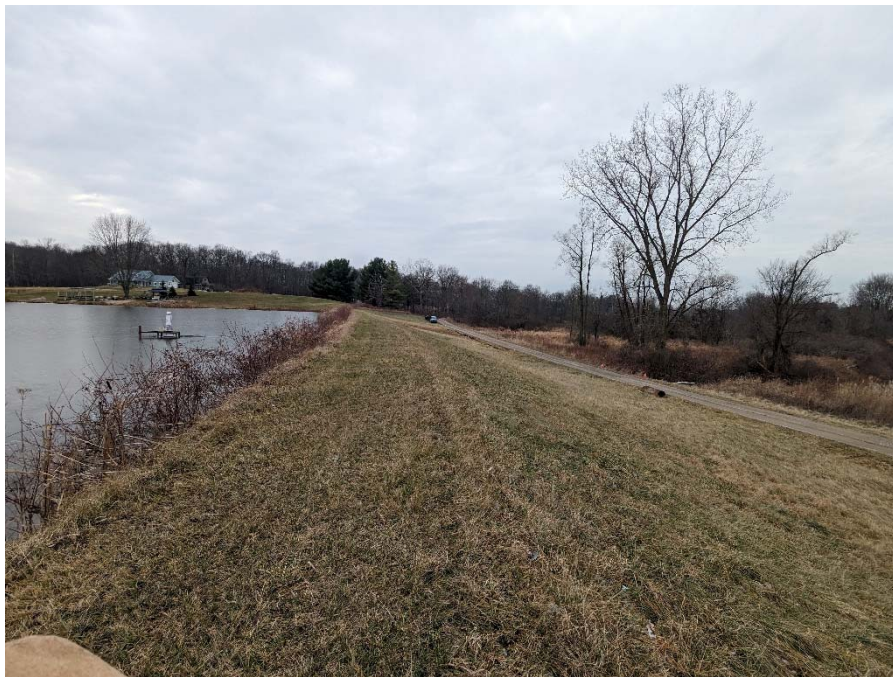
Figure 2a - Looking west along top edge of dam.

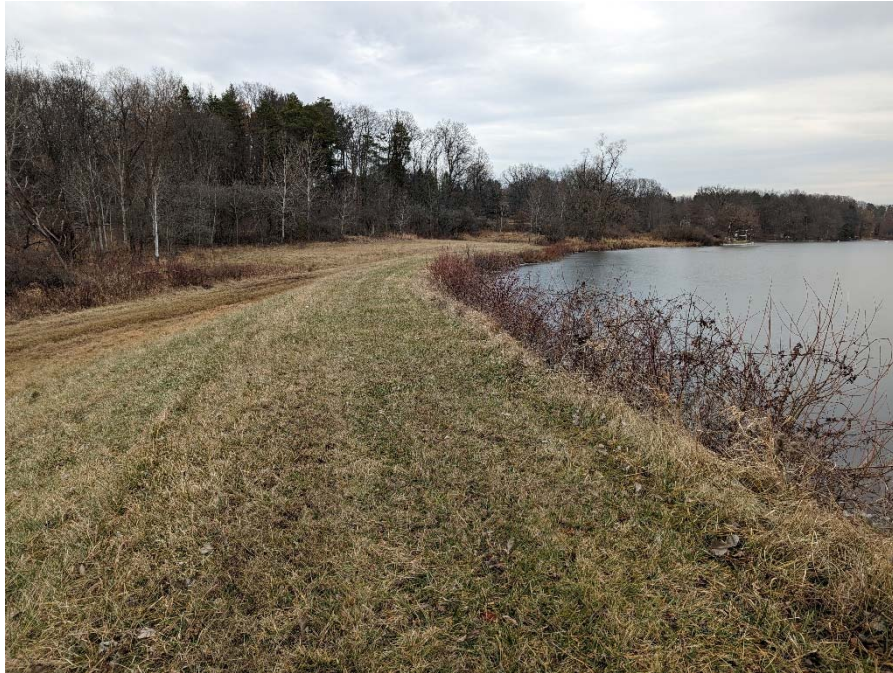
Figure 2b - Looking east along top edge of dam.

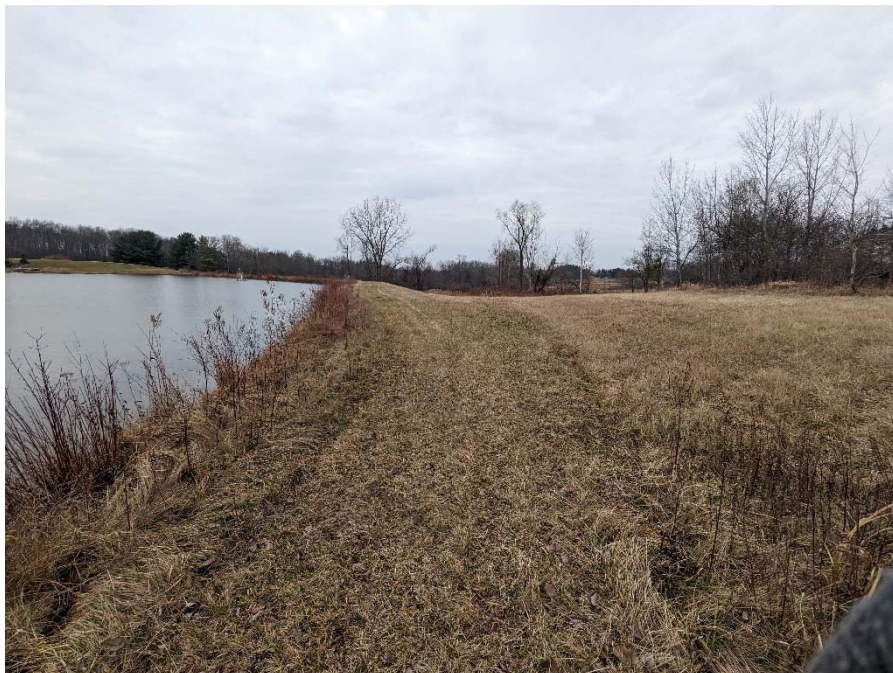
Figure 3 - Looking north, low spot lake overflows to the north into ditch.

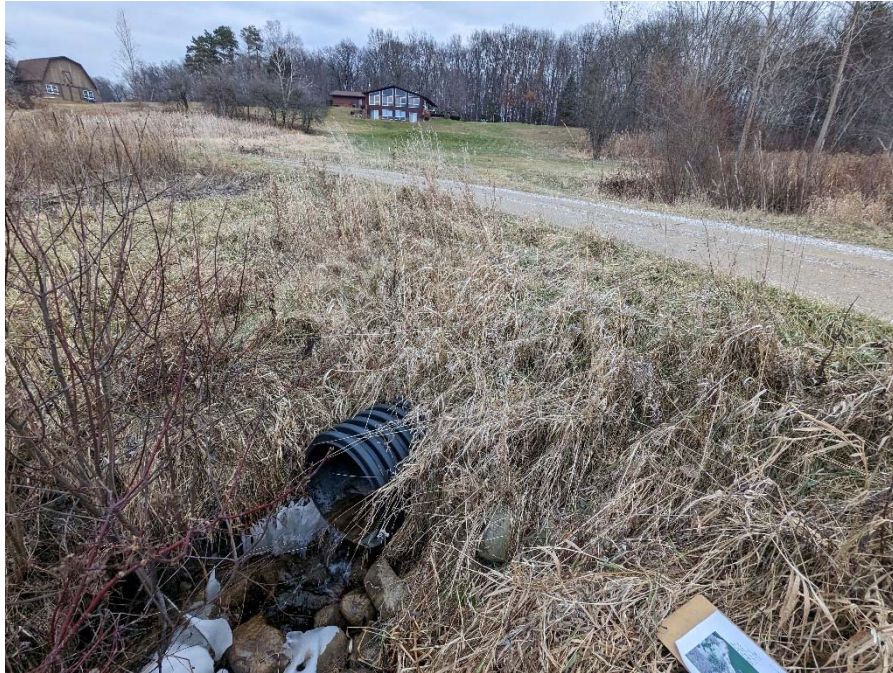
Figure 4 - Looking north at 24" HDPE culvert.

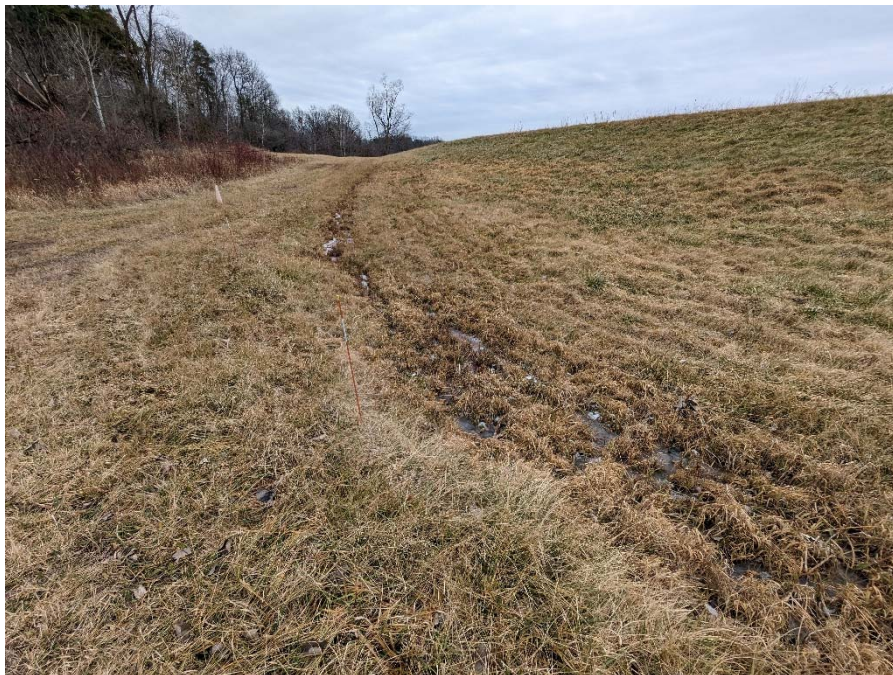
Figure 5a - Looking south uphill at seepage flow.

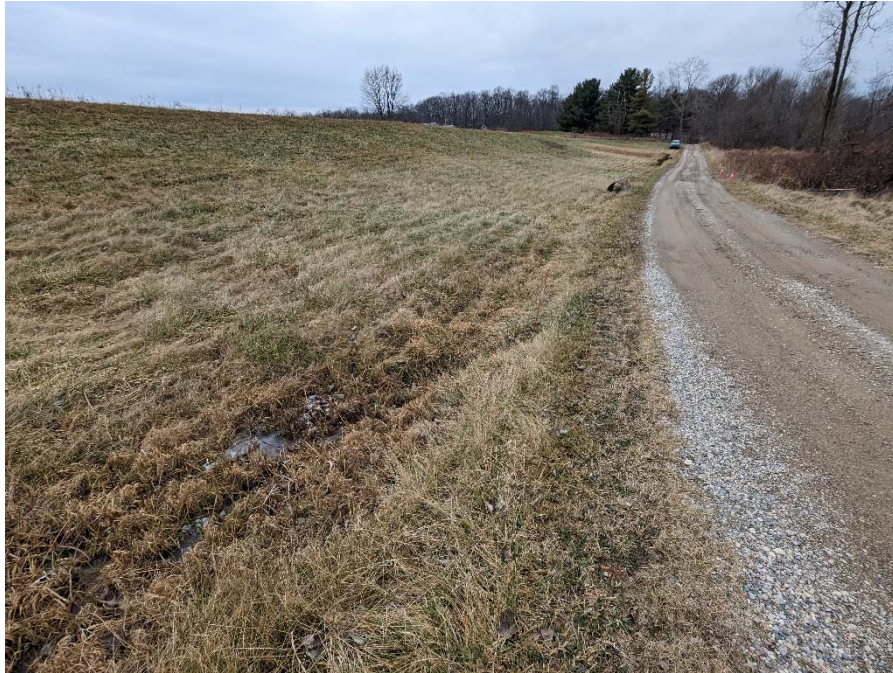
Figure 5b - Looking west along road.

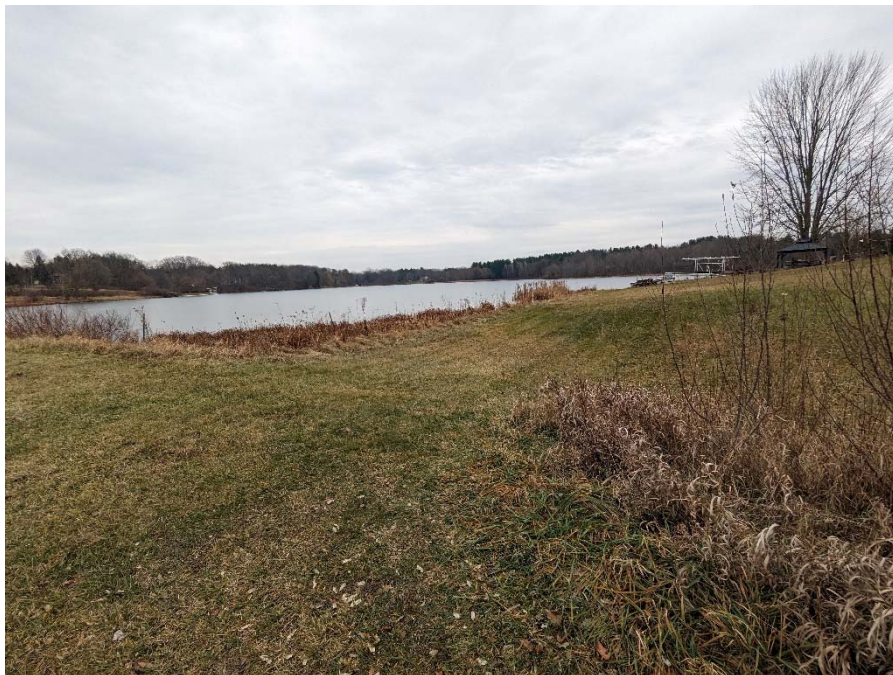
Figure 6 - Looking south at emergency overflow area.

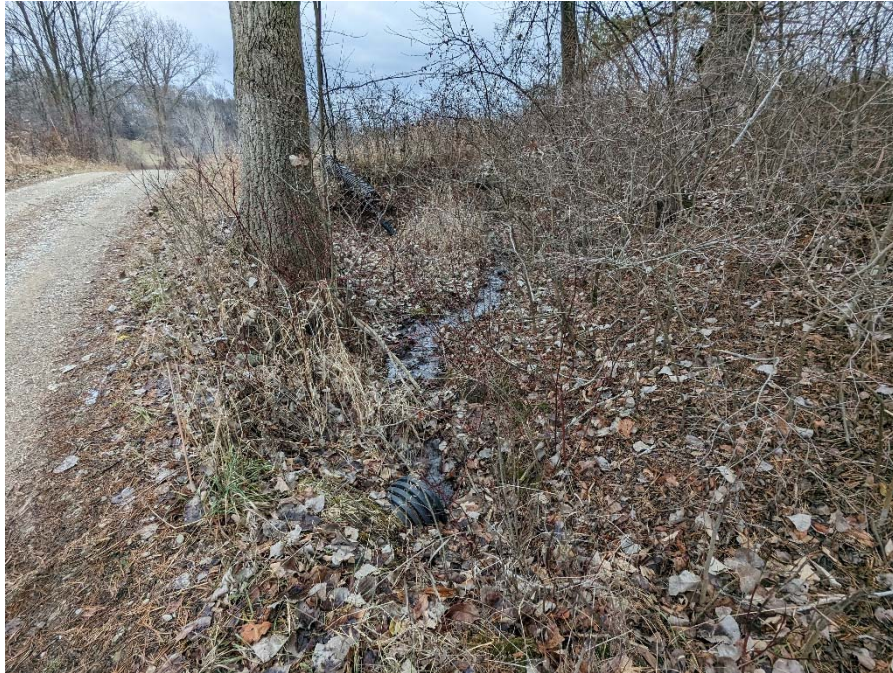
Figure 7a - Looking north at lower end of emergency overflow ditch to 12" HDPE/CMP

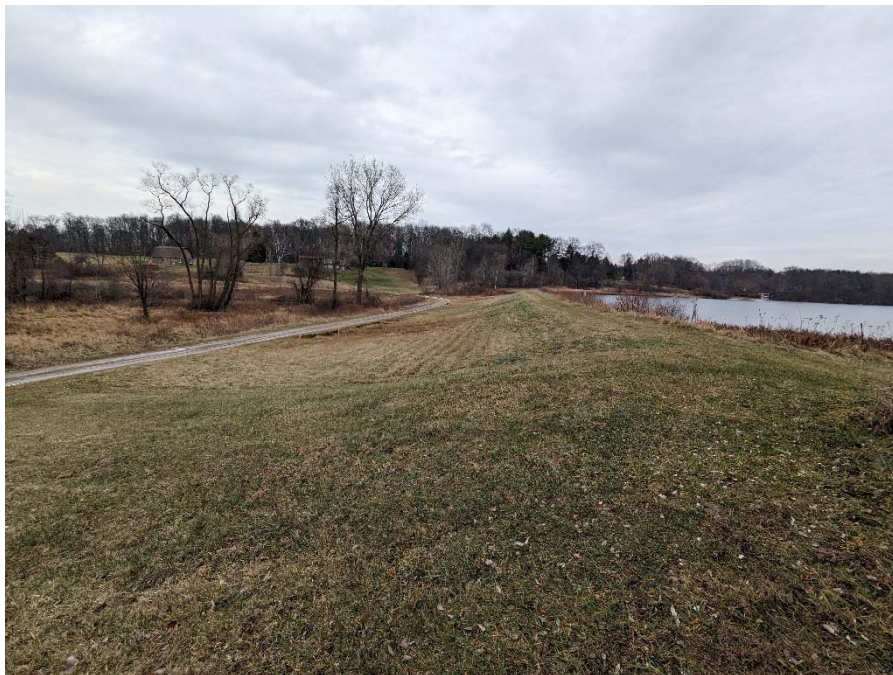
Figure 8 - Looking east at slope, bank between lake and road is typically wet ,

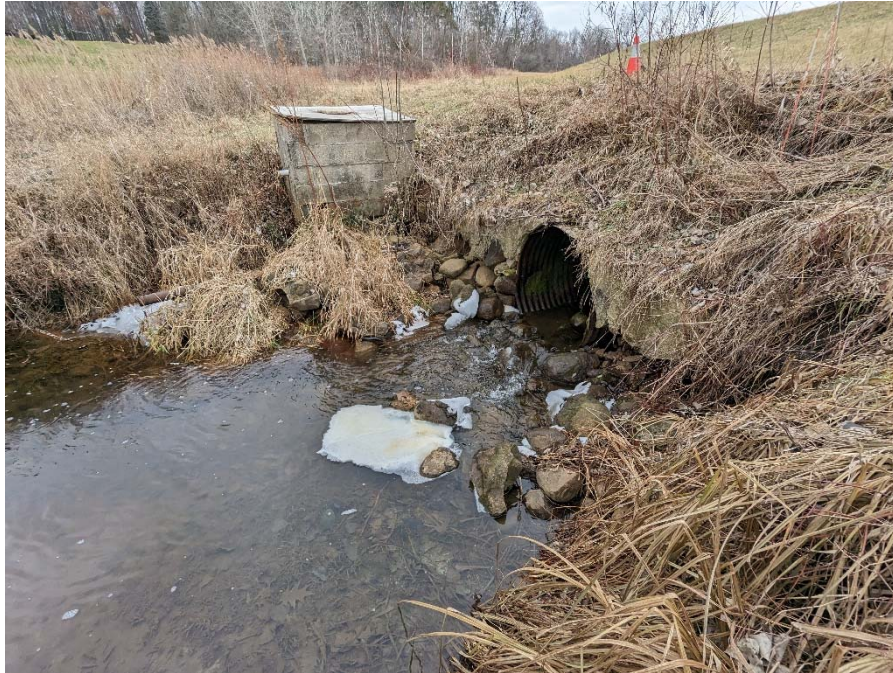
Figure 9a - Dam outlet, measured 40" CMP, corroding inside and deformed, headwall is falling apart and has sinkhole between road and outlet. Box is the irrigation system used for watering the nearby pumpkin patch, no longer in use.

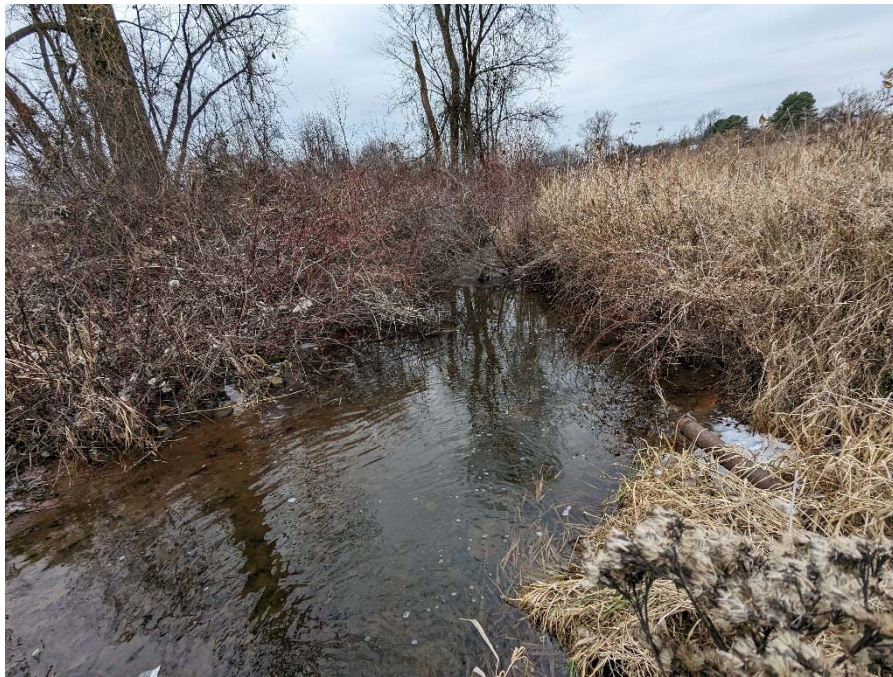
Figure 9b - Looking north/downstream from outlet.

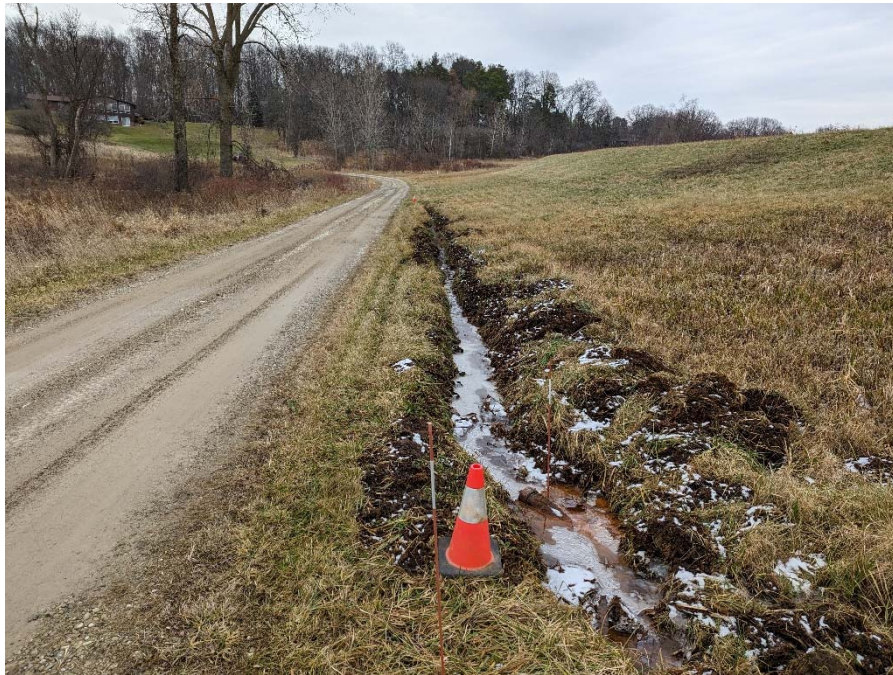
Figure 10 - Looking east at hand dug ditch to collect seepage flow from lake.
