**CONSTRUCTION COMMITTEE**  
**AGENDA**

August 20, 2018

# REQUEST FOR CHANGE ORDER

PROJECT: Livingston County 911 Dispatch Center

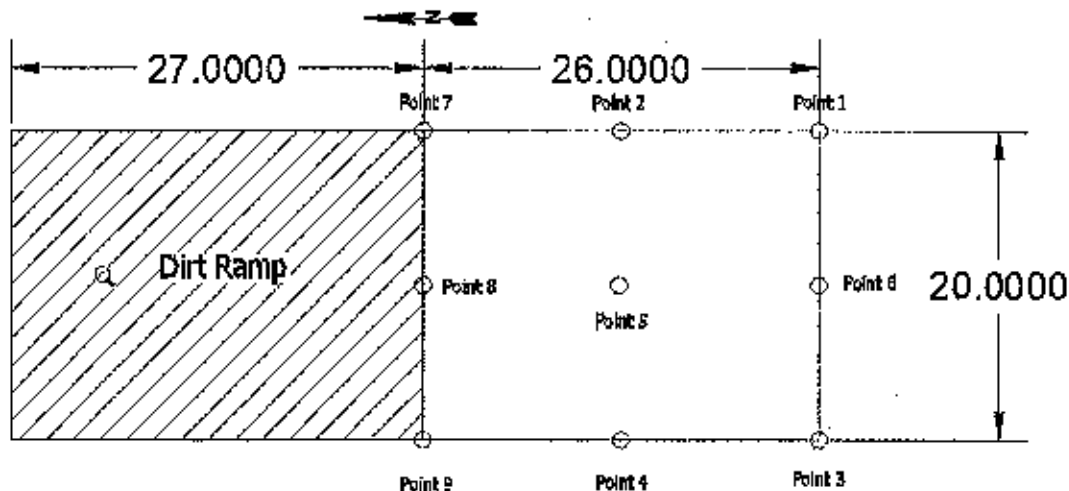
On Arrival, digging was underway for the footing of the building. Hole was dug on the proposed southeast part of the building location. Benchmark was set up on the Iron rod on a power pole on the northern part of the site which has an elevation of 903.50. Elevations in the chart below signify the points shown in the hole to obtain bottom of hole elevation. The figure on the bottom shows the location of these points relative to the hole that was dug. Soil Inspector (Mike) was on site inspecting the soil at the bottom of the hole. Around 11:00 am, Joe Recka shut down the project for the day. The hole that was dug was not filled.

Benchmark Elevation 903.50	Units: Feet
Point Identifier	Elevation
1	898.33
2	898.25
3	897.28
4	897.79
5	897.73
6	898.01
7	898.03
8	897.78
9	897.73

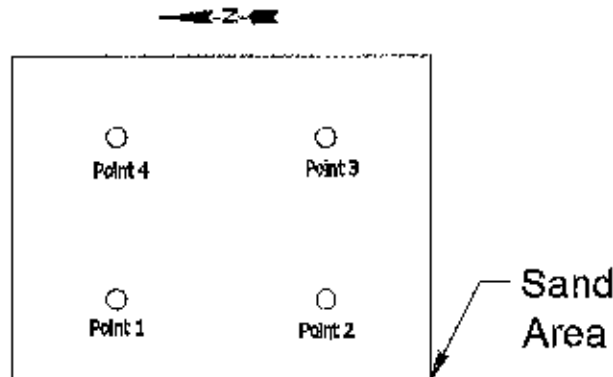
On Arrival, site was done with construction for the day with no workers present. Matt approached me and instructed me to take elevation shots on a sand filled area to determine the elevation of the sand surface. This sand filled area was the same area that was previously dug on 7/20/18. Matt proceeded to stake the area with four different locations and wanted the elevations of these spots. Using the bench mark that was located to the north of the site on a power pole, the elevation of the surface at these stakes were measured (which is stated below). These elevations were then written on the stakes. Matt explained that the elevation of this area should be around 900 ft, so around 2.5 ft of sand needs to be removed.

Benchmark Elevation 903.50	Units: Feet
Point Identifier	Elevation
1	902.38
2	902.52
3	902.75
4	902.67

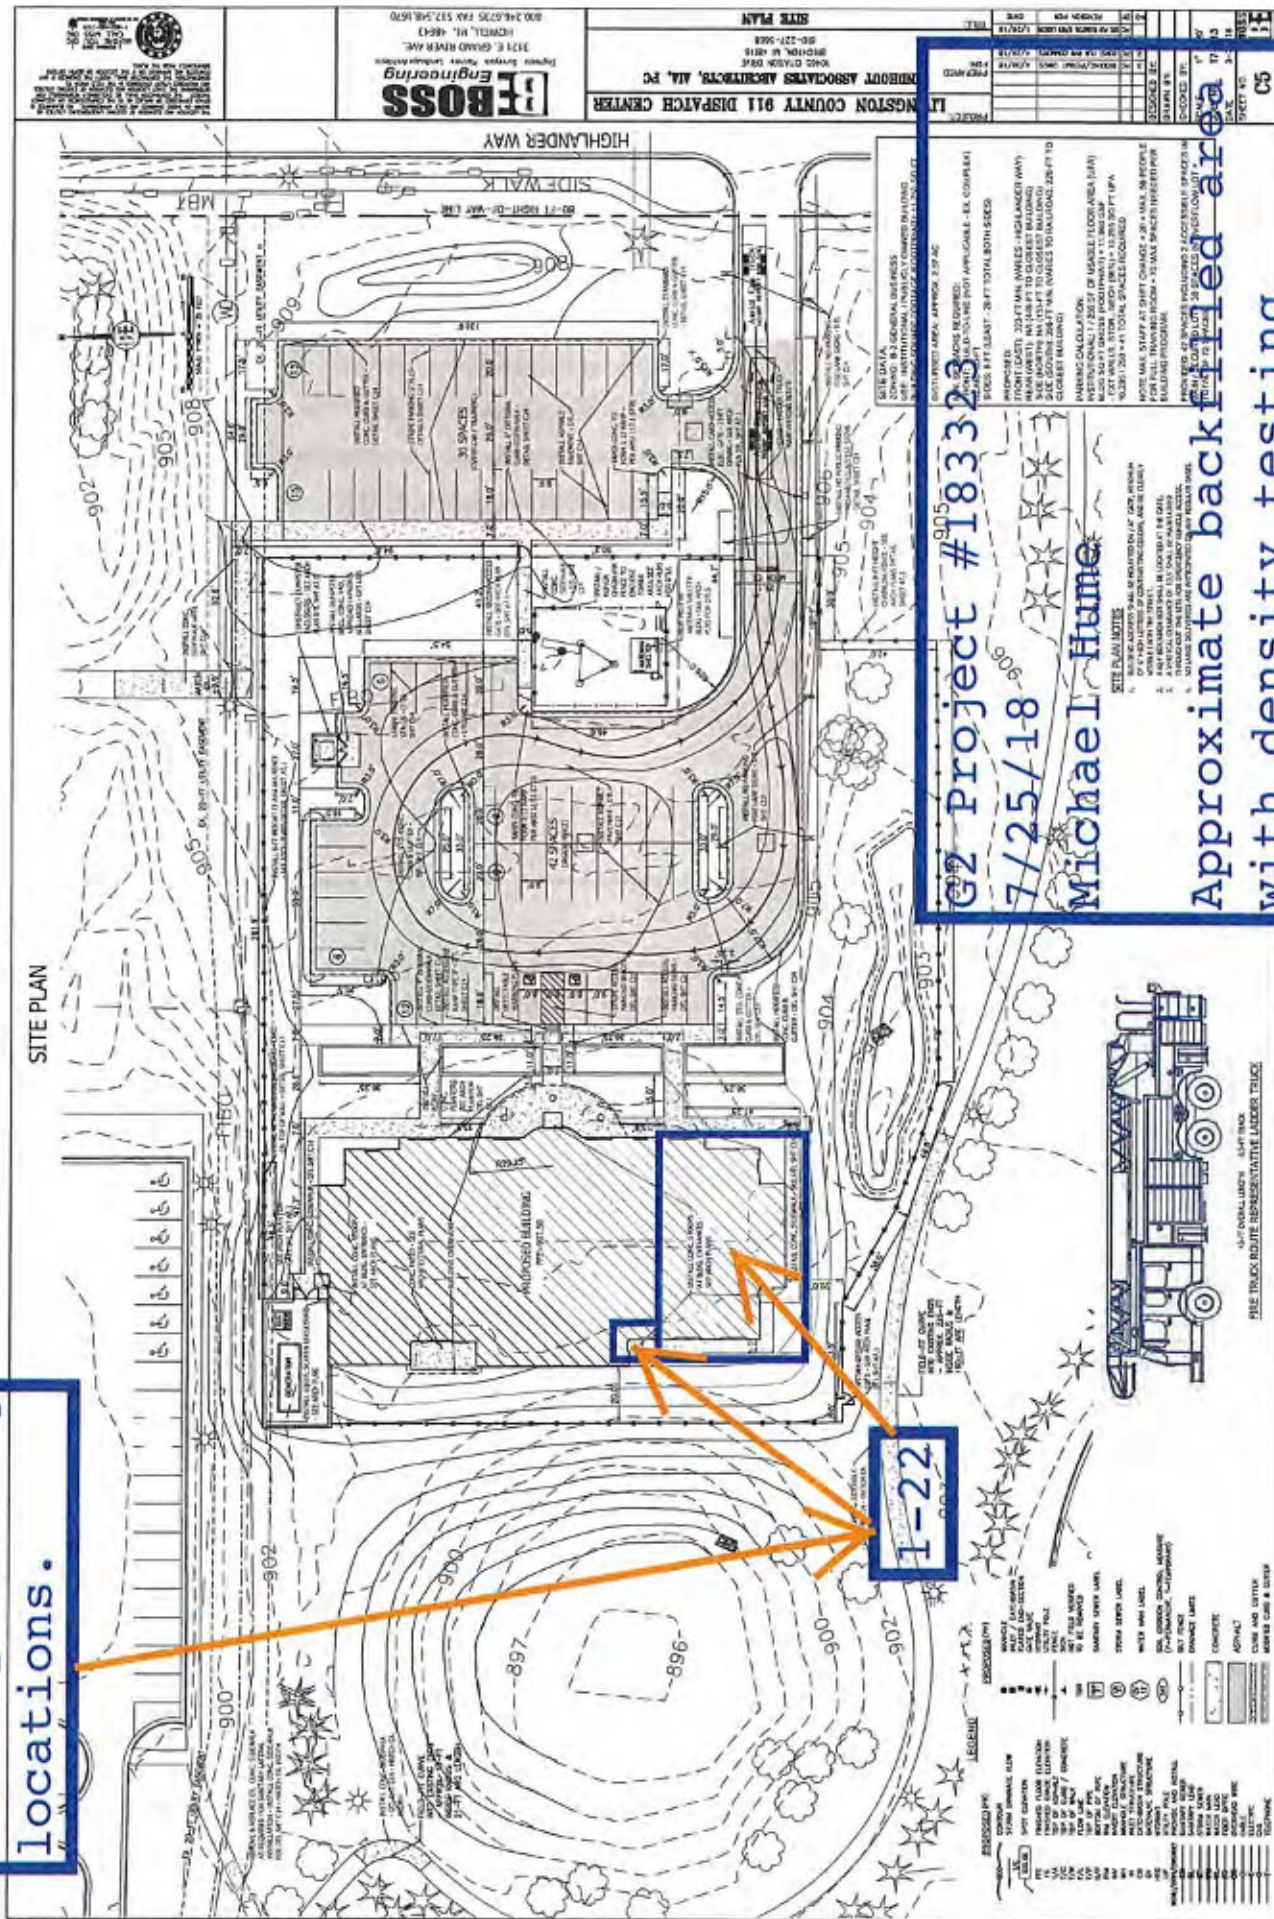
## Density testing locations.

Approximate backfilled area  
with density testing  
locations.
