Wade Trim Associates, Inc.
25251 Northline Road • Taylor, MI 48180
734.947.9700 • www.wadetrim.com

January 25, 2023

Re: Faussett Lake Dam Technical Memorandum

Faussett Lake Dam Site Investigation
December 22, 2022

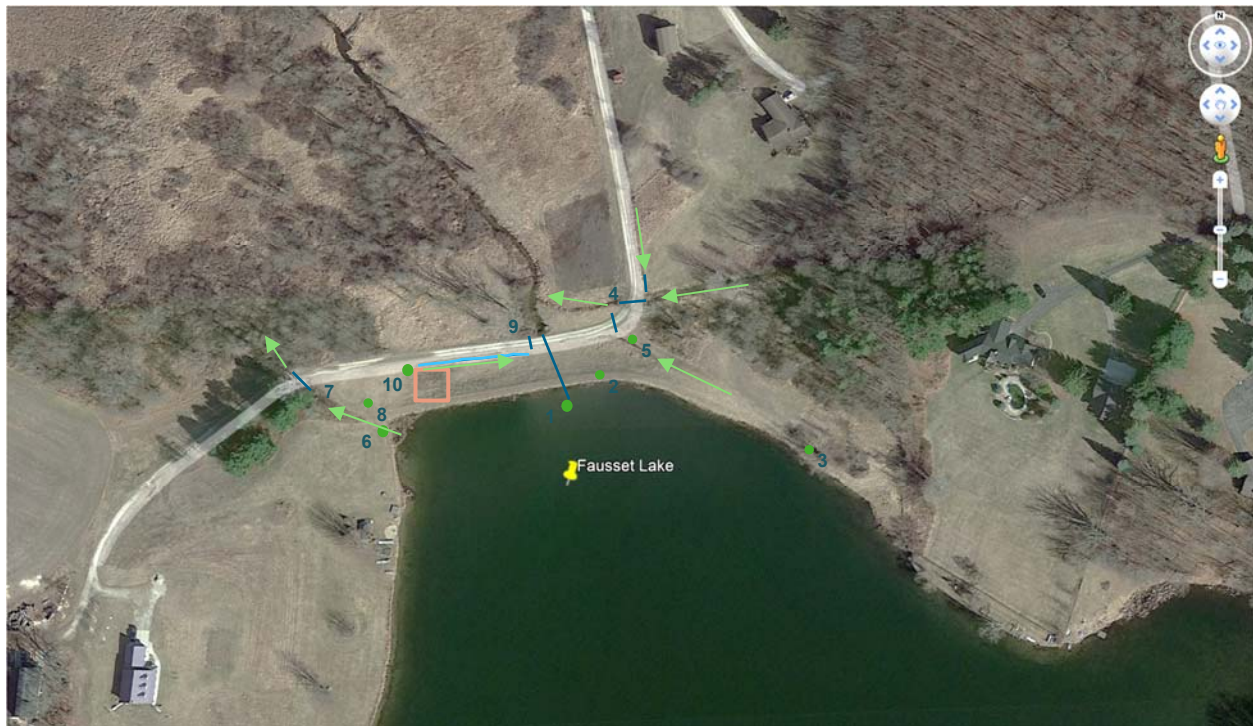
There is an area towards the west end of the embankment, on the downstream side, that is exhibiting continuous seepage through the embankment. It is a large wet and soggy area the day of this inspection and the understanding from the owner, as well as other information provided, is that this area is continuously wet.^(1,2) The SME Geotechnical Evaluation referenced herein indicates existing soil conditions at the embankment to be largely “embankment fills,” consisting of very loose to medium dense silty sand with clayey sand layers. Below the embankment fills are natural clays that are classified as very stiff to hard consistency. It appears from the geotechnical investigation that rather than utilizing an impermeable clay core for construction of the embankment, loose fills were employed that are leading to the seepage through the embankment. In addition, the groundwater in the embankment varies from 0.2 feet below ground surface to +/- 15 feet below. This is a direct result of the Faussett Lake level impacting the groundwater elevations and helps to verify the indication that water seepage is occurring through the embankment.
