Faussett Lake Dam Inspection Report

Dam Identification No.: 307
Hazard Potential: Low
Section 33 ; T.04N. – R.05E.
Deerfield Township, Livingston County, Michigan
Located on the Yellow River
Per Part 315, Act 451 of 1994

Date of Inspection: August 9, 2022
Date of Final Report: December 22, 2022

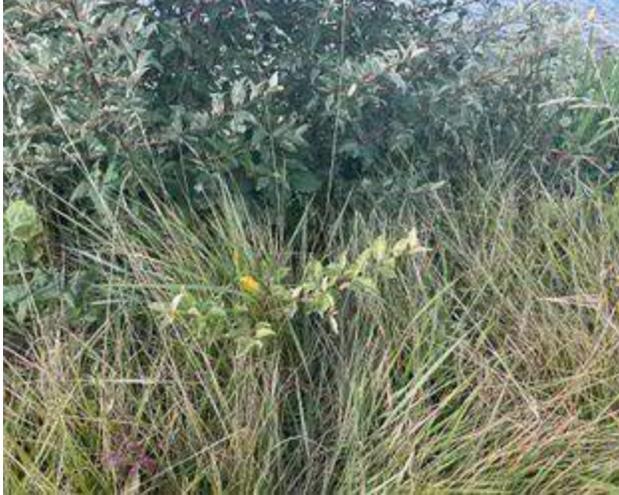
DESCRIPTION: Animal burrow in bank

SEVERITY: Medium

Recommend: Fill in the animal burrows. Determine if these are muskrats and if they can be trapped and removed. Please see the attached fact sheet regarding the identification and remediation of animal burrows contained in Appendix F.

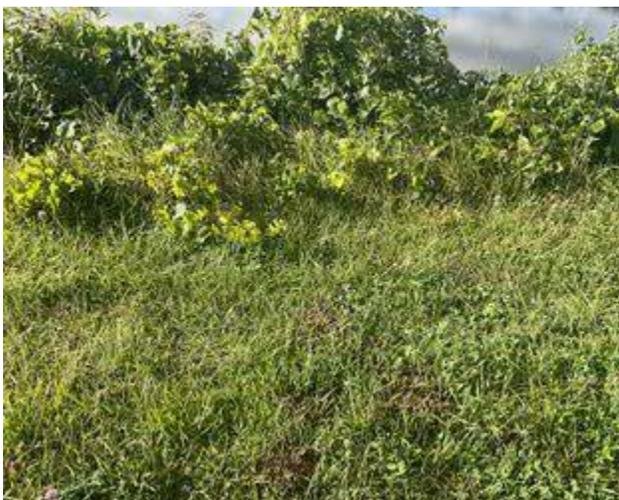
DESCRIPTION: Animal burrows in bank

SEVERITY: Medium

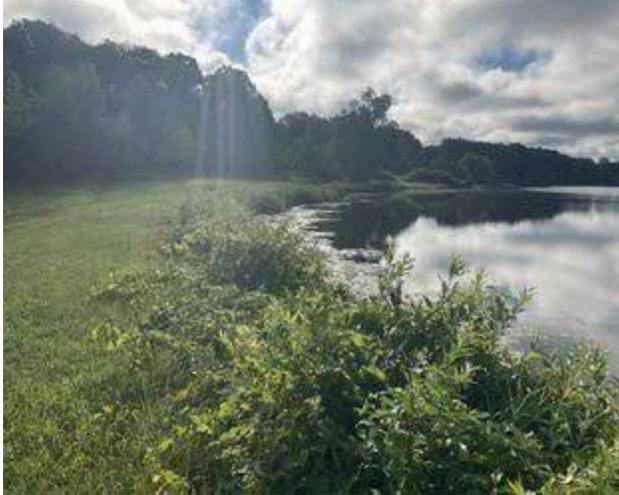
DESCRIPTION: Looking east at top of embankment, bank well vegetated

SEVERITY: Low

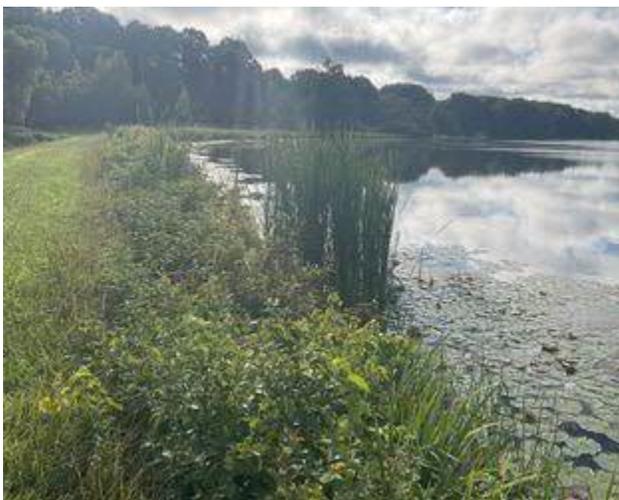
DESCRIPTION: Looking east at vegetation growth in lake, bank well vegetated

SEVERITY: Low

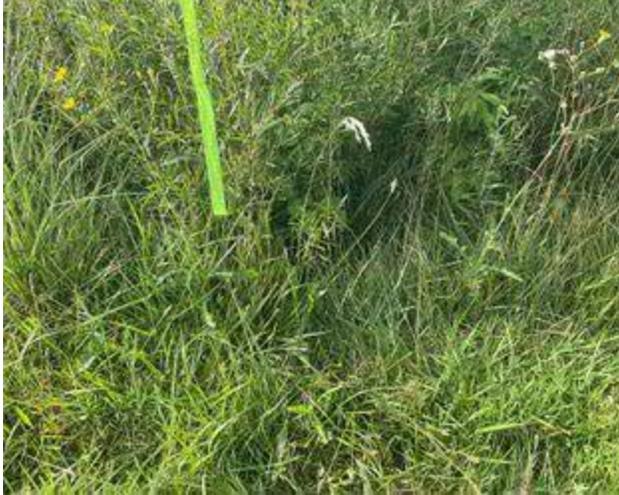
DESCRIPTION: Animal burrows
in bank

SEVERITY: Medium

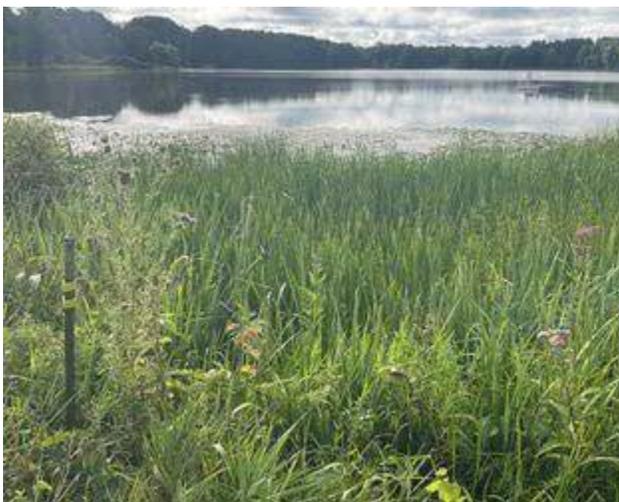
DESCRIPTION: Looking south
at vegetation in lake

SEVERITY: Low

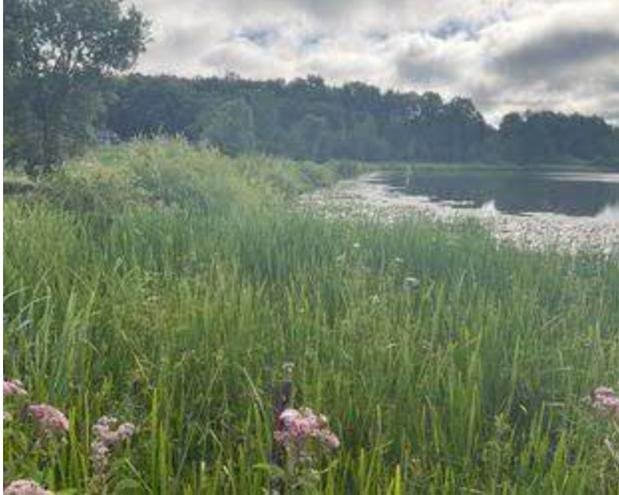
DESCRIPTION: Looking east at upstream bank, well vegetated

SEVERITY: Low

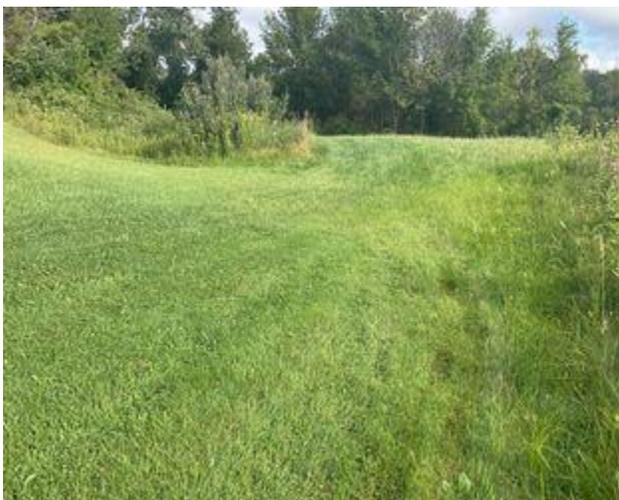
DESCRIPTION: Looking downstream at spillway

SEVERITY: Low

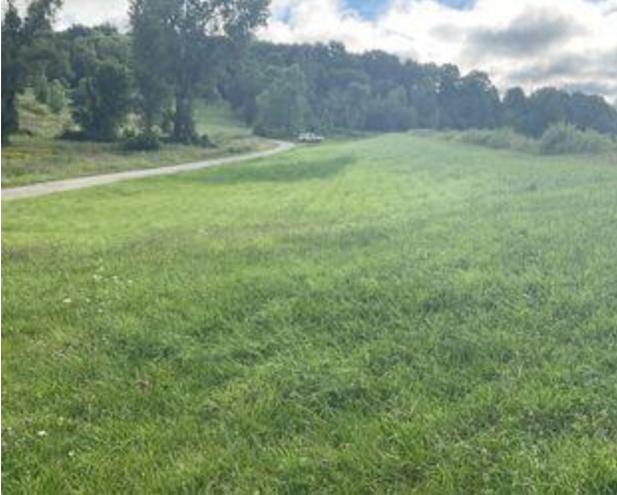
DESCRIPTION: Looking from east, downstream slope of embankment

SEVERITY: Low

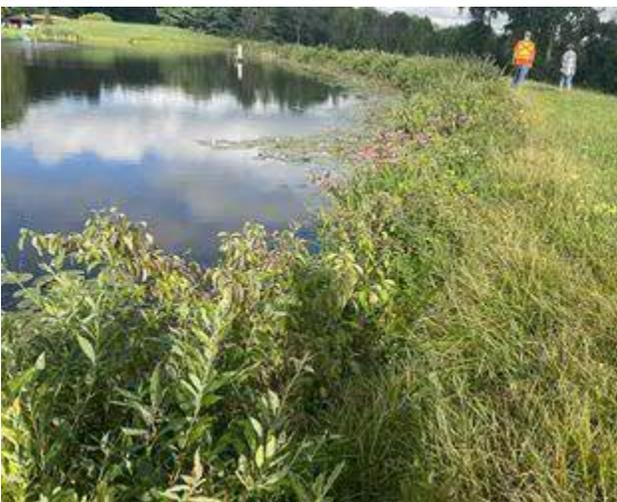
DESCRIPTION: Looking west at rock placed on bank, bank well vegetated

SEVERITY: Low

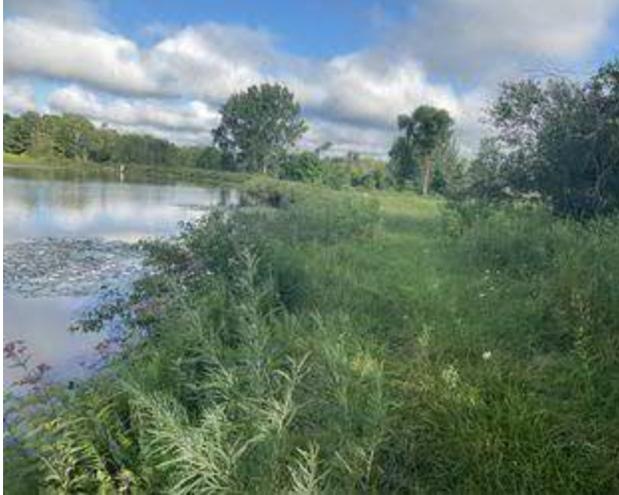
DESCRIPTION: Looking north at embankment and spillway, bank well vegetated

SEVERITY: Low

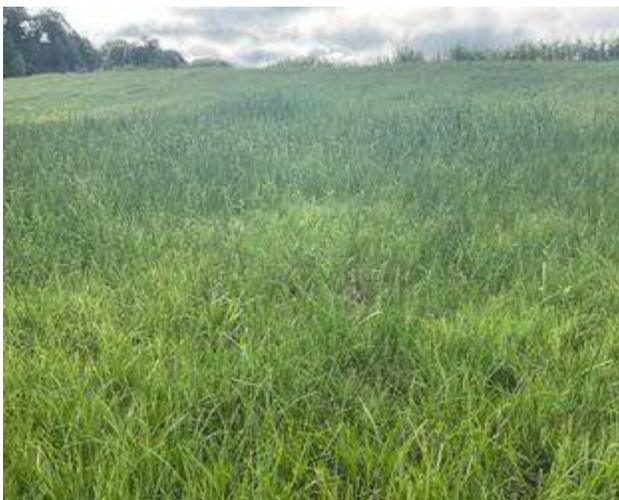
1. There is continuing seepage on the downstream slope on the western end of the earthen dam. The seepage is slowly running onto the drive at the base of the slope. No piping was noted or erosion was noted during this inspection.

DESCRIPTION: Looking south at saturated ground on downstream embankment

SEVERITY: Low

Recommend: As recommended in the 2022 geotechnical report (included in Appendix E) a drained buttress should be implemented to remediate seepage and stabilize the earthen embankment. Continue to routinely monitor seepage until remedial action is taken.

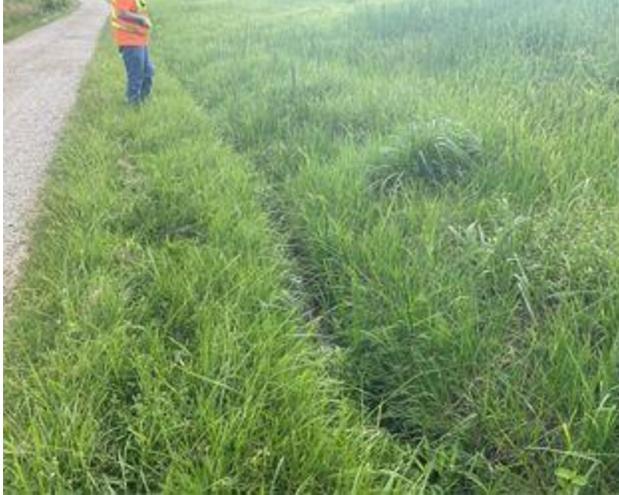
DESCRIPTION: Looking east
at toe drain on bottom of
embankment

SEVERITY: Low

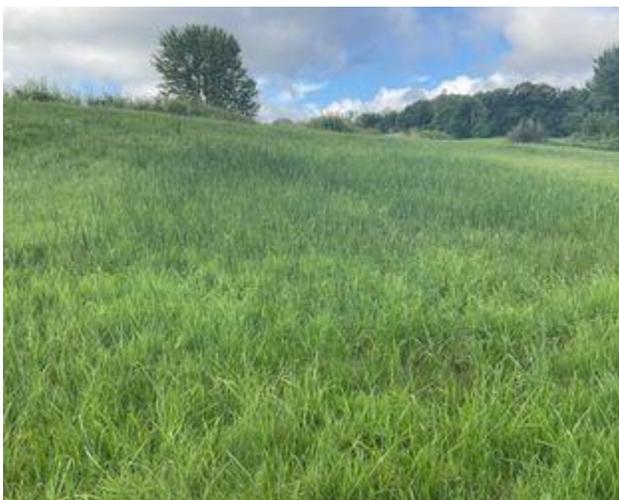
DESCRIPTION: Looking west at
saturated ground on down-
stream slope of embankment

SEVERITY: Low

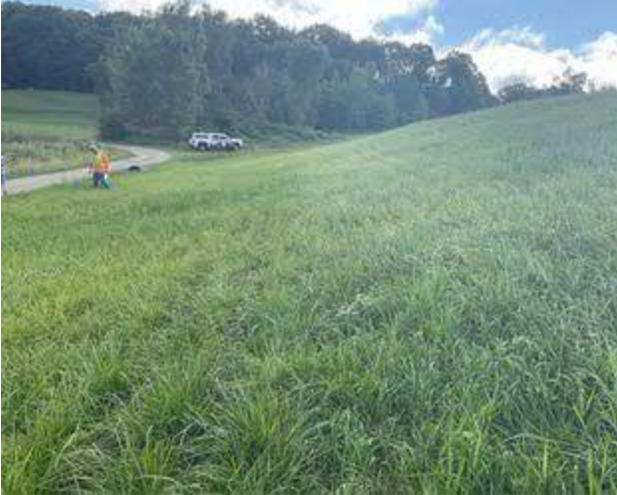
DESCRIPTION: Looking east
at downstream slope of
embankment

SEVERITY: Low

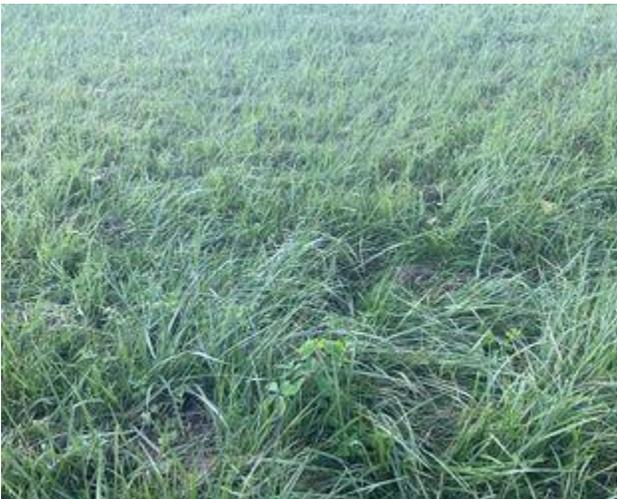
2. The 36” corrugated metal pipe (CMP) outlet is corroding and the outlet headwall is failing. Minor settlement was observed at the downstream toe of the embankment along the alignment of the outlet pipe.

DESCRIPTION: Sinkhole over
outfall pipe

SEVERITY: Low

Recommend: Continue to monitor the corrosion annually until repair or replacement can be made to the pipe and headwall. Monitor the soil over the length of the top of the outlet pipe for evidence of additional settlement or sinkholes.

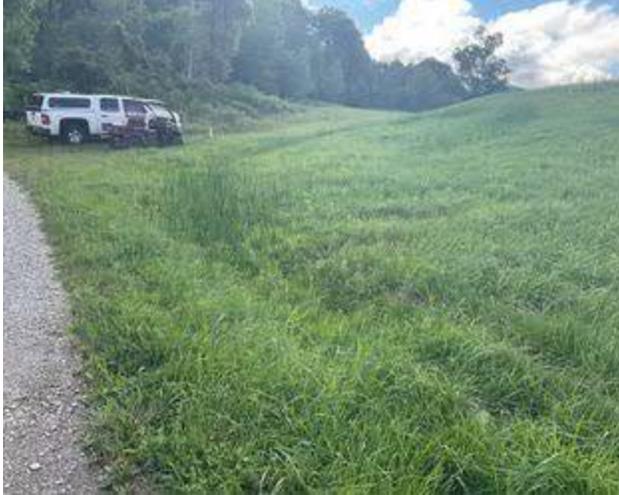
DESCRIPTION: Looking east at downstream toe of embankment, auxiliary spillway

SEVERITY: Low

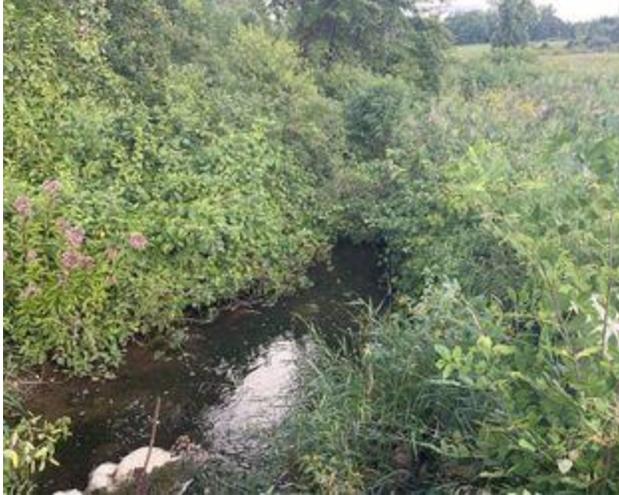
DESCRIPTION: Downstream watercourse

SEVERITY: Low

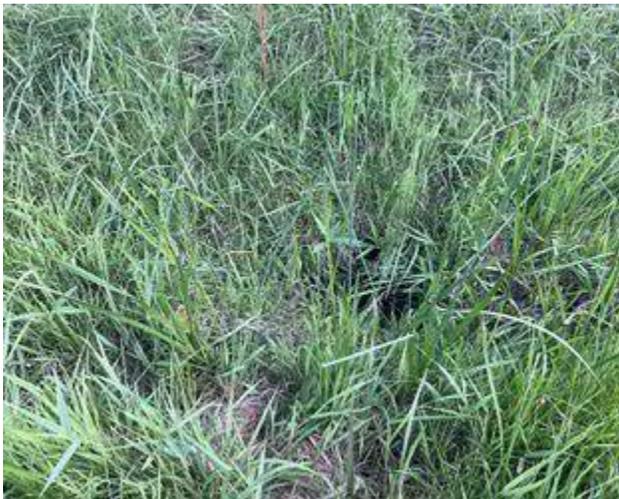
DESCRIPTION: looking downstream at culvert under access road

SEVERITY: Low

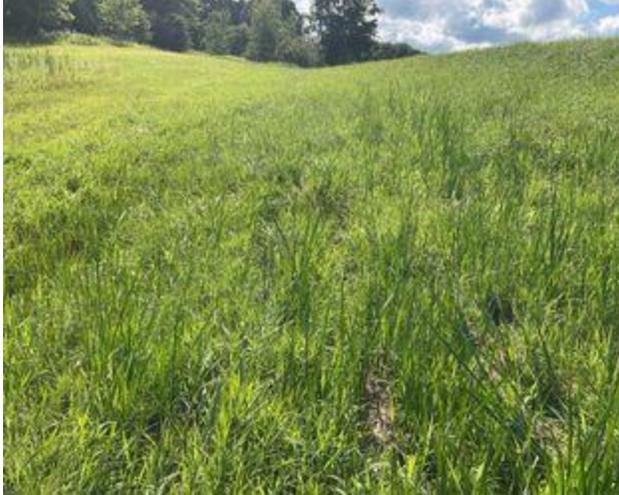
DESCRIPTION: Looking south at small area of seepage beginning near auxiliary spillway

SEVERITY: Medium

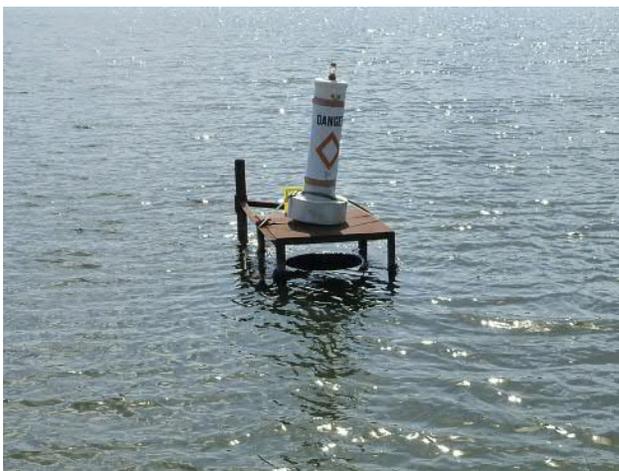
DESCRIPTION: Standpipe Control Structure

SEVERITY: Low

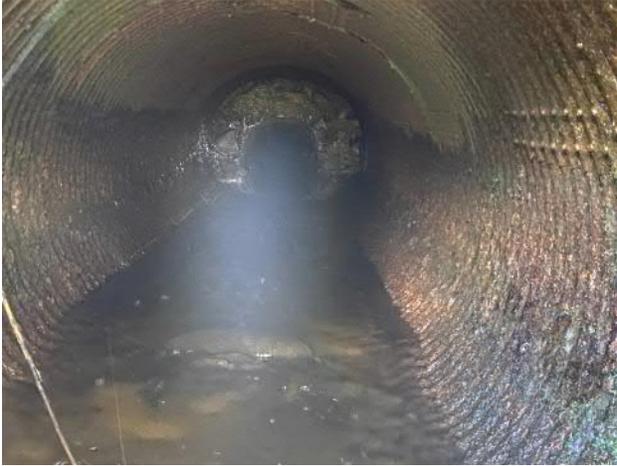
DESCRIPTION: Looking upstream
transition from RCP to CMP in
outlet

SEVERITY: Low

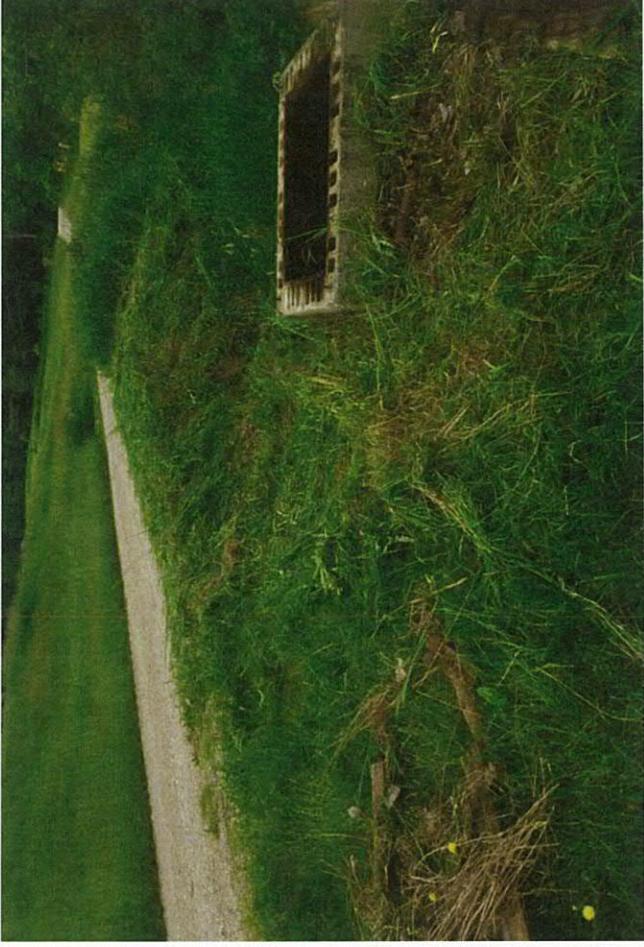
Downstream face of dam, looking west.

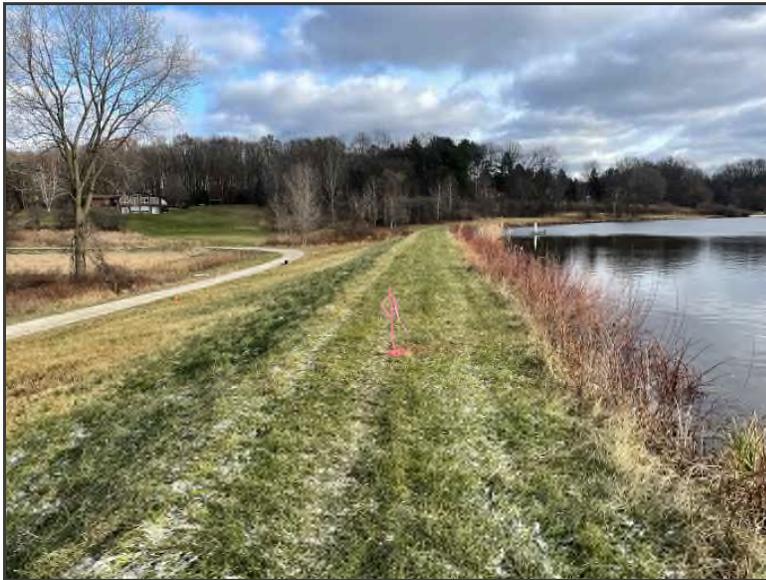
Image 1: Looking east along the crest of the dam embankment (photo date: 12/7/2021).

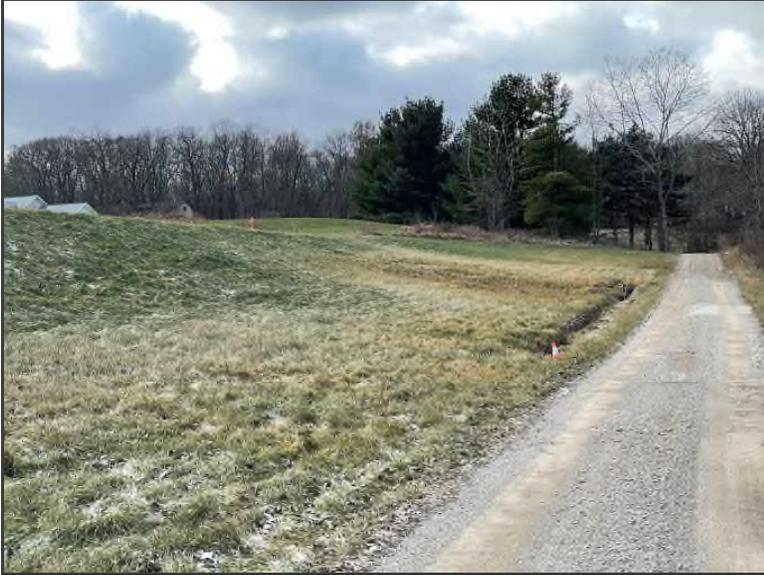
The area of subject seepage is located along the western portion of the downstream embankment, and generally located within the lower half of the embankment. The approximate area of the seepage is denoted on Figure No. 1. The seepage area is estimated to extend over an area measuring roughly 60 feet by 35 feet. The presence of seepage in this area was denoted in the 2007 Faussett Lake Dam Inspection Report, the 2012 Faussett Lake Dam Inspection Report, and the 2017 Faussett Lake Dam Inspection Report.

Image 4: Looking west along the driveway at the toe of the embankment. The seepage area is visible to the left of the driveway (photo date: 12/7/2021).

Noticeable seepage was emanating from the downstream slope of the embankment during our field exploration. The area of seepage is located within about the lower half of the embankment and toward the western end of the overall embankment. The conditions within this area are depicted on Images 3 through 5 above, and the approximate area where seepage is present on the downstream slope face is illustrated on Figure No. 1. At the time of our field exploration, this area was visibly wet and very soft, making even walking over this area difficult. Our engineer easily sank several inches into the subgrade while walking over the area. The downstream slope of the embankment had been mowed in the fall of 2021, prior to the SME field exploration performed in December 2021. However, photographs of the embankment contained in the referenced safety inspection reports indicate that cattails routinely grow in the area of seepage each summer. This seepage has also been noted in safety inspection reports prepared by Spicer and dating back to 2007. Inspection reports from 1997 and 2002 are referenced in the 2007 Faussett Lake Dam Inspection Report prepared by Spicer, but copies of these previous reports were not provided for review to verify notes on potential seepage observations in 2002 and 1997.

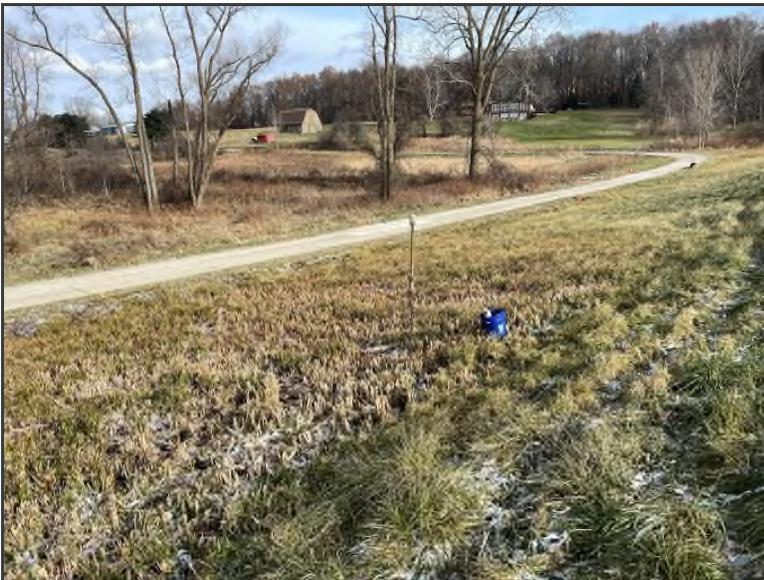
Image 5: Looking northeast at the seepage area. The blue bucket is located near the upstream edge of the seepage (photo date: 12/7/2021).

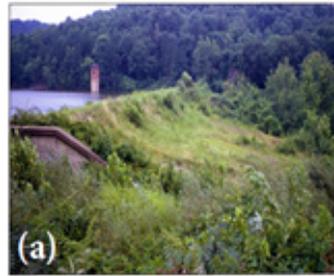
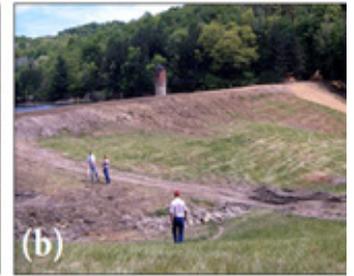
(a) Embankments covered with trees and brush makes inspections difficult. (b) Cleared of trees and brush, this embankment is much easier to inspect, but needs a good vegetal cover.

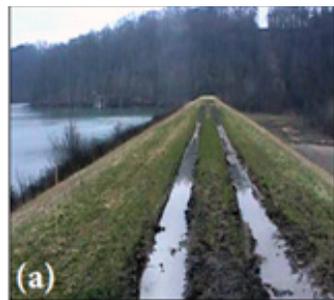
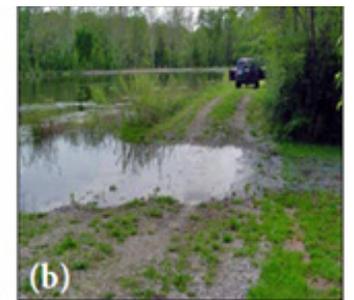
(a) Embankment crests with vehicle ruts will collect water and weaken the embankment. (b) Crest beginning to overtop in low area. This could lead to erosion and failure of the dam.

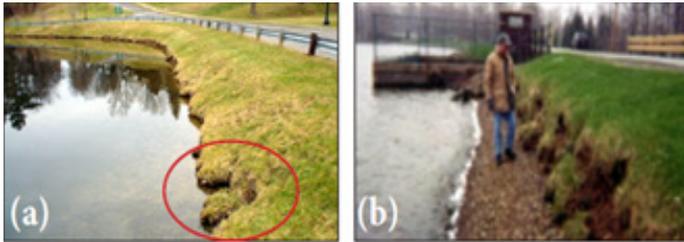
(a) Collapsed muskrat burrows increase shoreline erosion and sloughing. (b) This shoreline has eroded due to lack of proper erosion protection leading to sloughing and cracking of the slope.

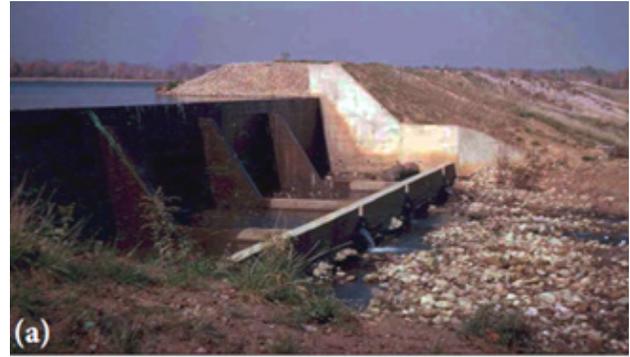
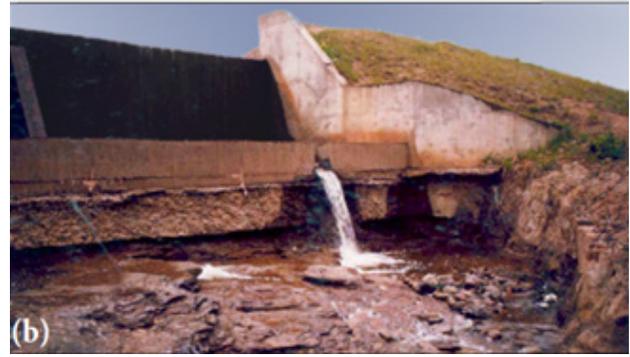
(a) A spillway outlet area as originally constructed. (b) Severe erosion has undermined the spillway outlet and threatens the overall structural safety of the spillways.

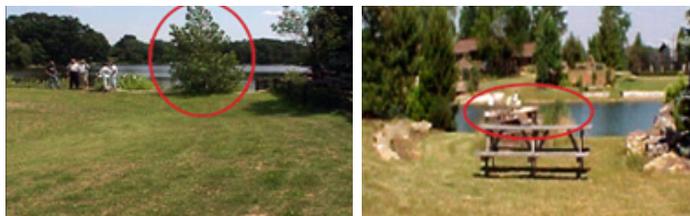
Left: A tree is obstructing this spillway. Right: Notice the landscaping directly behind the table. Obstructions in the spillway reduce the capacity to convey water. They also can collect debris, further diminishing the capacity of the spillway.

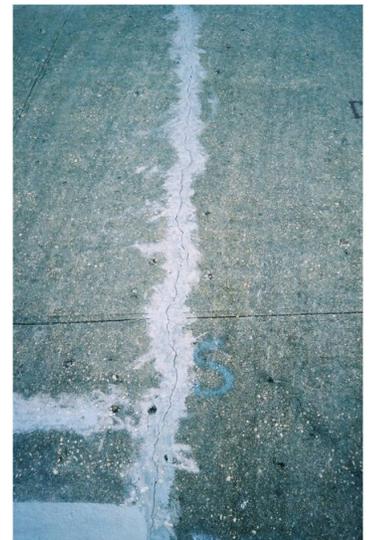
Example of cracking.
